# VEHICLE INSPECTION REPORT

**KE17GYA**

## Seat Leon 1.4 EcoTSI 150 FR Technology 5dr DSG

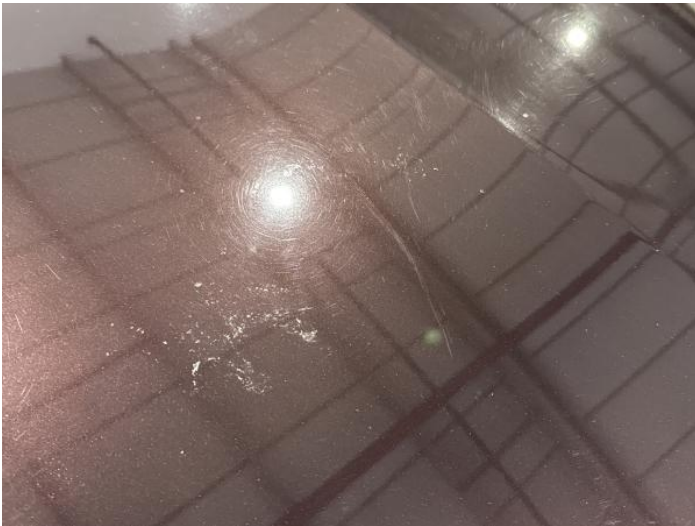
1: Bonnet  
Scratched  
Over 25mm Thru Paint

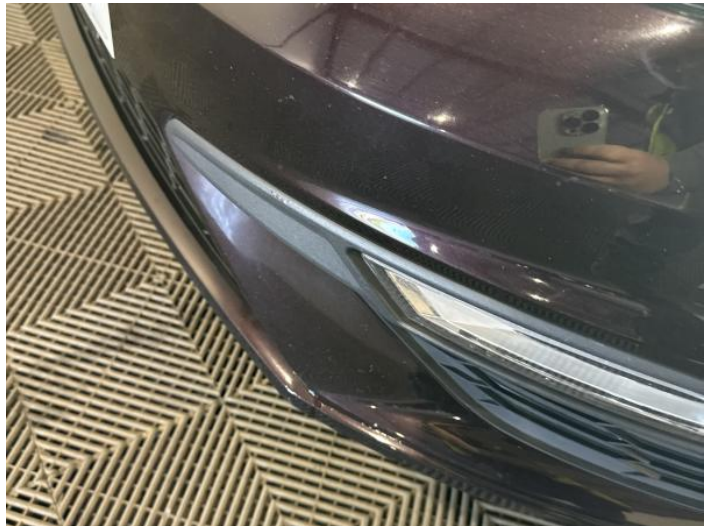
2: Bumper Front  
Chipped  
Multiple Chips

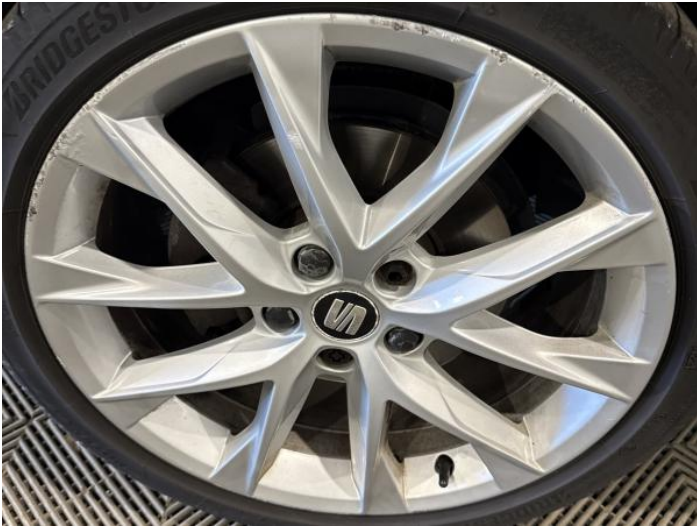
3: Wheel nsf  
Scratched  
Over 50mm

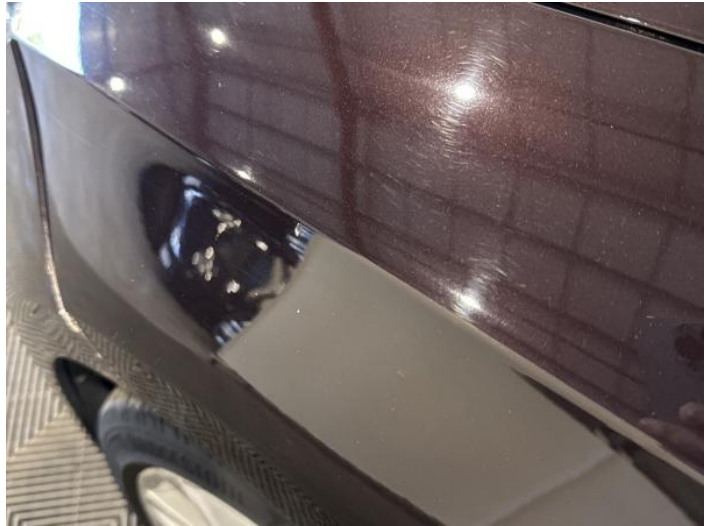
4: Wing nsf  
Chipped  
1 To 5

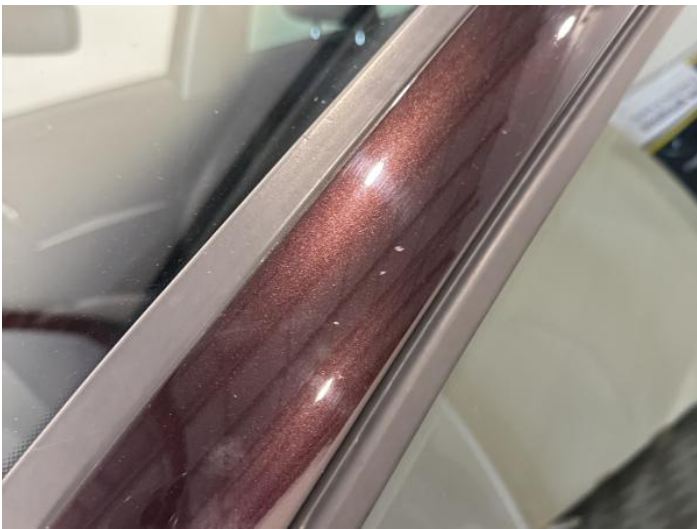
5: A Post ns  
Chipped  
1 To 5

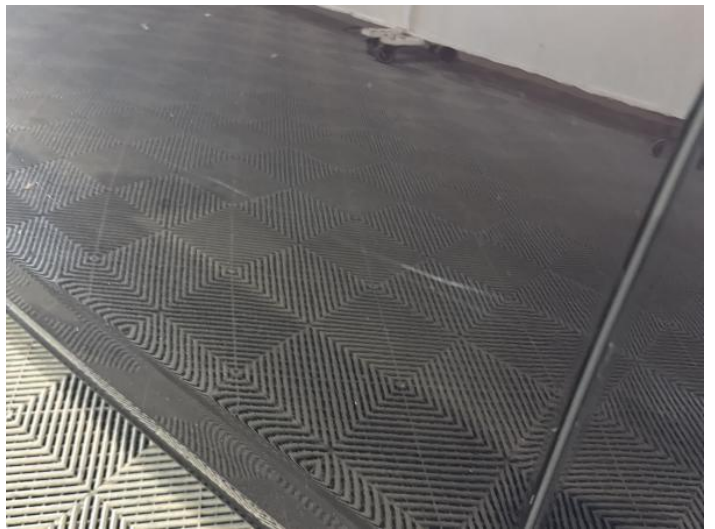
6: Door nsf  
Scratched  
Over 25mm Thru Paint

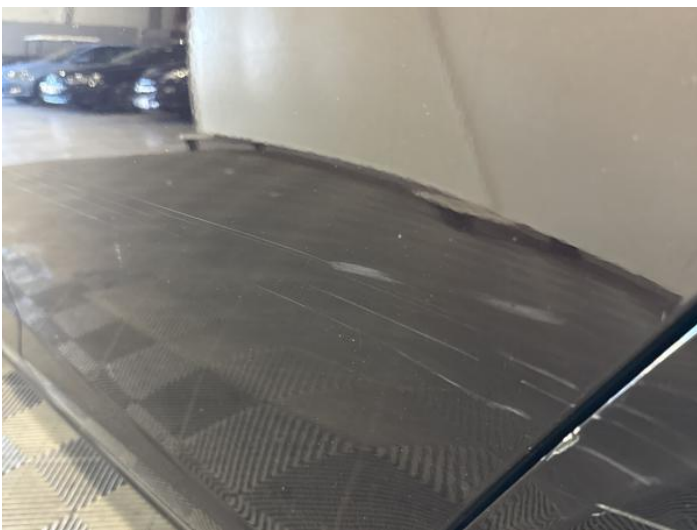
7: Door nsf  
Scratched  
Over 25mm Thru Paint

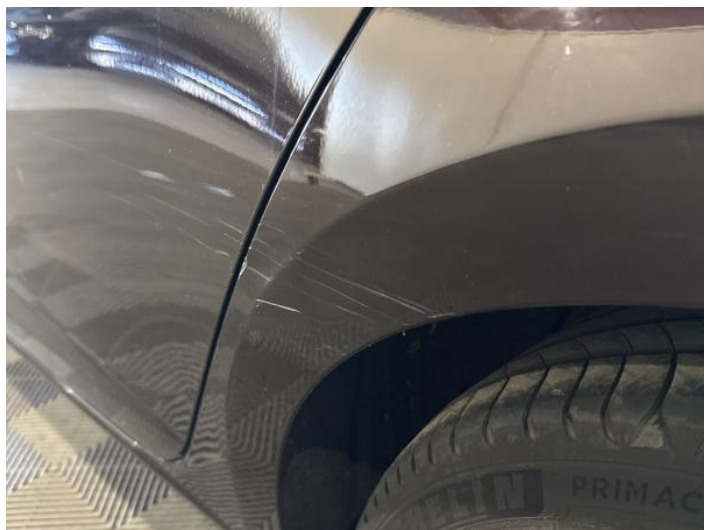
8: Qtr Panel nsr  
Dented  
With Paint Damage

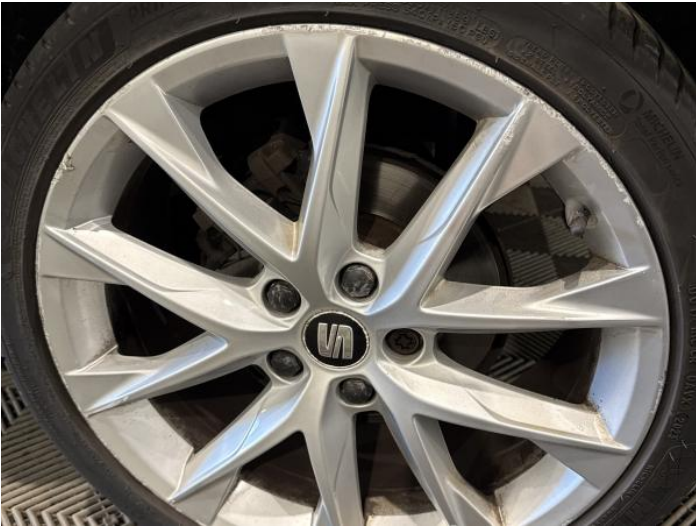
9: Wheel nsr  
Scratched  
Over 50mm

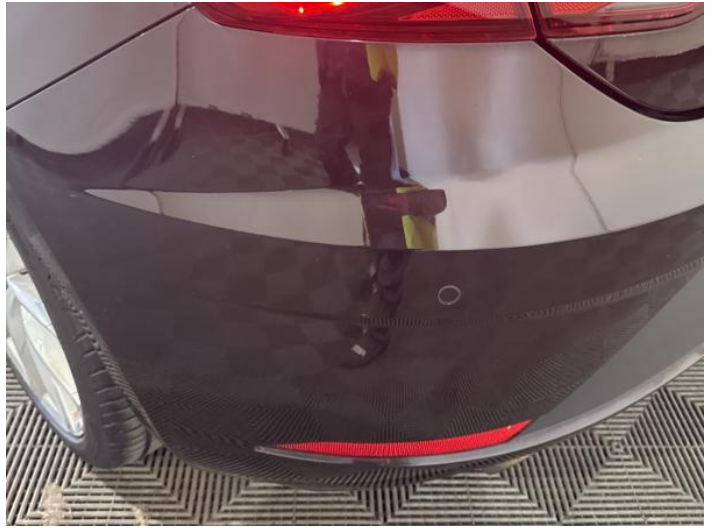
10: Bumper Rear  
Scratched  
25 to 100mm Thru Paint

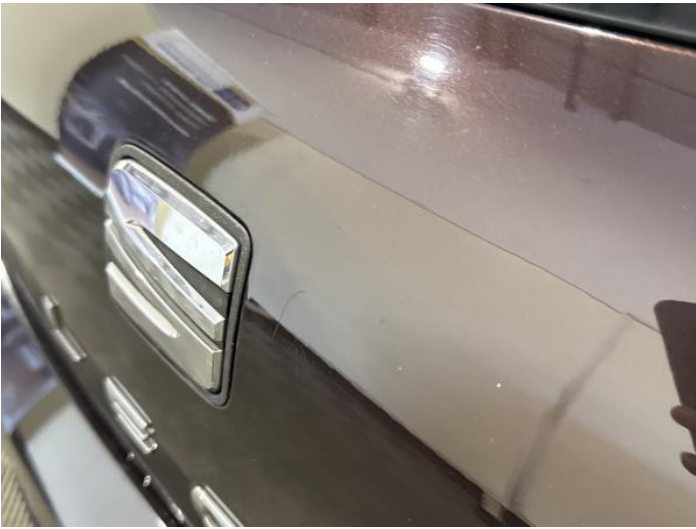
11: Tailgate  
Scratched  
UpTo 25mm Thru Paint

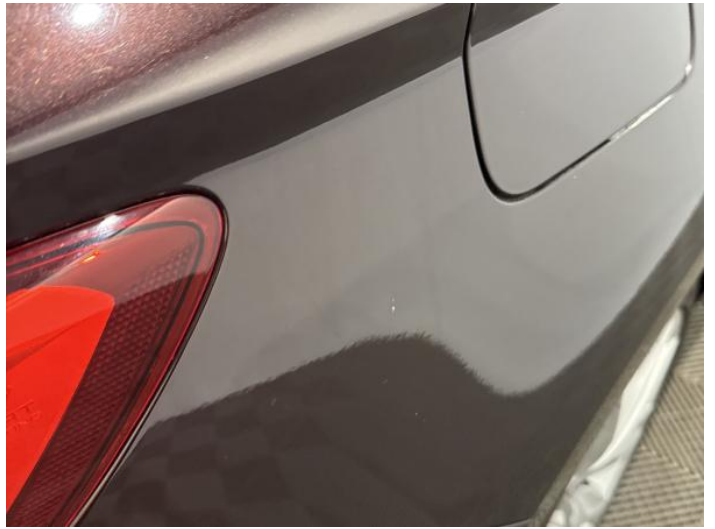
12: Qtr Panel osr  
Dented  
Between 10mm + 30mm

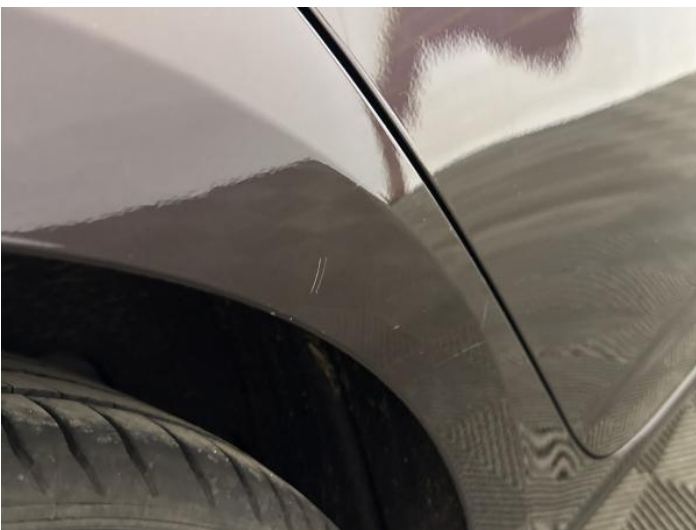
13: Qtr Panel osr  
Scratched  
Over 25mm Thru Paint

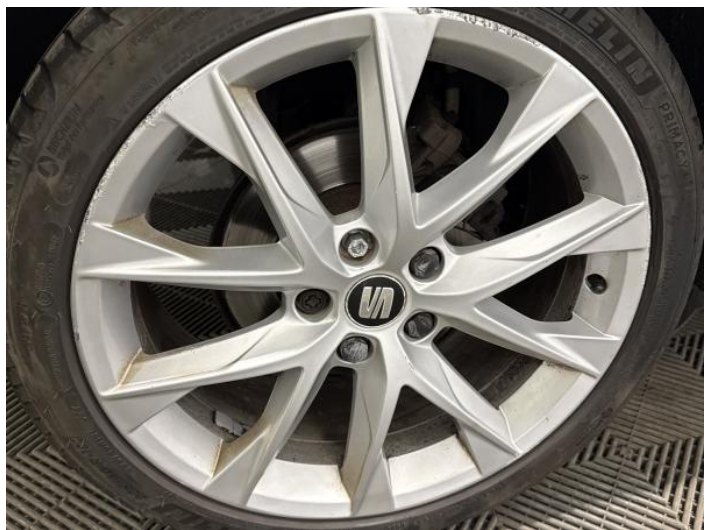
14: Wheel osr  
Scratched  
Over 50mm

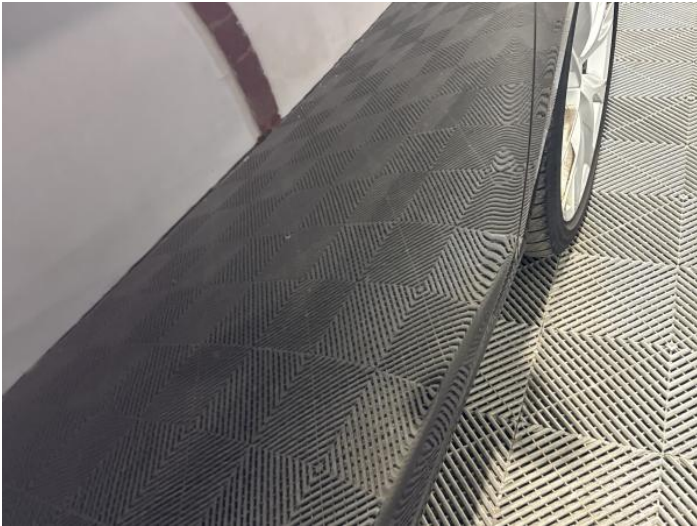
15: Door osf  
Chipped  
1 To 5

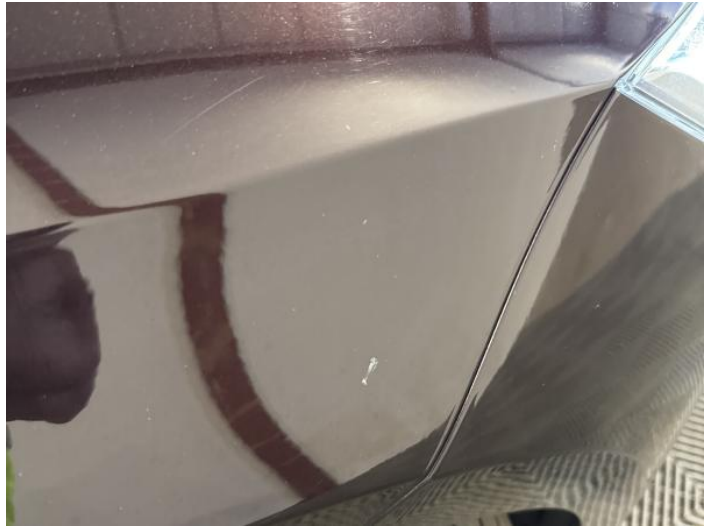
16: Wing osf  
Scratched  
UpTo 25mm Thru Paint

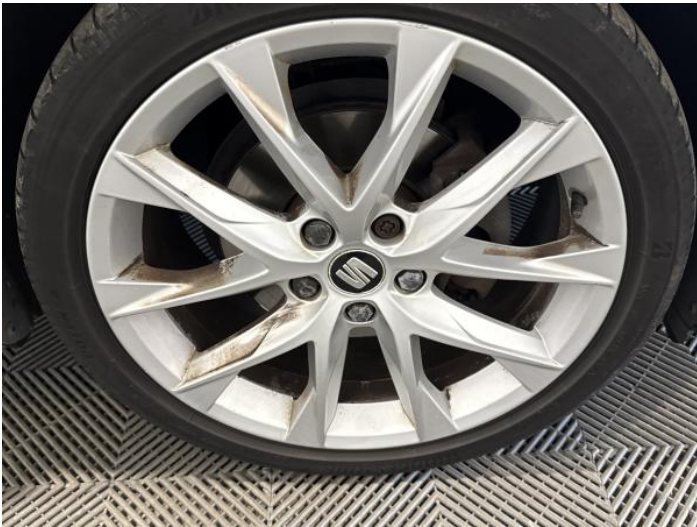
17: Wheel osf  
Scratched  
Up To 50mm
