VEHICLE INSPECTION REPORT

RO13VNS

Volkswagen Golf 1.6 TDI 105 SE 5dr

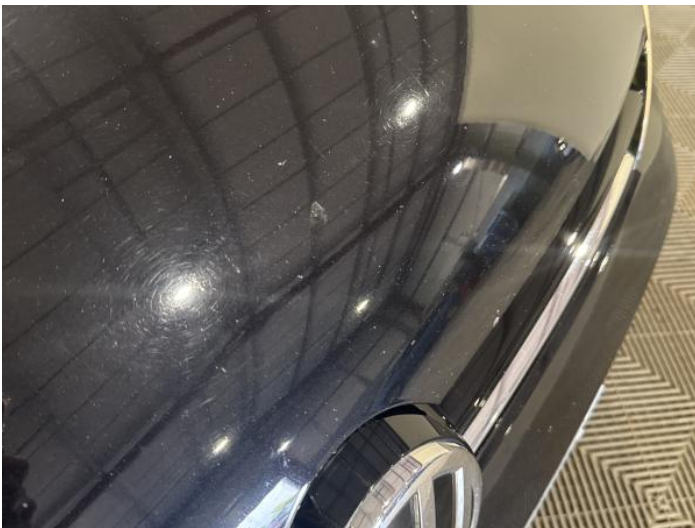
1: Bonnet
Chipped
Multiple Chips

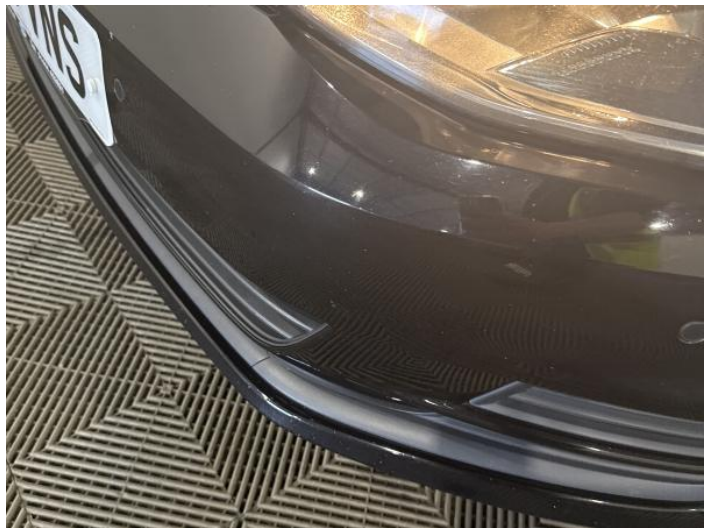
2: Bumper Front
Chipped
Multiple Chips

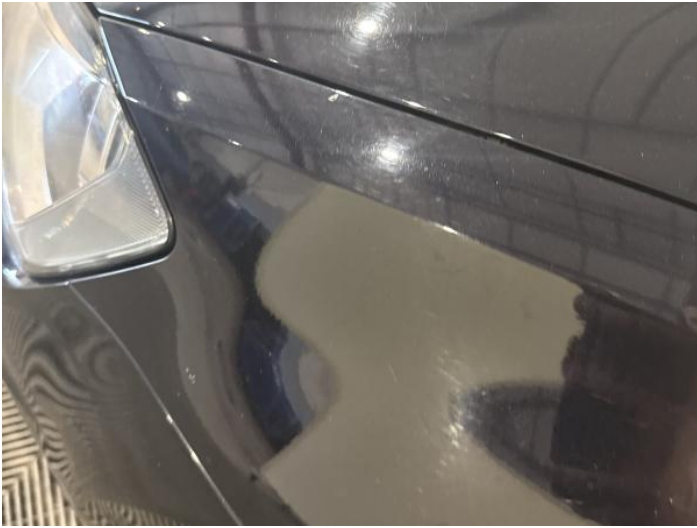
3: Wing nsf
Chipped
Multiple Chips

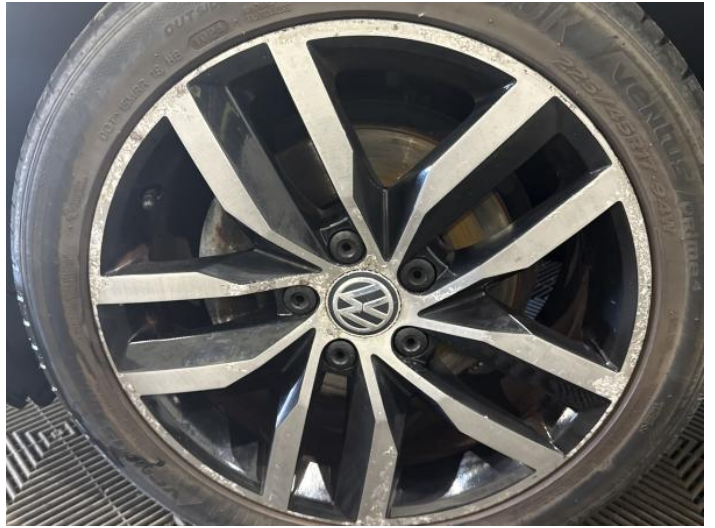
4: Wheel nsf
Scratched
Over 50mm

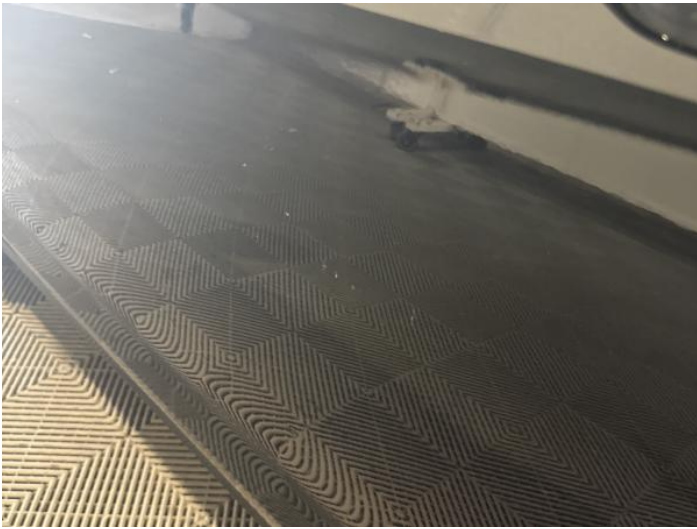
5: Door nsf
Chipped
Multiple Chips

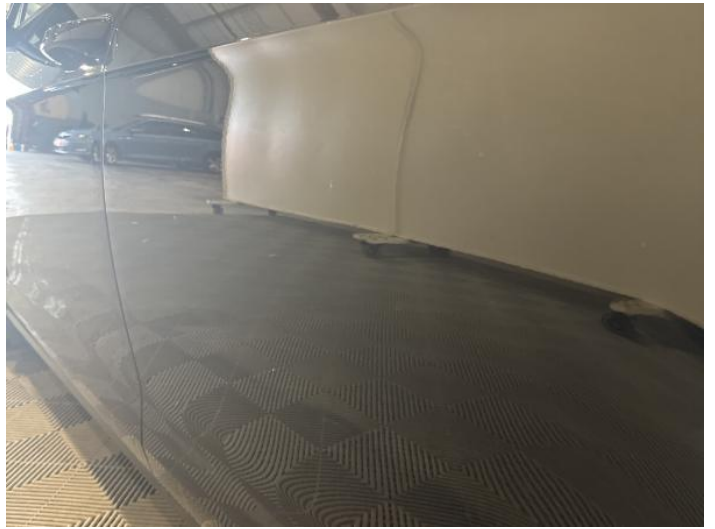
6: Door nsr
Chipped
Multiple Chips

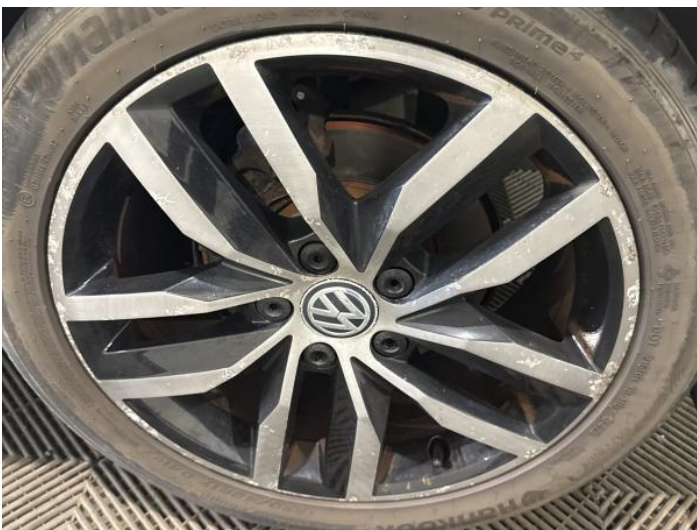
7: Wheel nsr
Scratched
Over 50mm

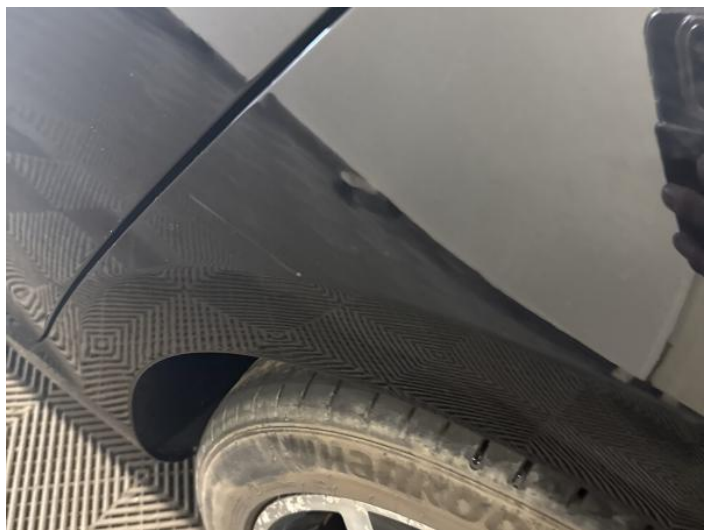
8: Qtr Panel nsr
Scratched
Over 25mm Thru Paint

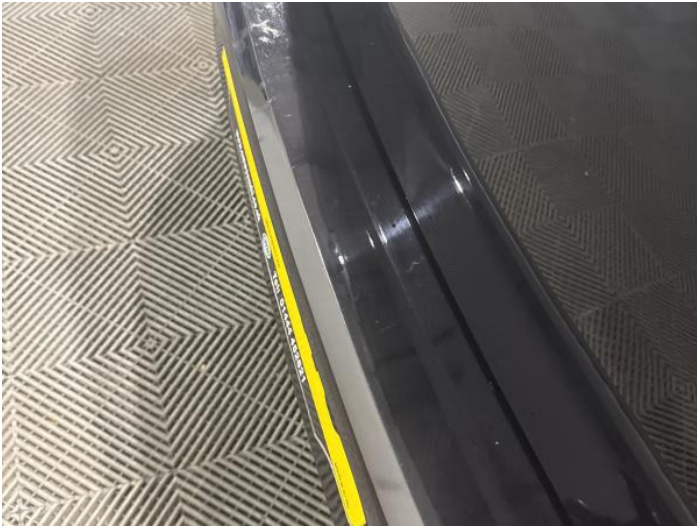
9: Bumper Rear
Scratched
25 to 100mm Thru Paint

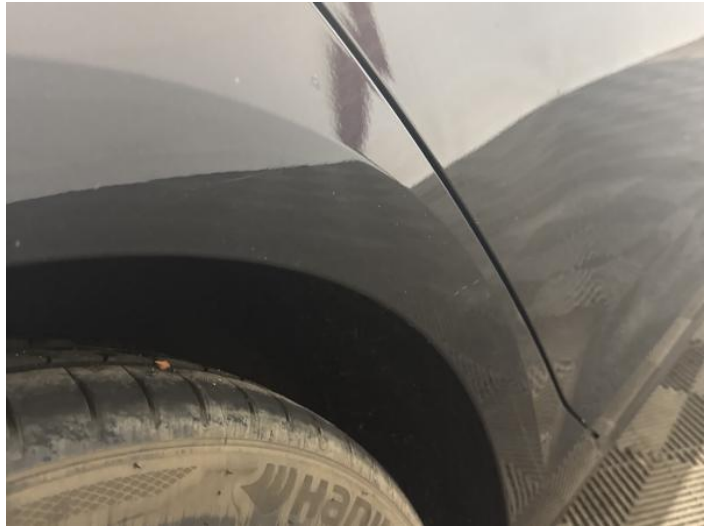
10: Qtr Panel osr
Scratched
Over 25mm Thru Paint

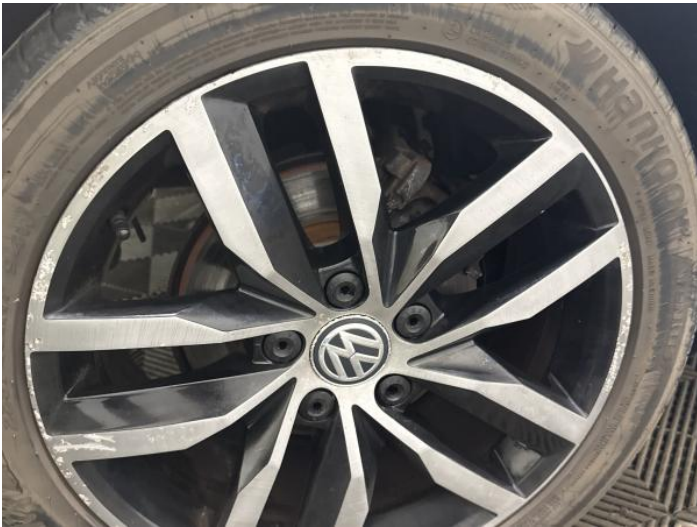
11: Wheel osr
Scratched
Over 50mm

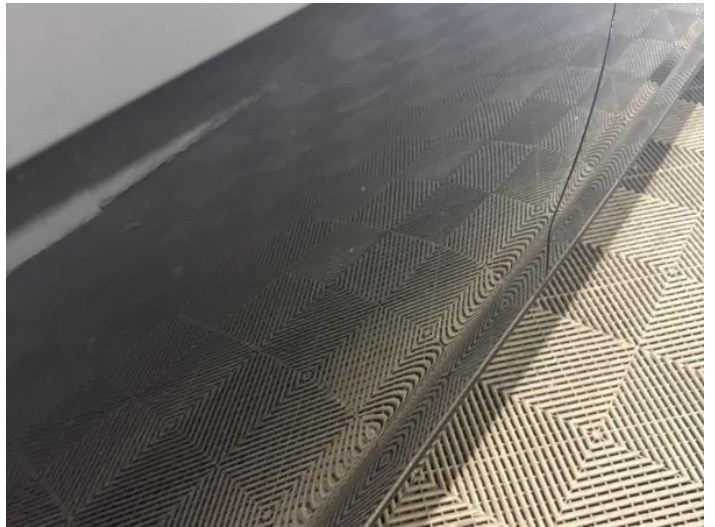
12: Door osr
Chipped
1 To 5

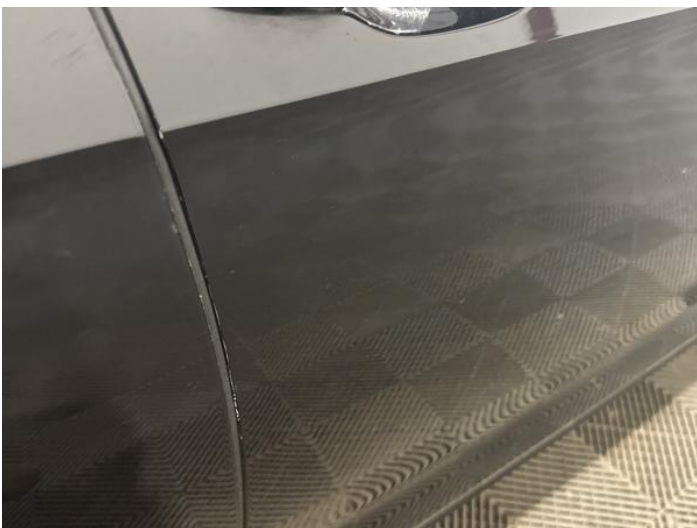
13: Door osf
Chipped
Edge Chip

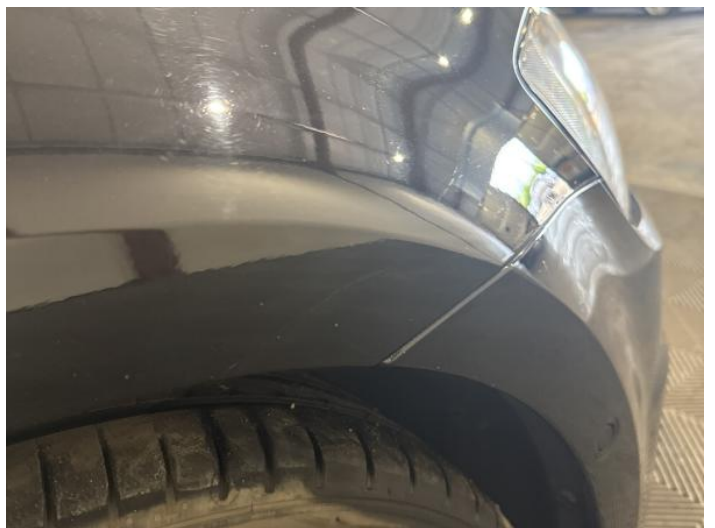
14: Wing osf
Scratched
Over 25mm Thru Paint

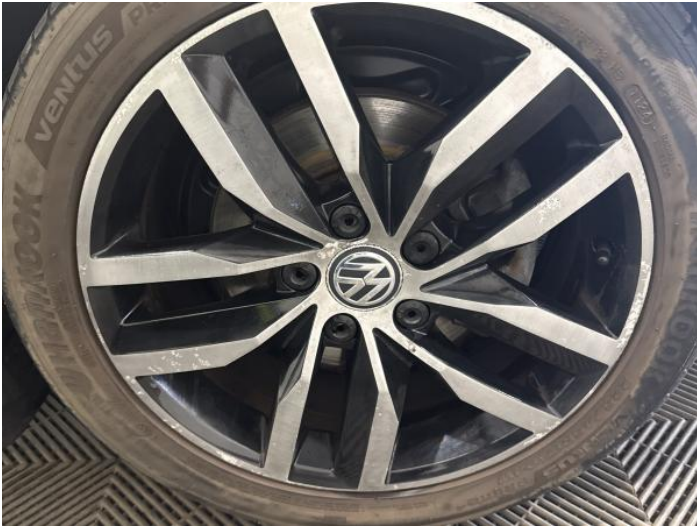
15: Wheel of
Scratched
Over 50mm

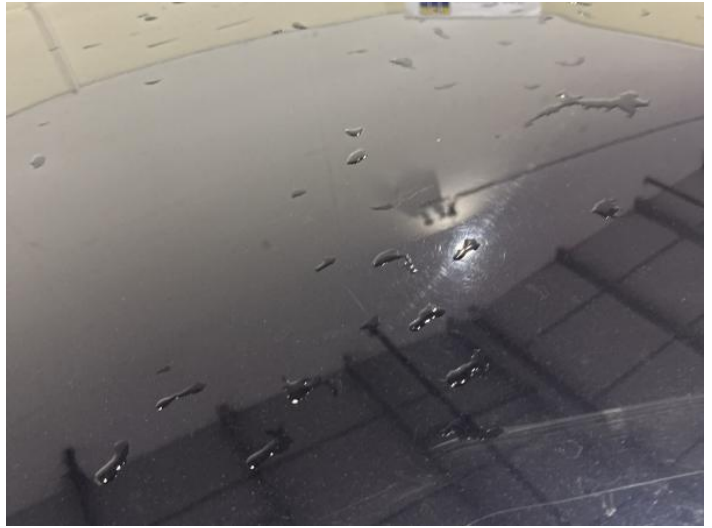
16: Roof
Scratched
Over 25mm Thru Paint

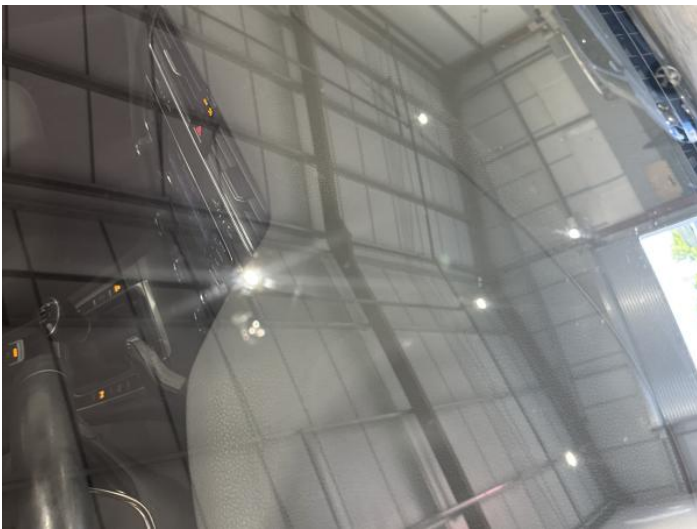
17: Screen Front
Cracked
Replace
