VEHICLE INSPECTION REPORT

GF10FYH

Volvo XC90 2.4 D5 R DESIGN SE Premium 5dr Geartronic

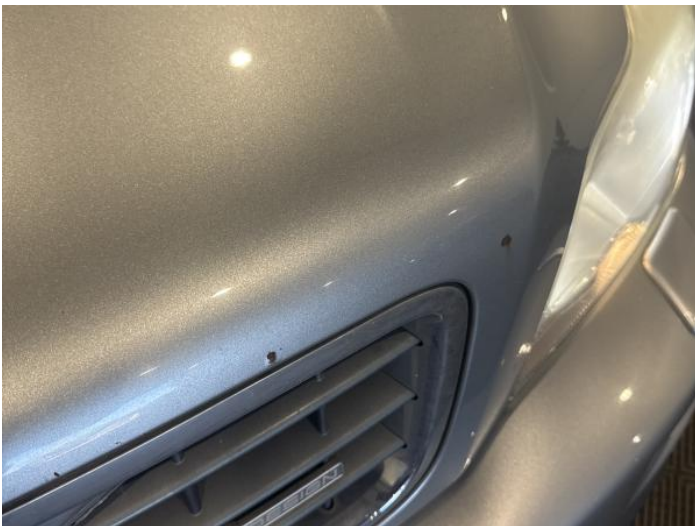
1: Bonnet
Rusted
Over 5mm

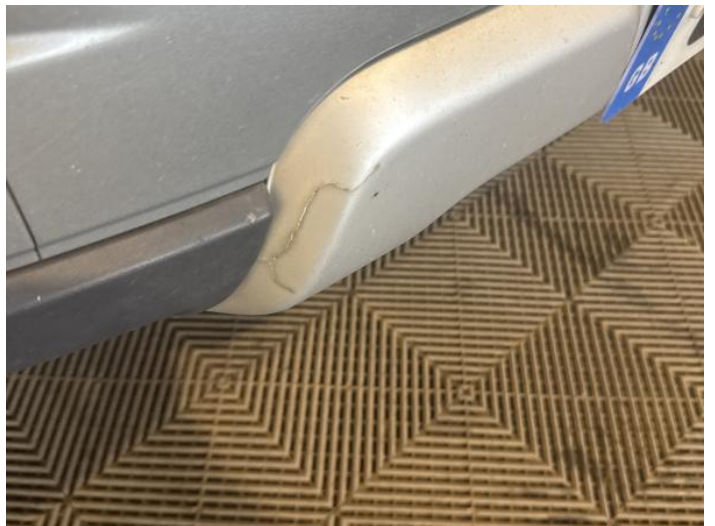
2: Bumper Front Moulding
Broken
Replace

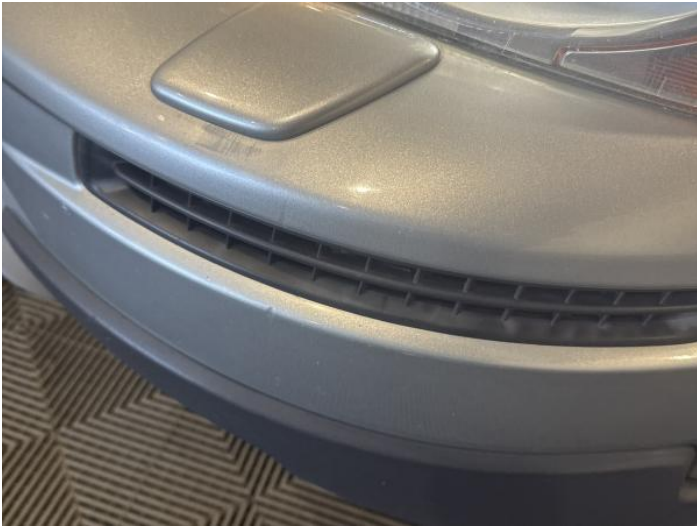
3: Bumper Front
Scratched
25 to 100mm Thru Paint

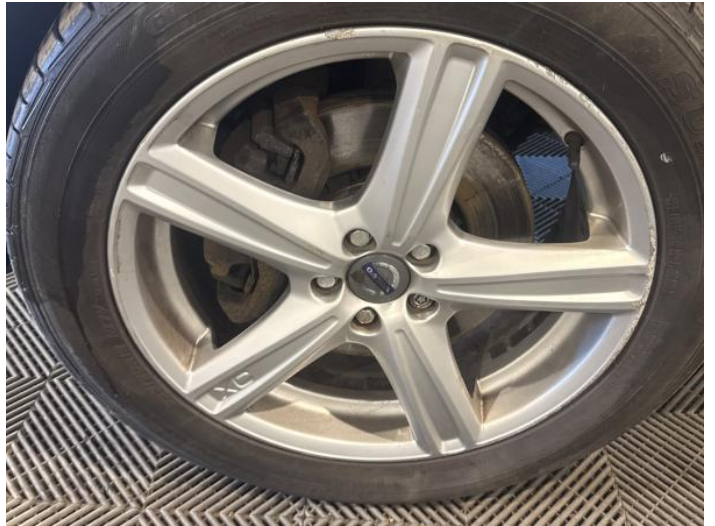
4: Wheel nsf
Scratched
Over 50mm

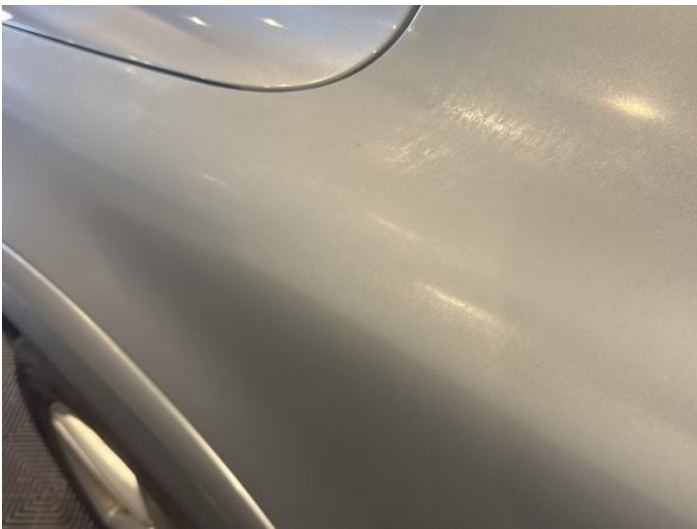
5: Wing nsf
Scratched
Over 25mm Thru Paint

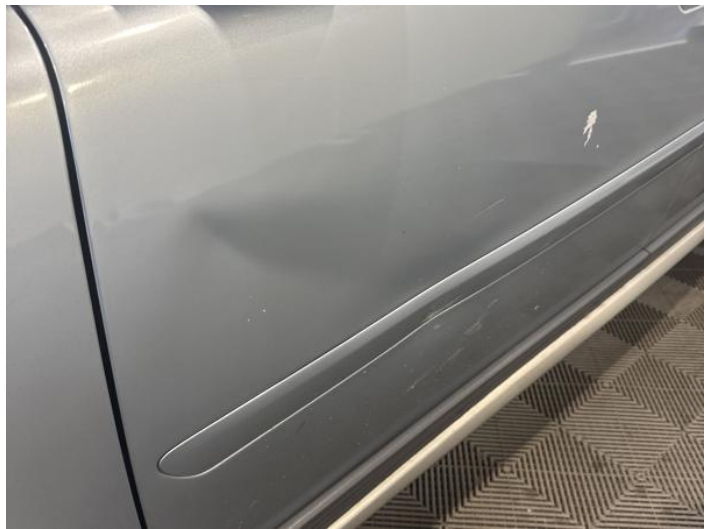
6: Door nsf
Dented
With Paint Damage

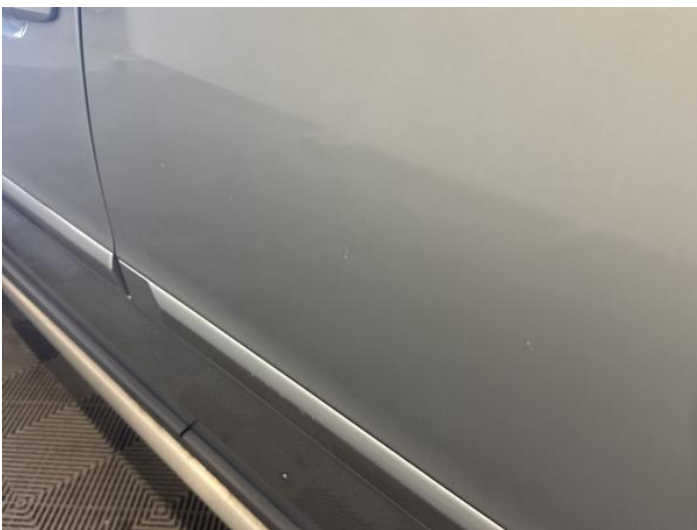
7: Door nsr
Chipped
Multiple Chips

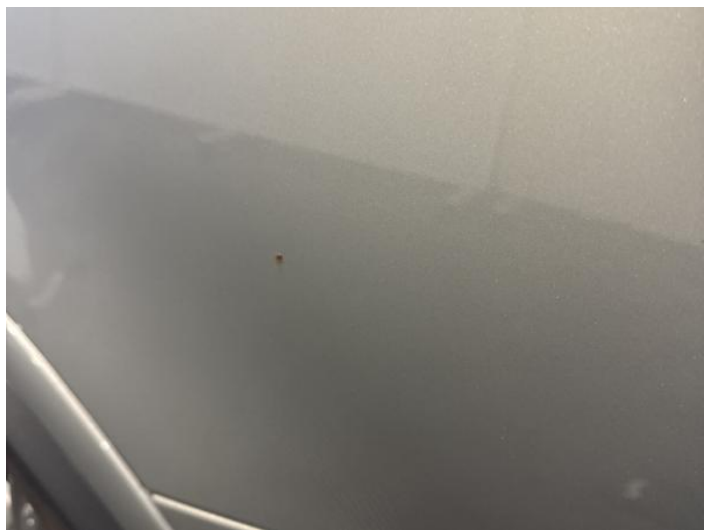
8: Qtr Panel nsr
Chipped
1 To 5

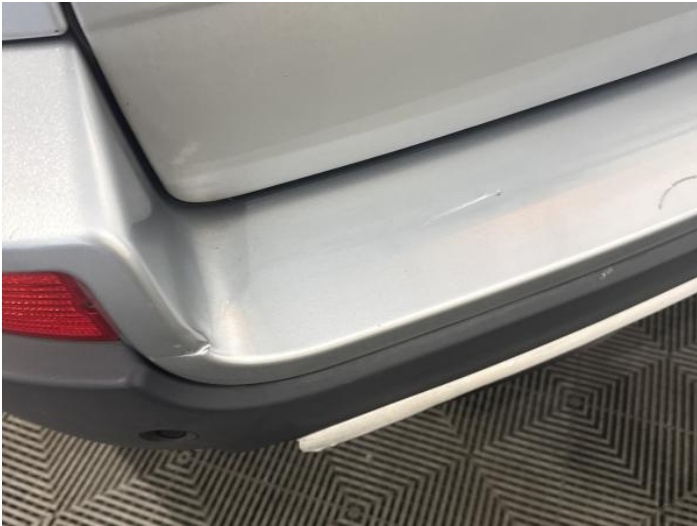
9: Bumper Rear
Dented
With Paint Damage

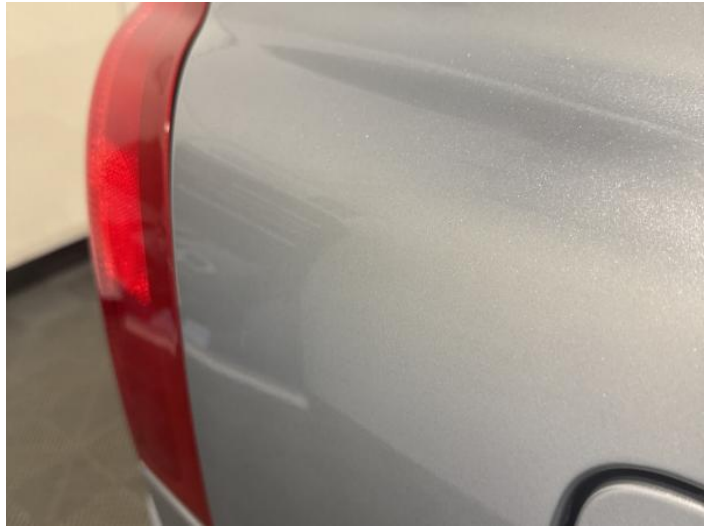
10: Qtr Panel osr
Scratched
Over 25mm Thru Paint

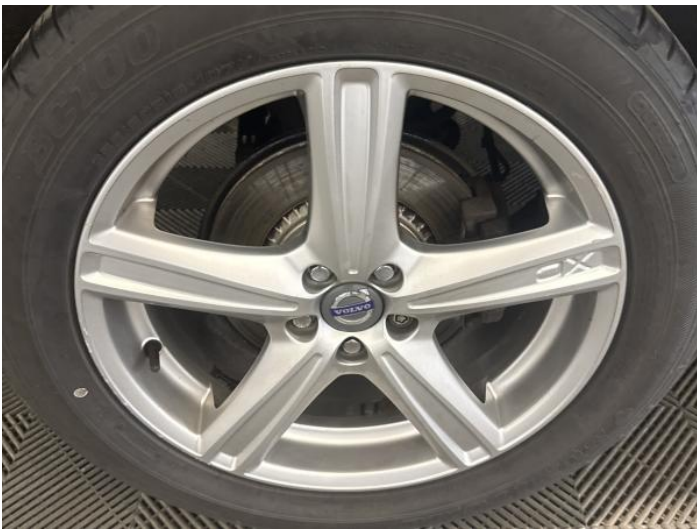
11: Wheel osr
Scratched
Over 50mm

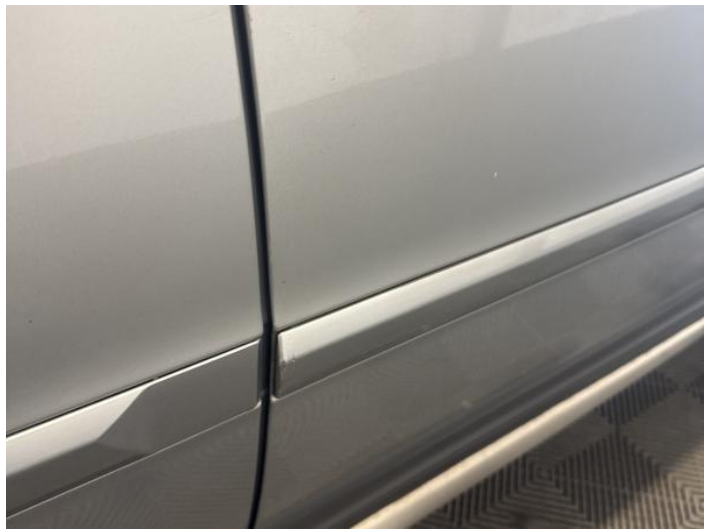
12: Door osf
Chipped
Edge Chip

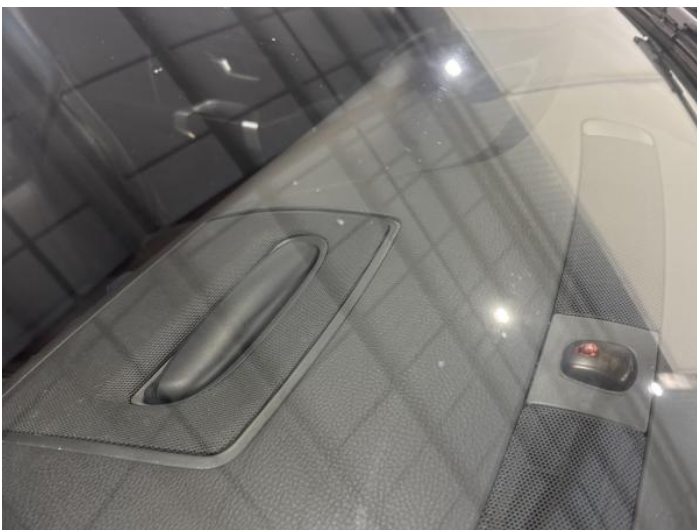
13: Screen Front
Chipped
Up To 10mm

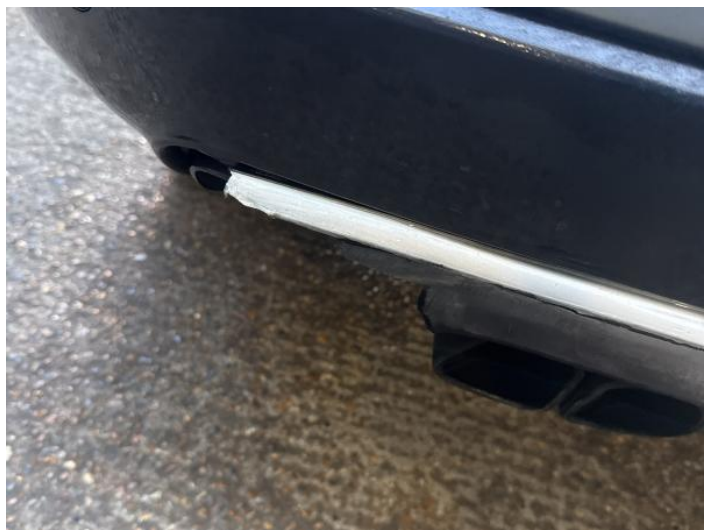
14: Bumper Rear Moulding
Broken
Replace
