# VEHICLE INSPECTION REPORT

**BF17HCV**

## Vauxhall Adam 1.2i Jam 3dr

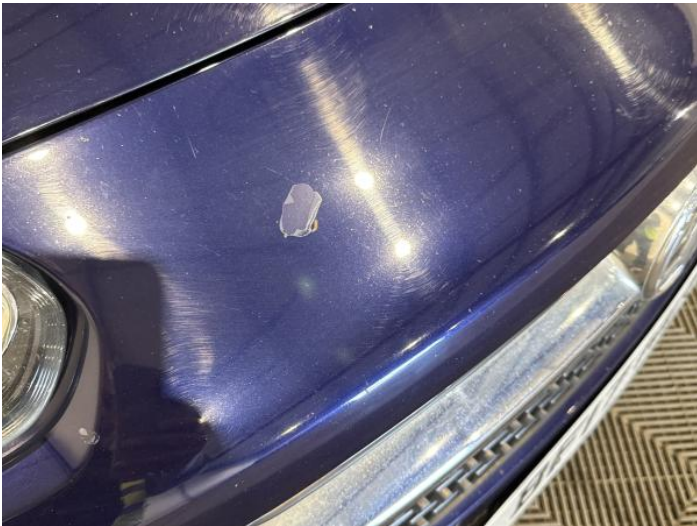
1: Bumper Front  
Poor Previous Repair  
Paint Flake

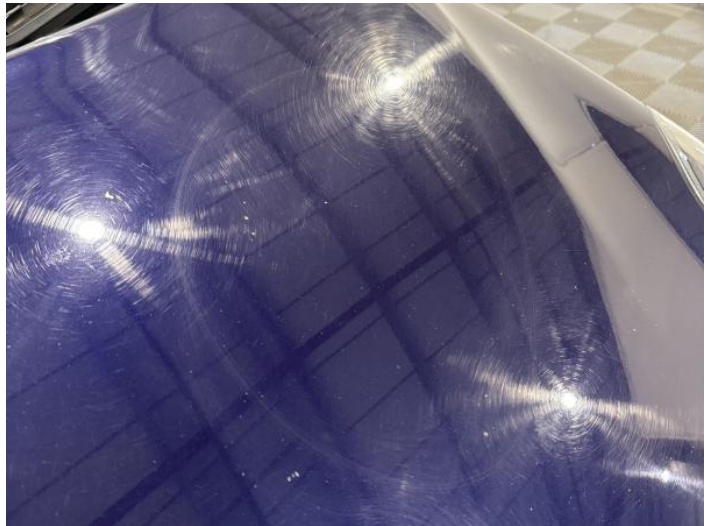
2: Bonnet  
Scratched  
Over 25mm Thru Paint

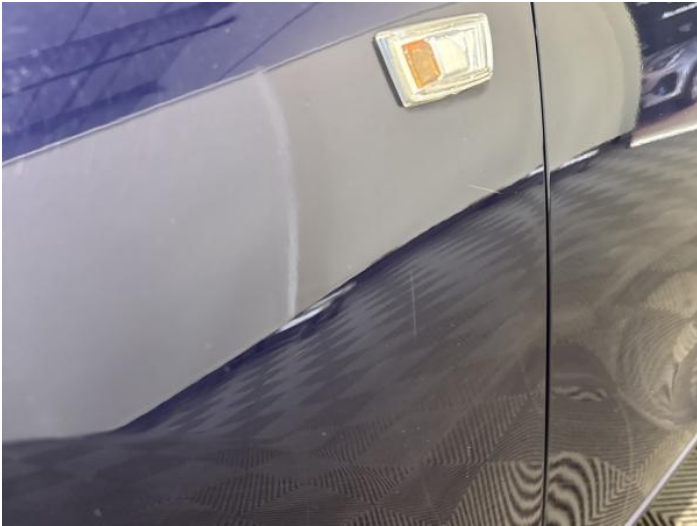
3: Wing nsf  
Scratched  
UpTo 25mm Thru Paint

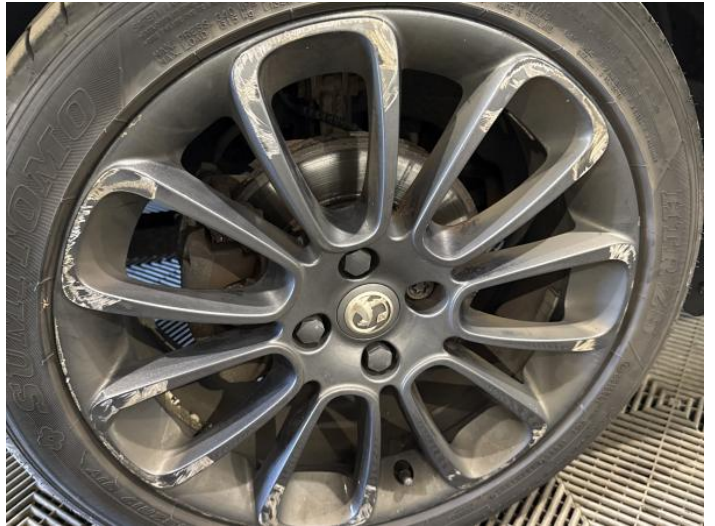
4: Wheel nsf  
Scratched  
Over 50mm

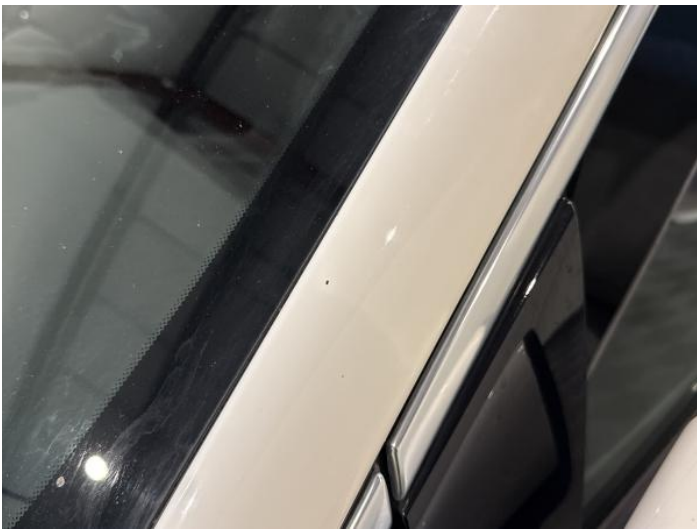
5: A Post ns  
Chipped  
1 To 5

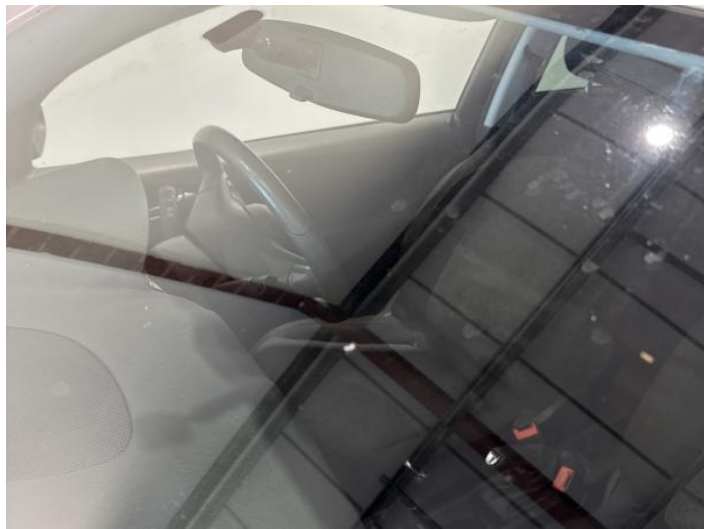
6: Screen Front  
Chipped  
UpTo 10mm

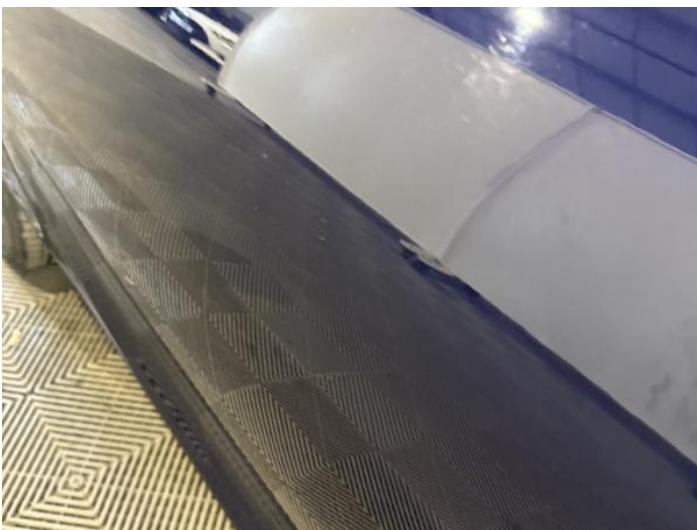
7: Door nsf  
Dented  
Between 10mm + 30mm

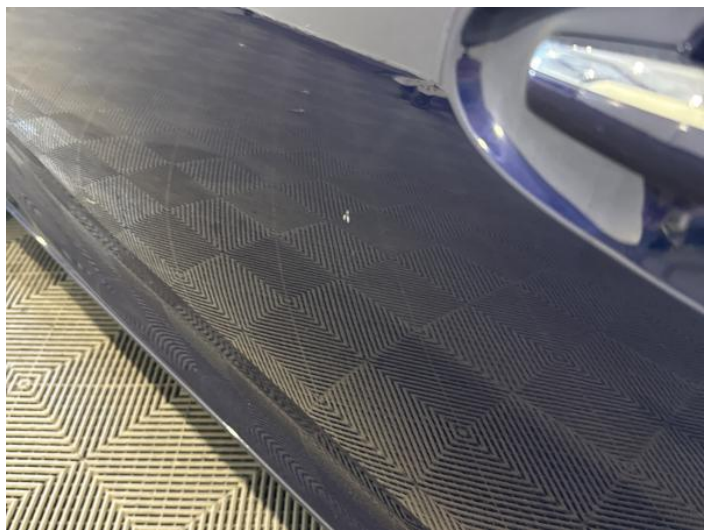
8: Door nsf  
Chipped  
1 To 5

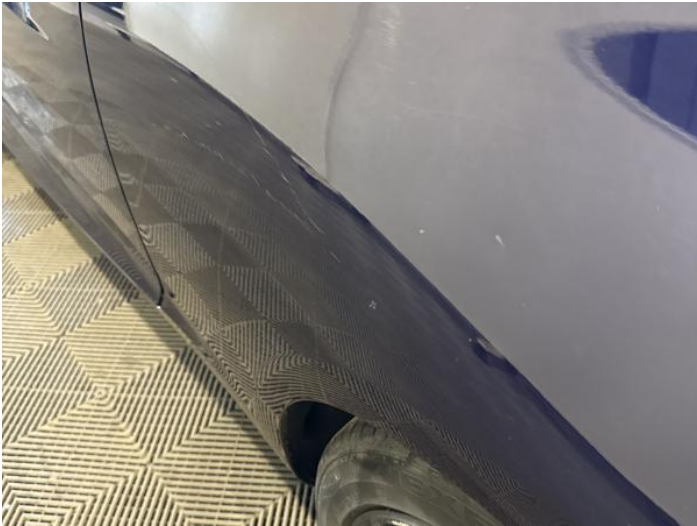
9: Qtr Panel nsr  
Dented  
With Paint Damage

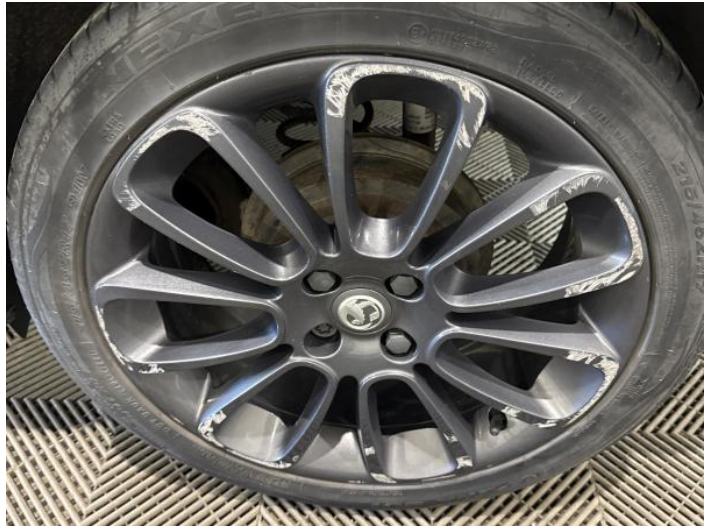
10: Wheel nsr  
Scratched  
Over 50mm

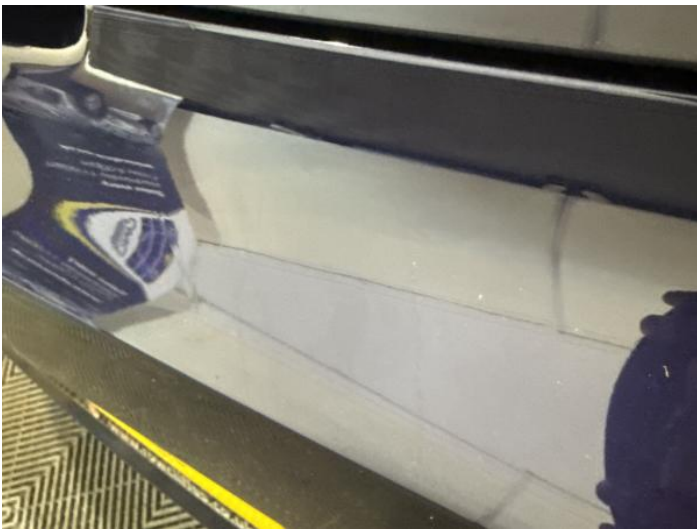
11: Bumper Rear  
Scratched  
25 to 100mm Thru Paint

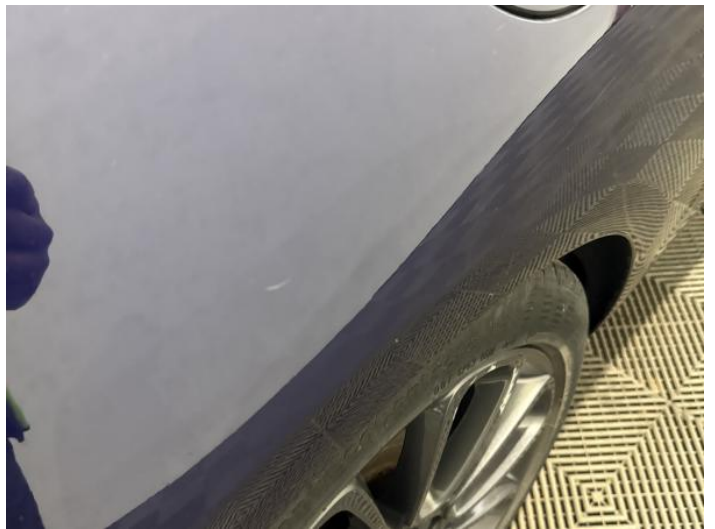
12: Qtr Panel osr  
Scratched  
Over 25mm Thru Paint

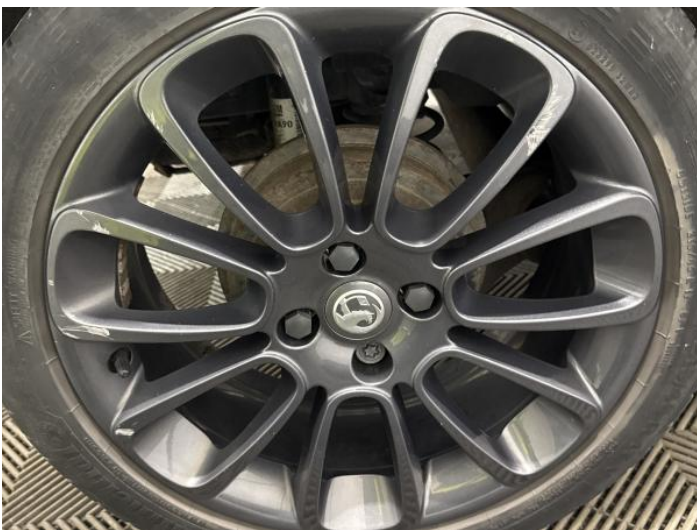
13: Wheel osr  
Scratched  
Over 50mm

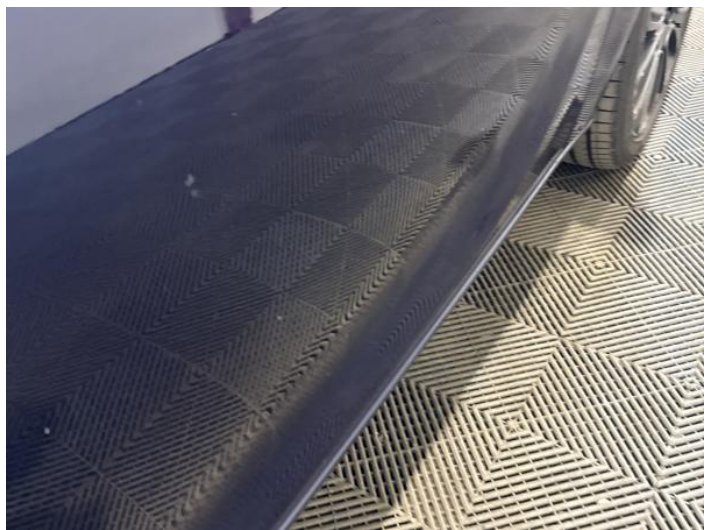
14: Door osf  
Dented  
Over 30mm

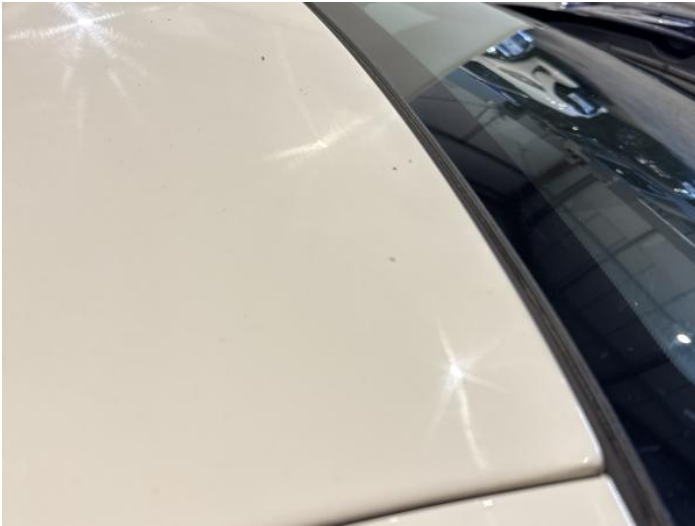
15: Roof  
Chipped  
1 To 5

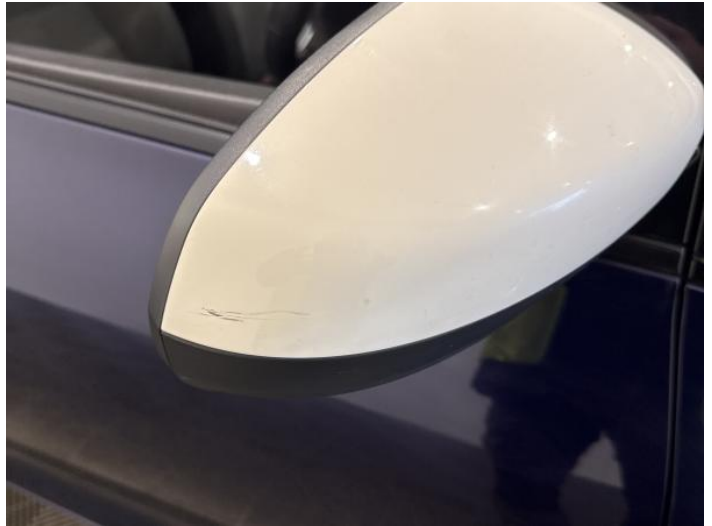
16: Door Mirror Assy osf  
Scratched (Painted)  
UpTo 25mm Thru Paint

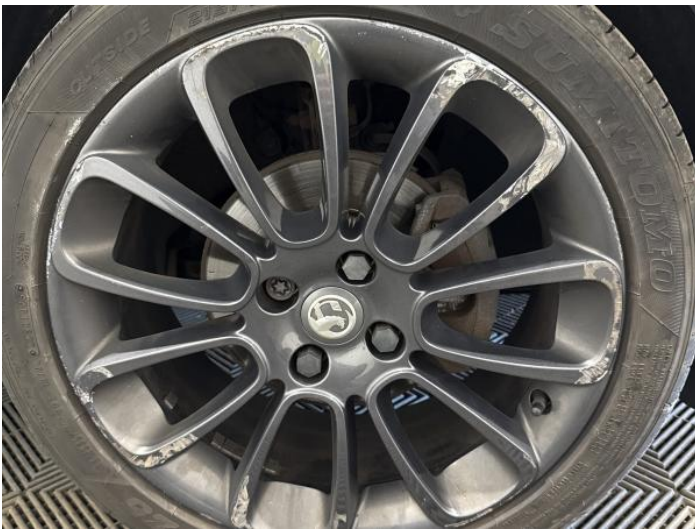
17: Wheel osf  
Scratched  
Over 50mm

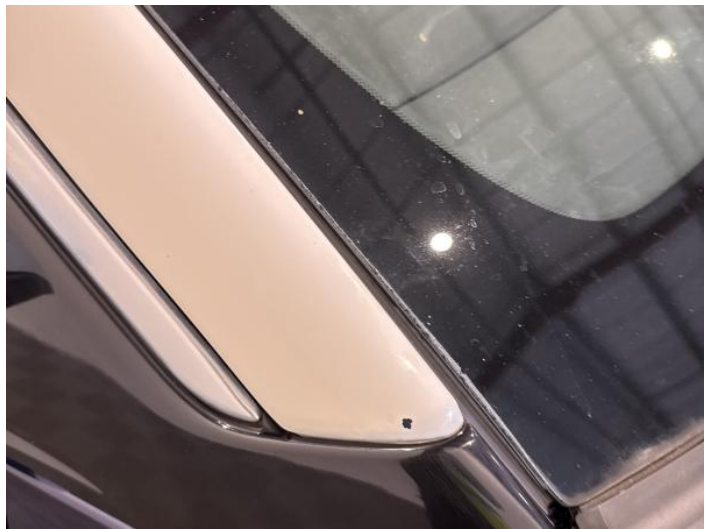
18: A Post os  
Chipped  
1 To 5
