VEHICLE INSPECTION REPORT

VN71AJO

Toyota Yaris 1.5 Hybrid Design 5dr CVT

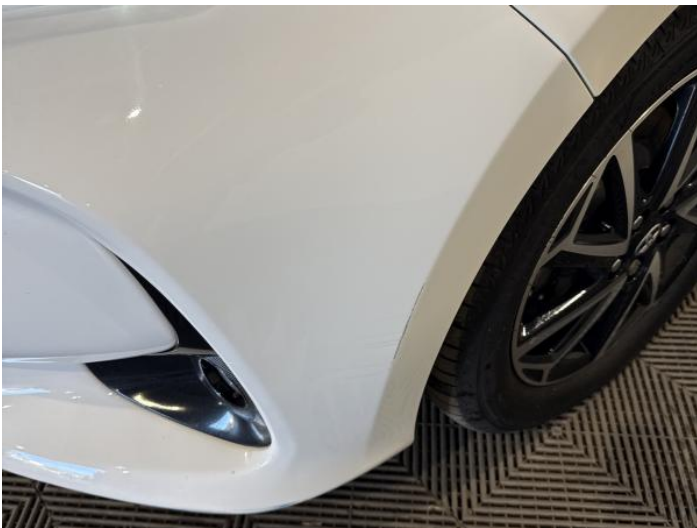
1: Bumper Front
Scratched
25 to 100mm Thru Paint

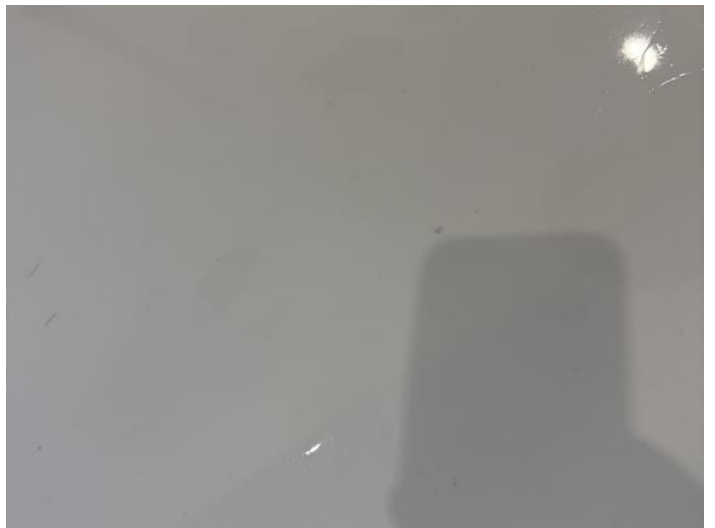
2: Bumper Front
Chipped
1 To 5

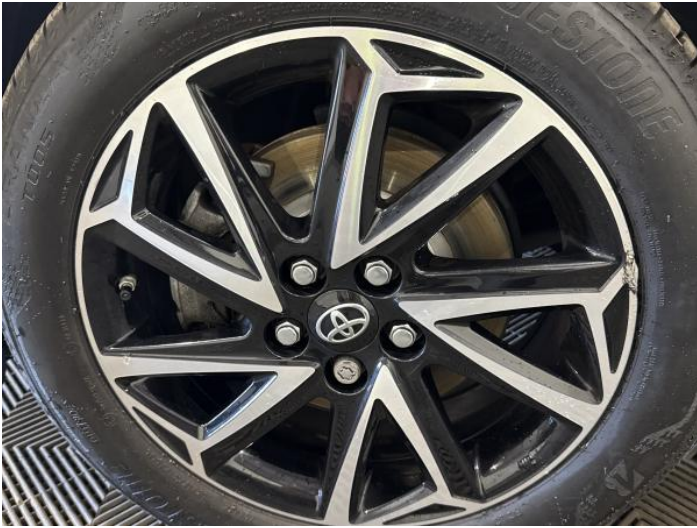
3: Wheel nsf
Dented
UpTo 30mm (Alloy)

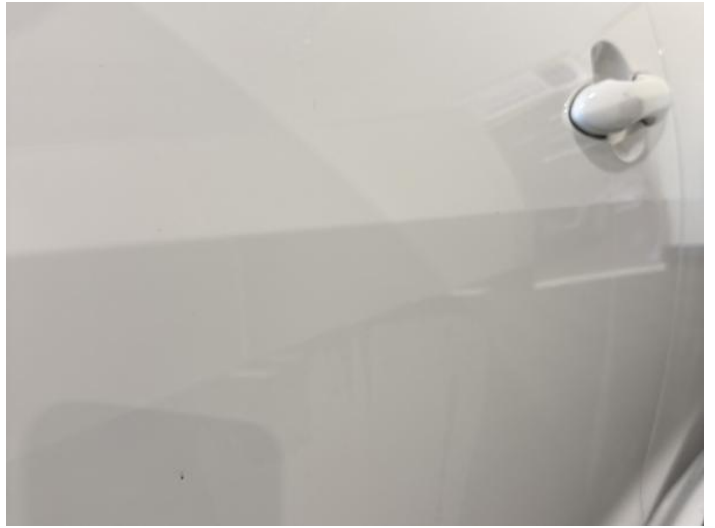
4: Door nsf
Dented
Between 10mm + 30mm

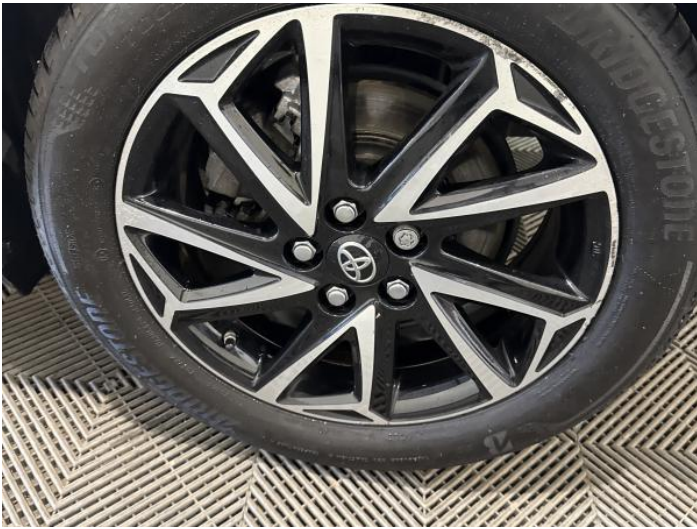
5: Wheel nsr
Scratched
Over 50mm

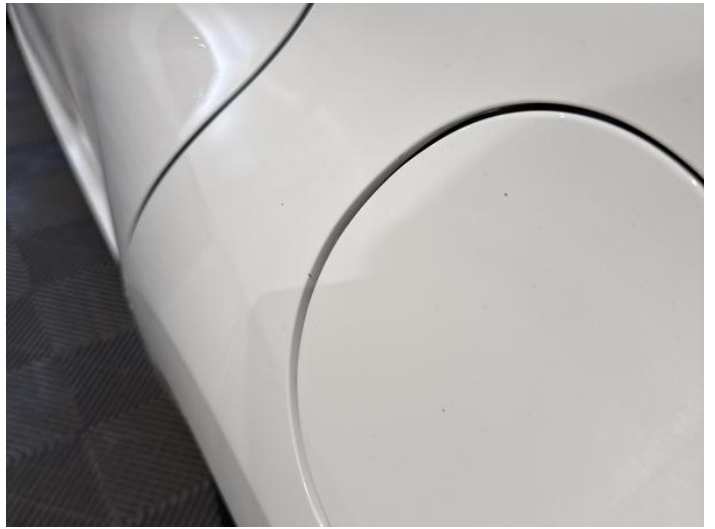
6: Qtr Panel nsr
Chipped
1 To 5

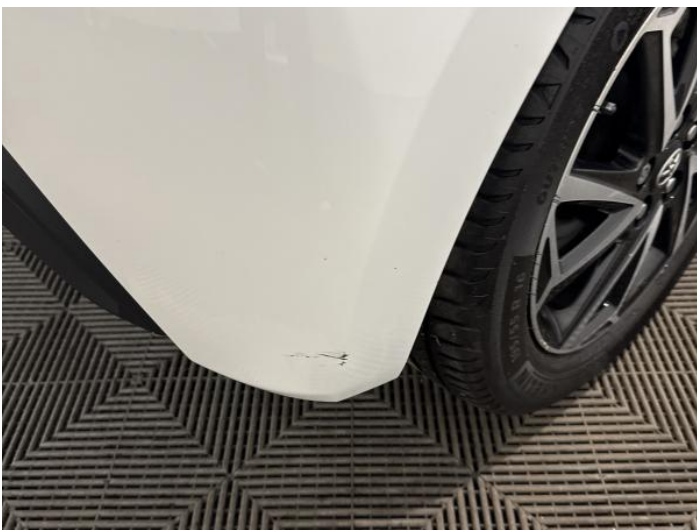
7: Bumper Rear
Scratched
25 to 100mm Thru Paint

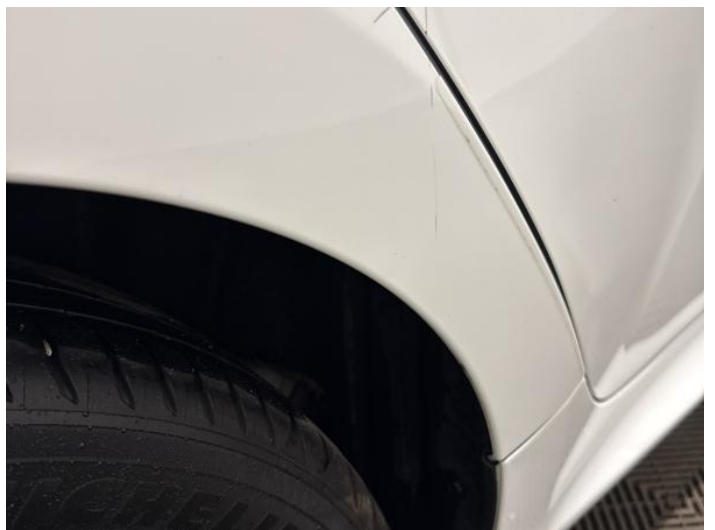
8: Qtr Panel osr
Scratched
Over 25mm Thru Paint

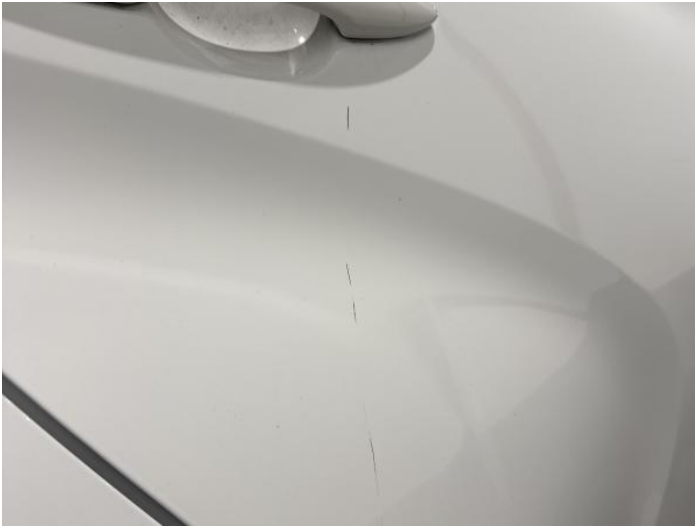
9: Door osr
 Scratched
 Over 25mm Thru Paint

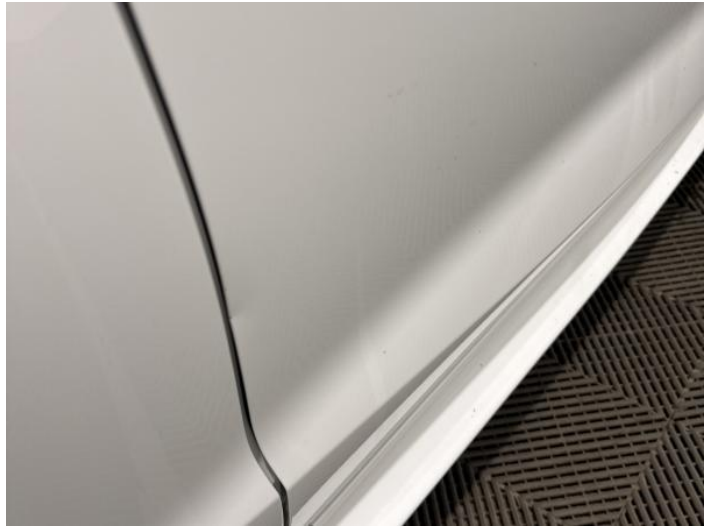
10: Door osf
 Dented
 Between 10mm + 30mm

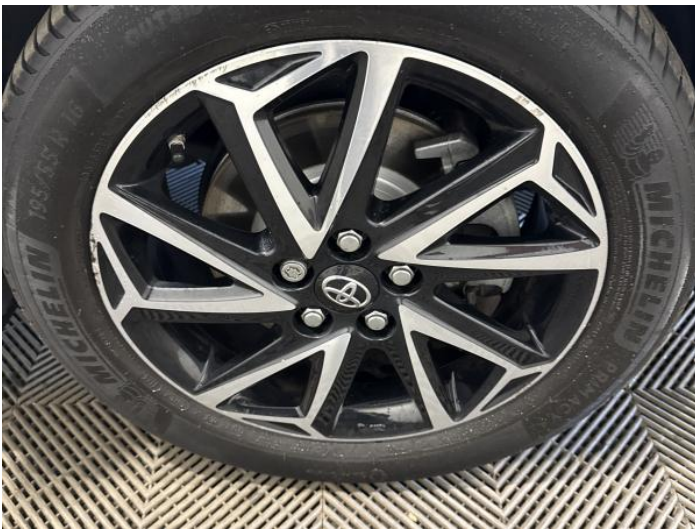
11: Wheel osf
 Scratched
 Over 50mm

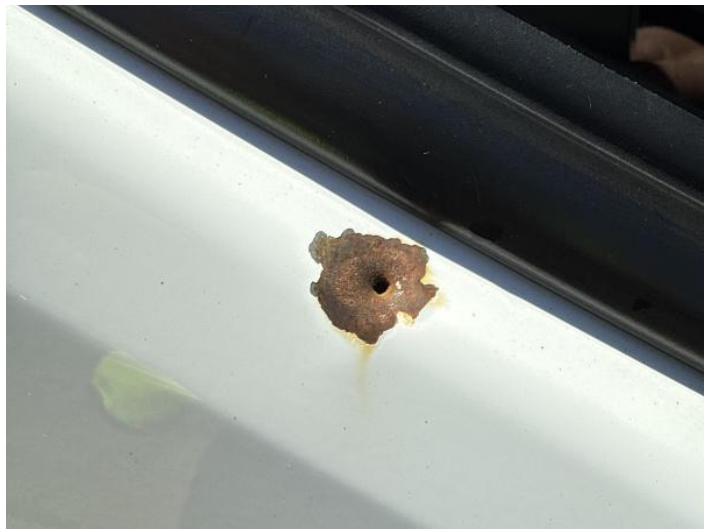
12: Door osr
 Hole
 Over 10mm
