# VEHICLE INSPECTION REPORT

**KS63GVU**

## Seat Leon 2.0 TDI 184 FR 5dr [Technology Pack]

nama  
GRADE  
**3**

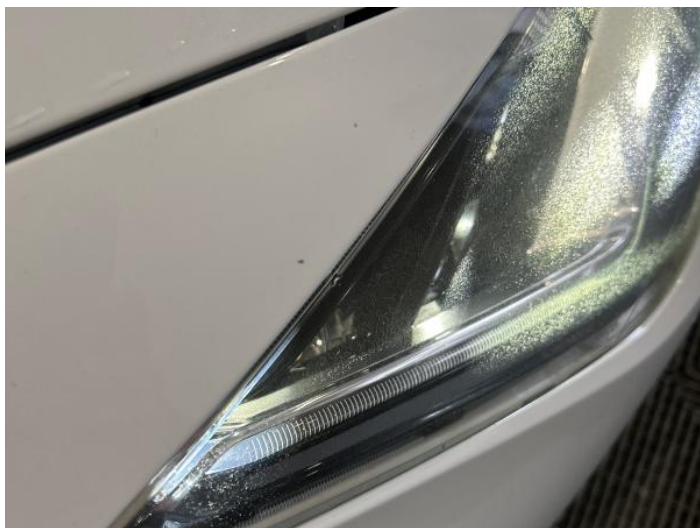
1: Wing osf  
Chipped  
1 To 5

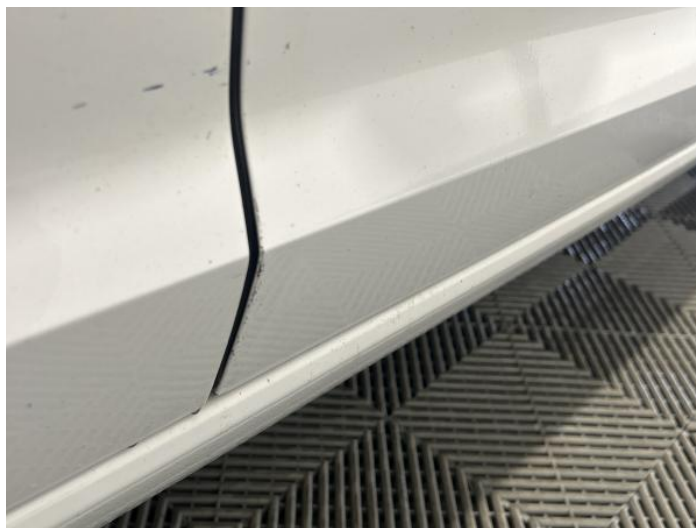
2: Door osf  
Chipped  
Edge Chip

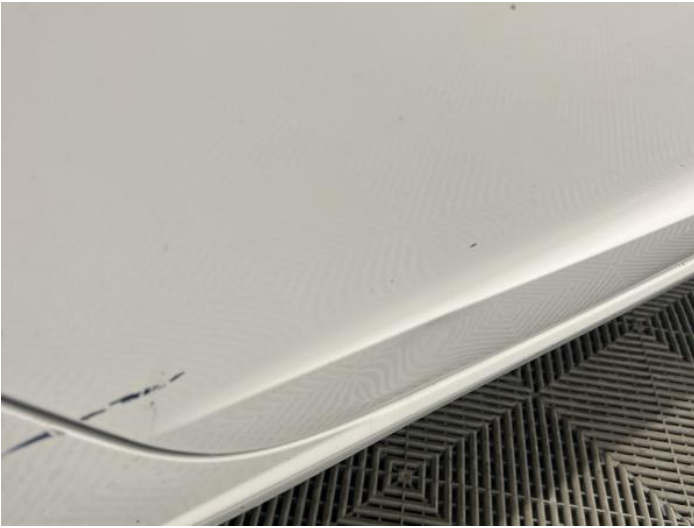
3: Door osr  
Scratched  
Over 25mm Not Thru Paint

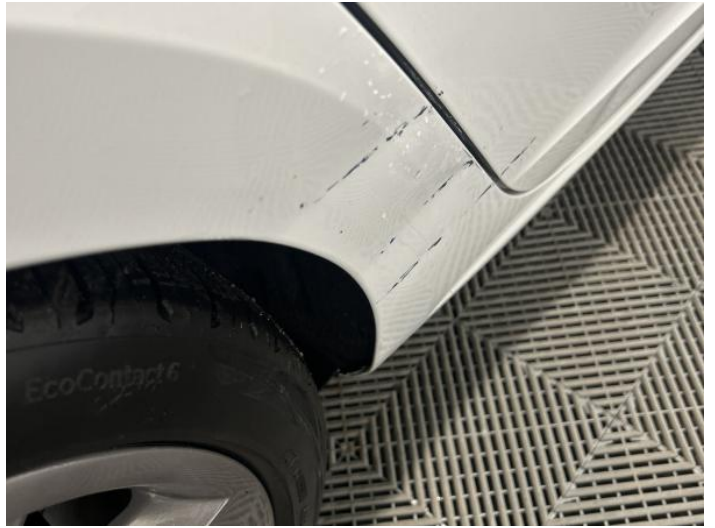
4: Qtr Panel osr  
Dented  
With Paint Damage

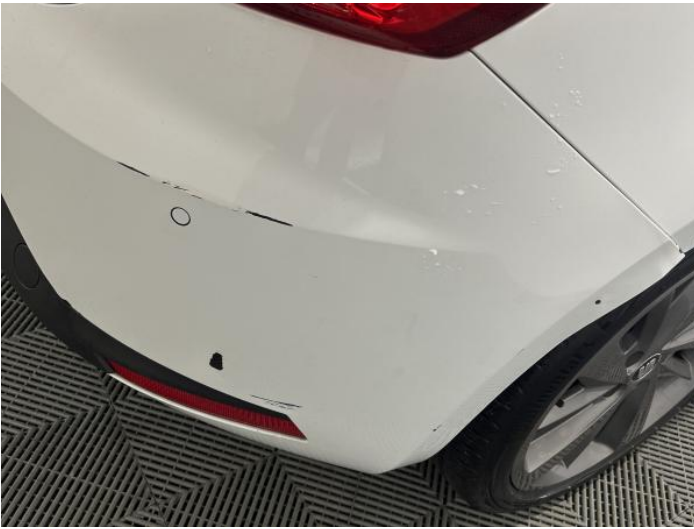
5: Bumper Rear  
Scratched  
25 to 100mm Thru Paint

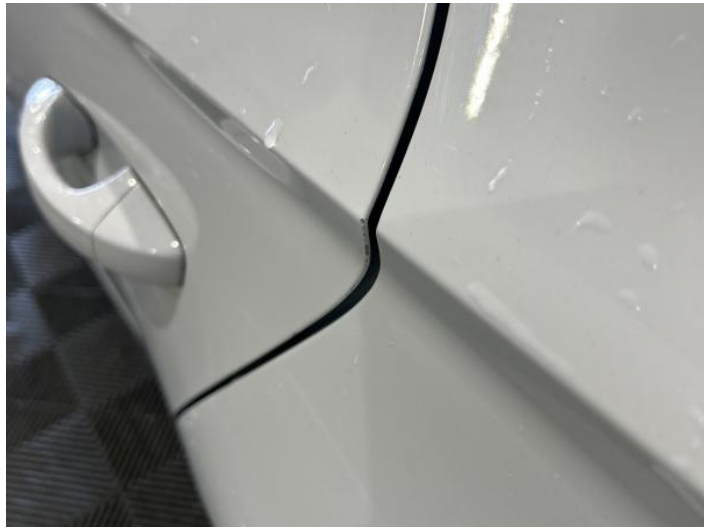
6: Door nsr  
Chipped  
Edge Chip

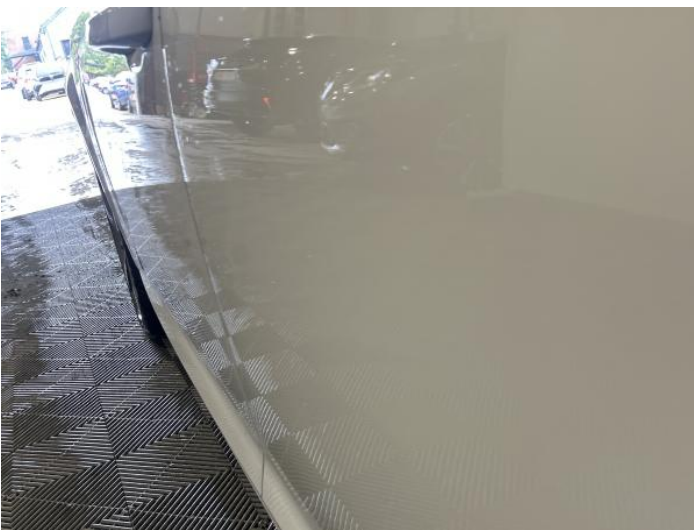
7: Door nsr  
Dented  
Between 10mm + 30mm

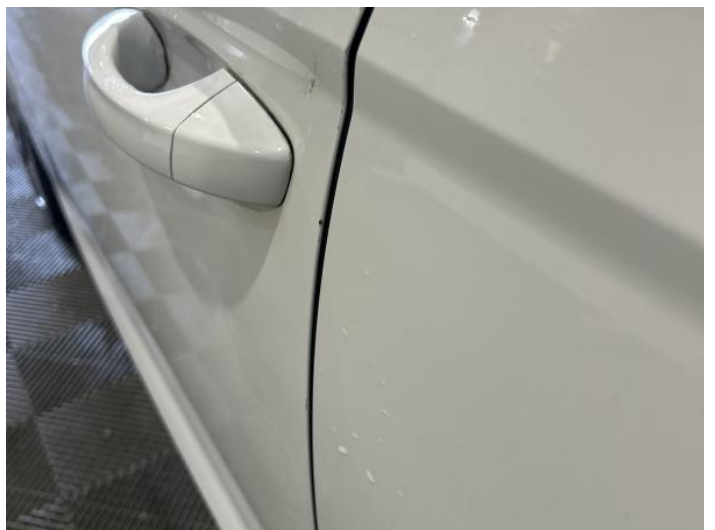
8: Door nsf  
Chipped  
Edge Chip

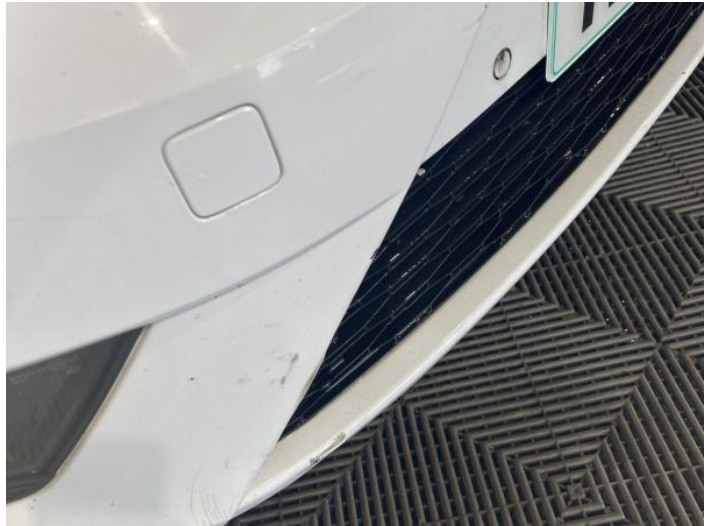
10: Bumper Front  
Scratched  
Over 100mm Thru Paint

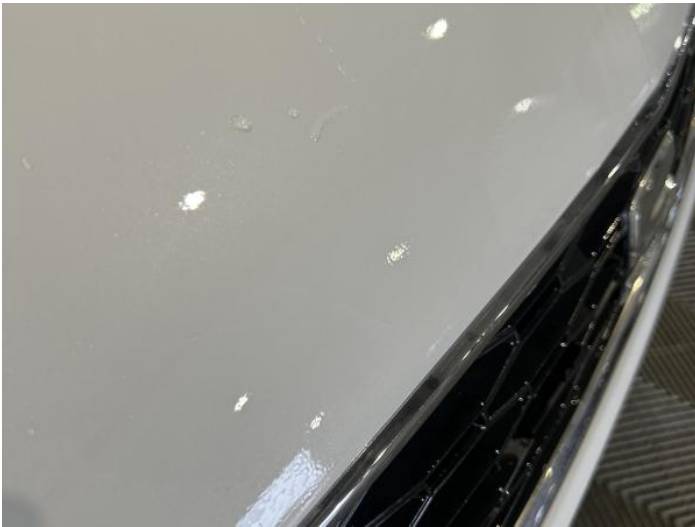
11: Bonnet  
Poor Previous Repair  
Poor Paint

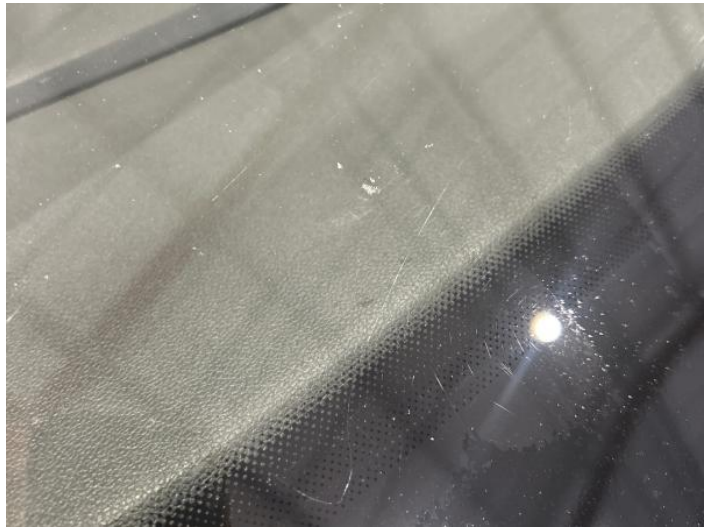
12: Screen Front  
Chipped  
UpTo 10mm

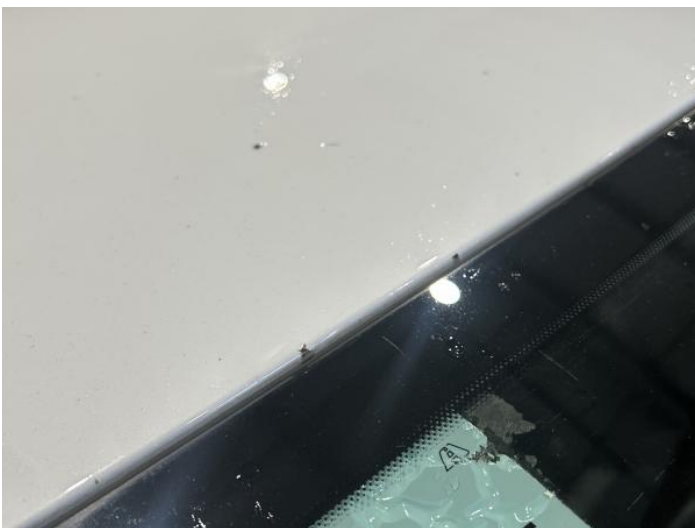
13: Roof  
Chipped  
1 To 5

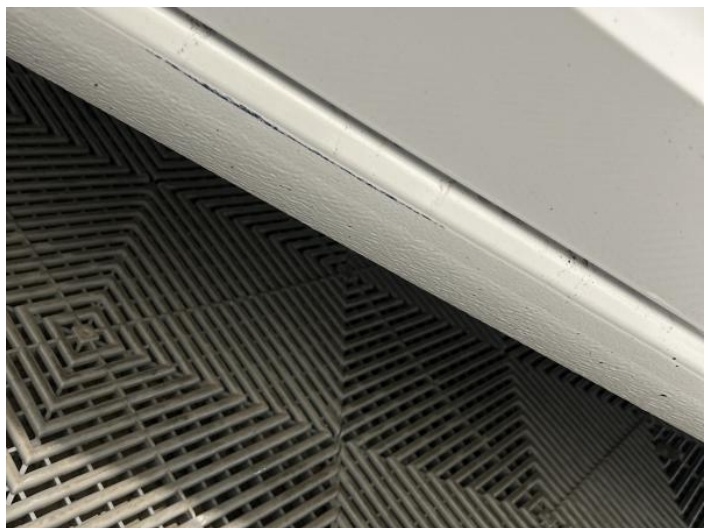
14: Sill os  
Scratched  
Over 25mm Not Thru Paint

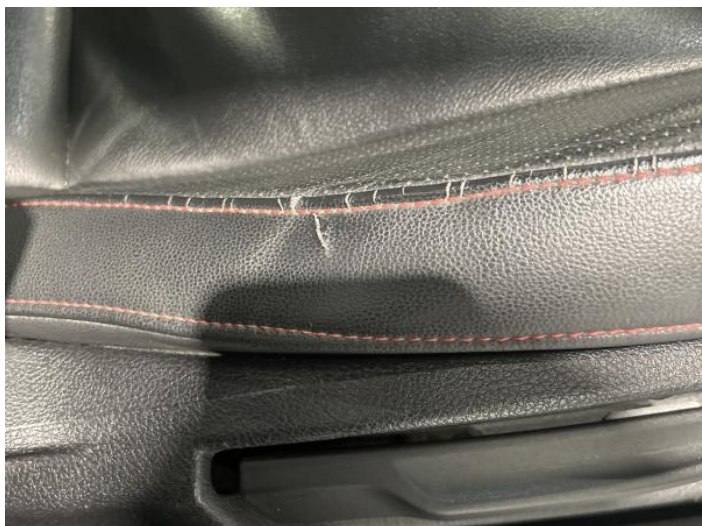
15: Seat Base Cover osf  
Torn  
UpTo 3mm
