# VEHICLE INSPECTION REPORT

**SM63UVR**

## Mitsubishi Outlander 2.2 DI-D GX4 5dr

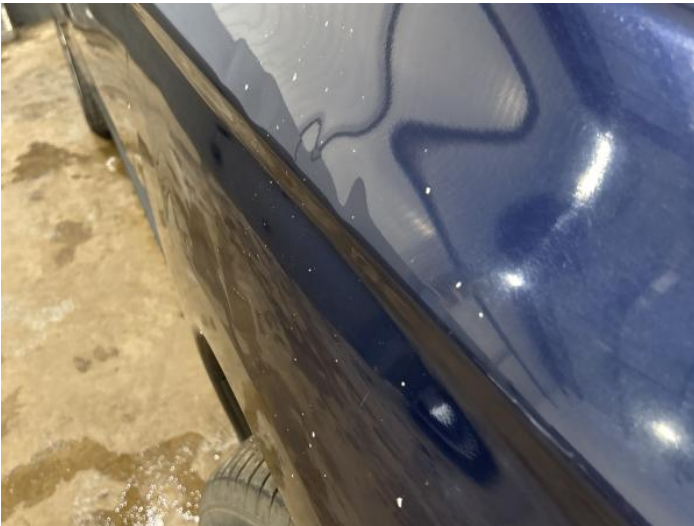
1: Wing osf  
Dented  
With Paint Damage

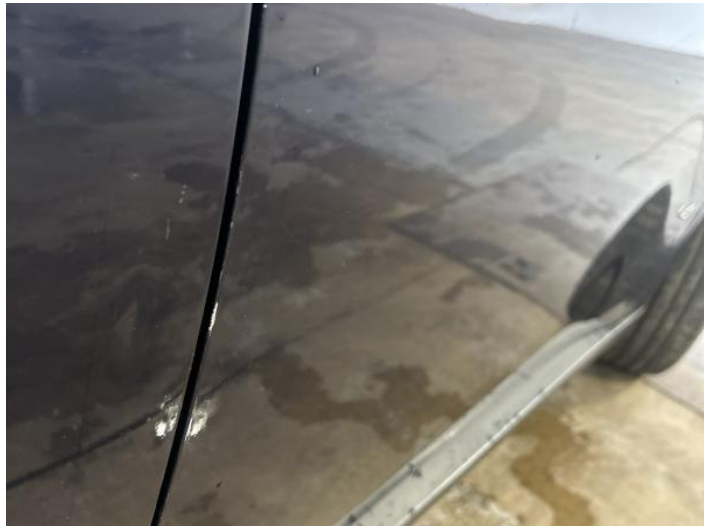
2: Door osf  
Chipped  
Edge Chip

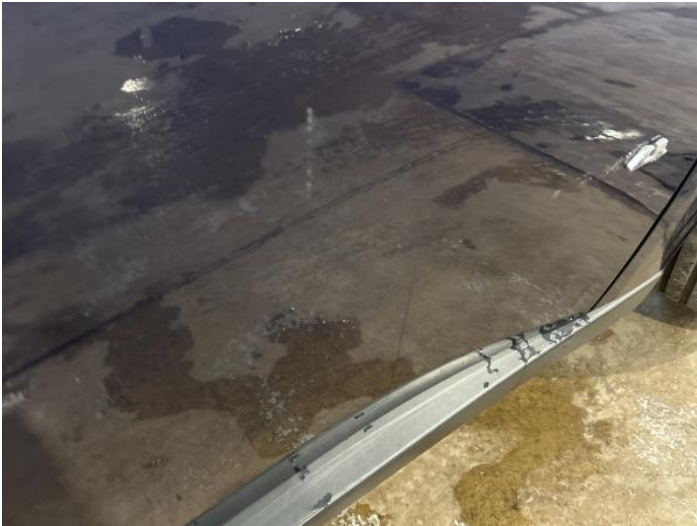
3: Door osf  
Scratched  
Up To 25mm Thru Paint

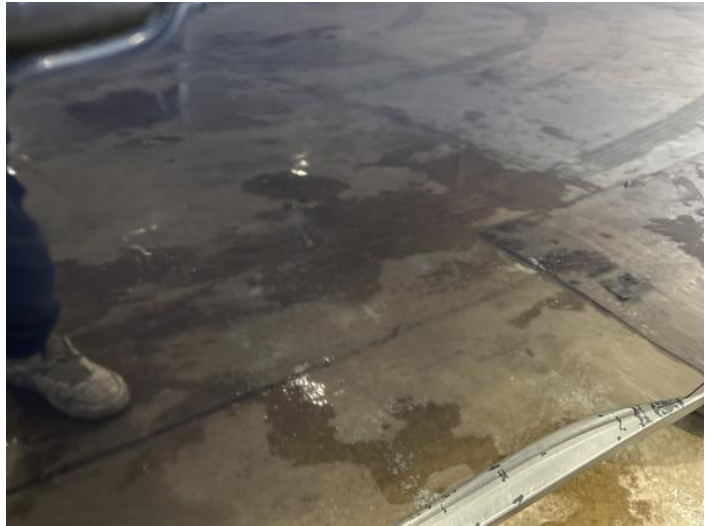
4: Door osf  
Chipped  
1 To 5

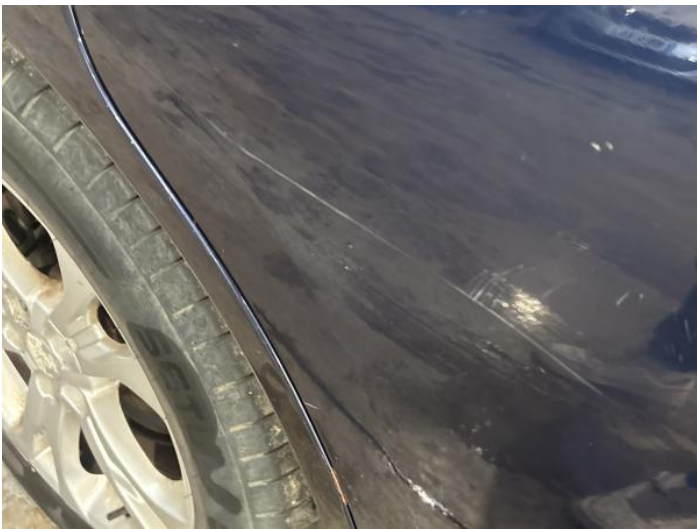
5: Door osr  
Dented  
With Paint Damage

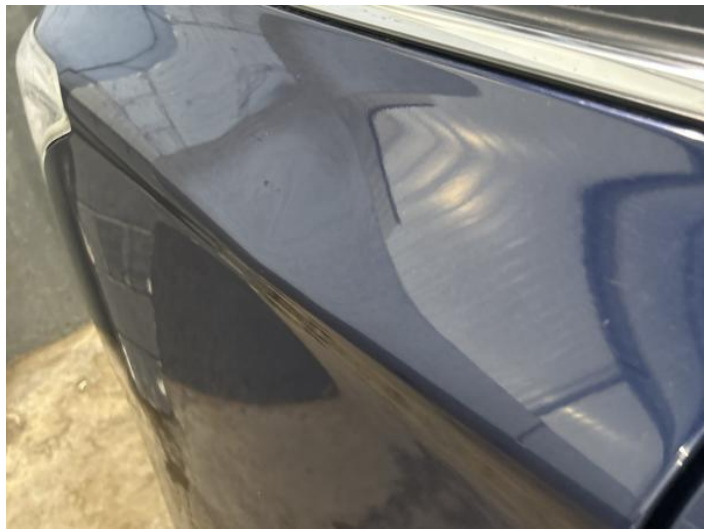
6: Qtr Panel osr  
Dented  
Over 30mm

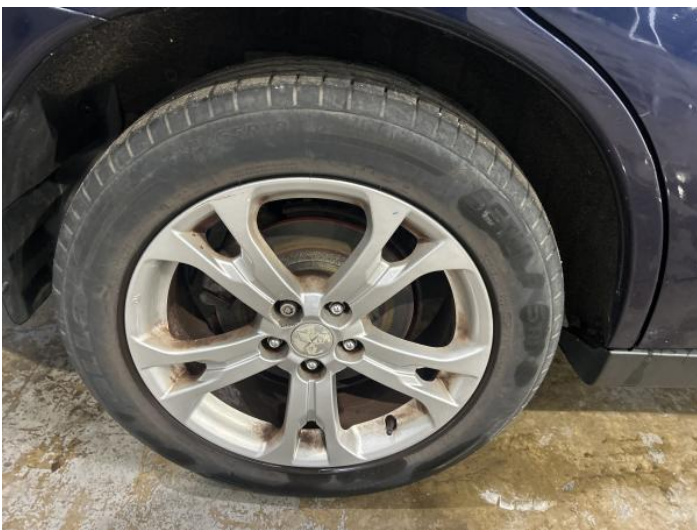
7: Wheel osr  
Scratched  
Up To 50mm

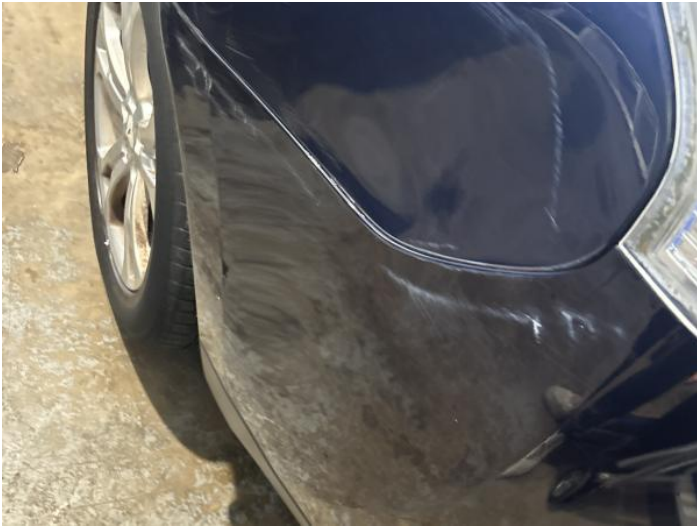
9: Bumper Rear  
Scratched  
Over 100mm Thru Paint

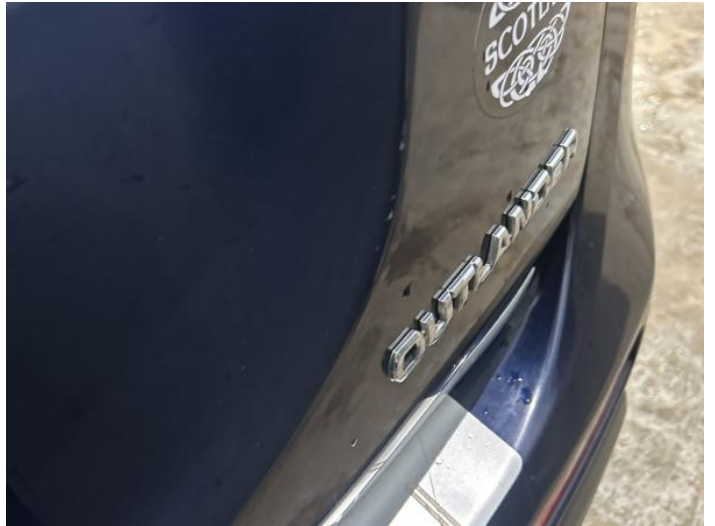
10: Tailgate  
Chipped  
1 To 5

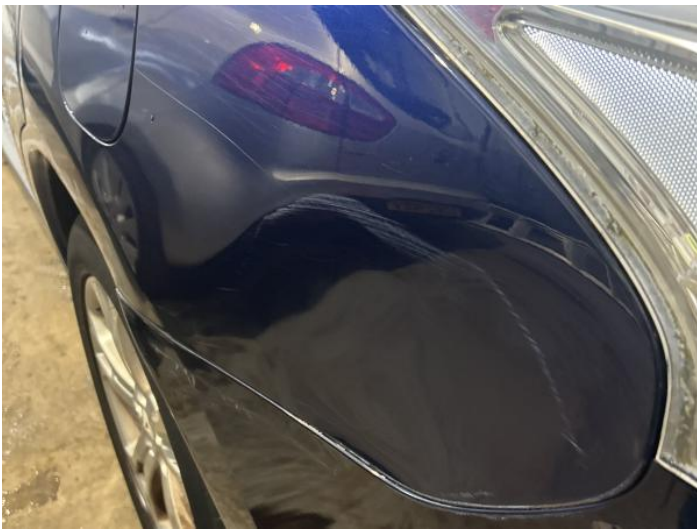
11: Qtr Panel nsr  
Dented  
With Paint Damage

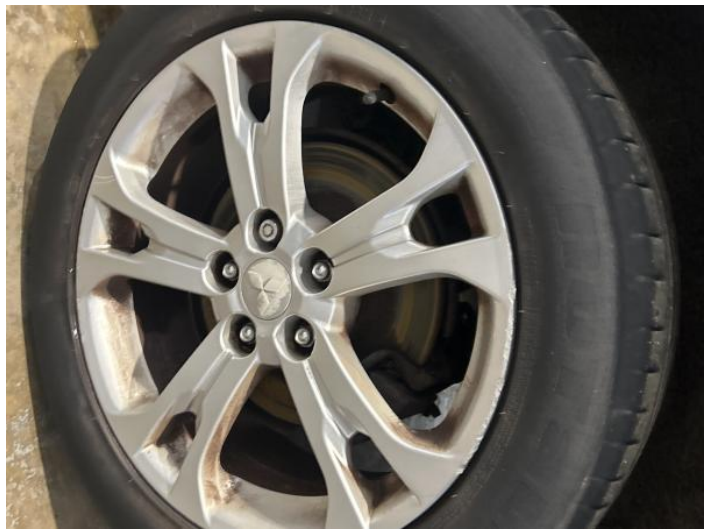
12: Wheel nsr  
Scratched  
Over 50mm

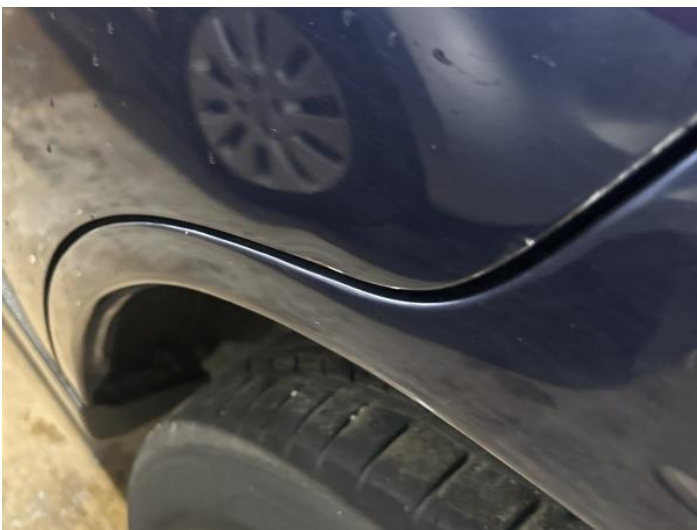
13: Door nsr  
Dented  
With Paint Damage

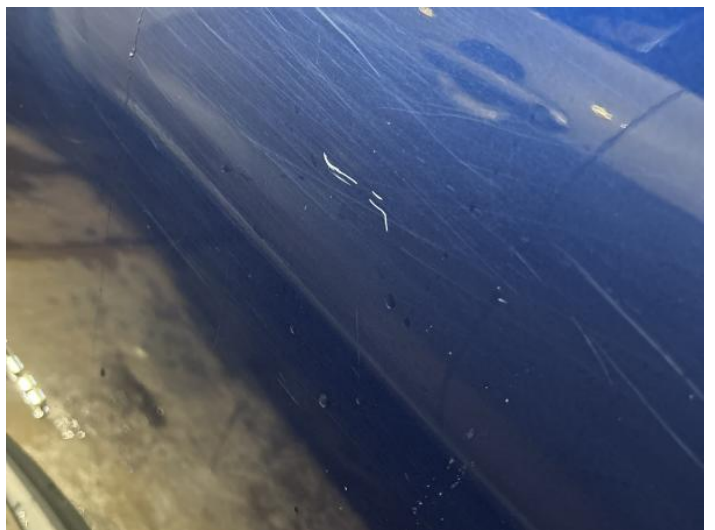
14: Door nsf  
Scratched  
Up To 25mm Thru Paint

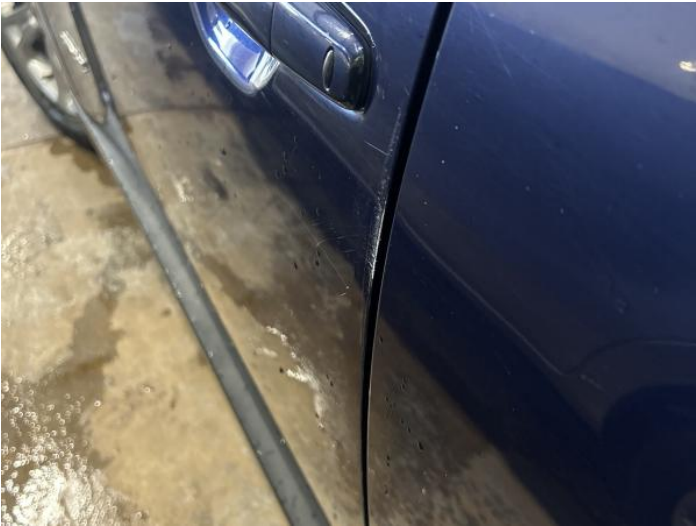
15: Door nsf  
Chipped  
Edge Chip

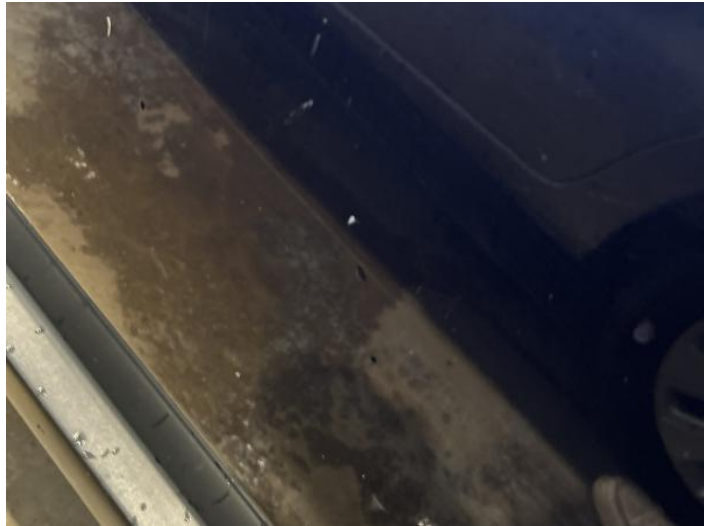
16: Door nsf  
Chipped  
1 To 5

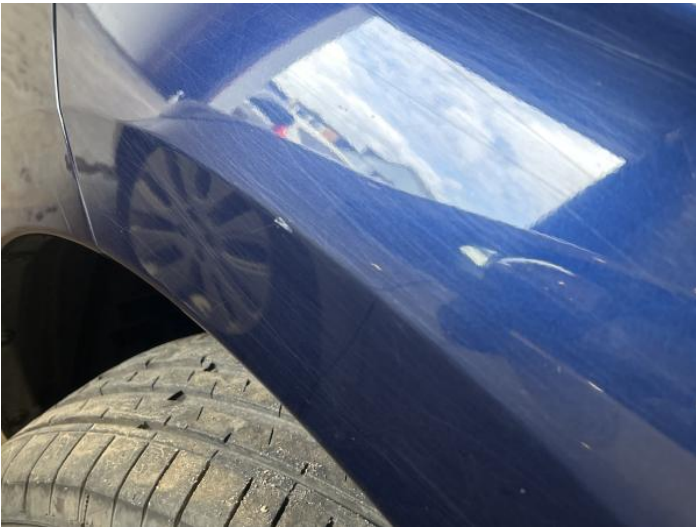
17: Wing nsf  
Chipped  
1 To 5

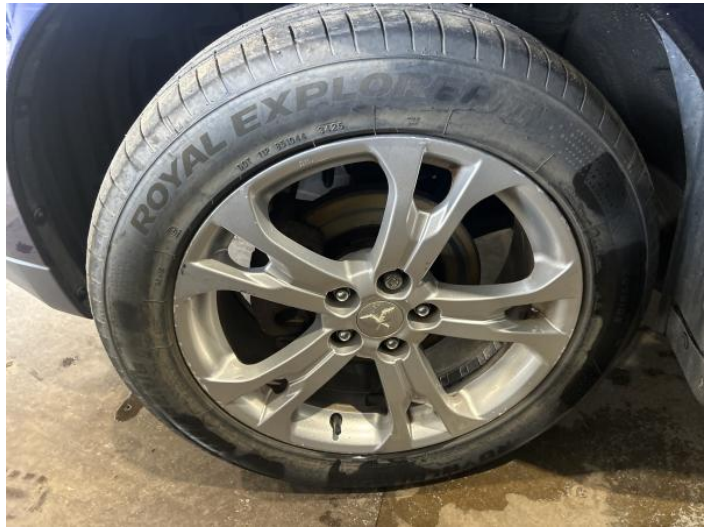
18: Wheel nsf  
Scratched  
Over 50mm

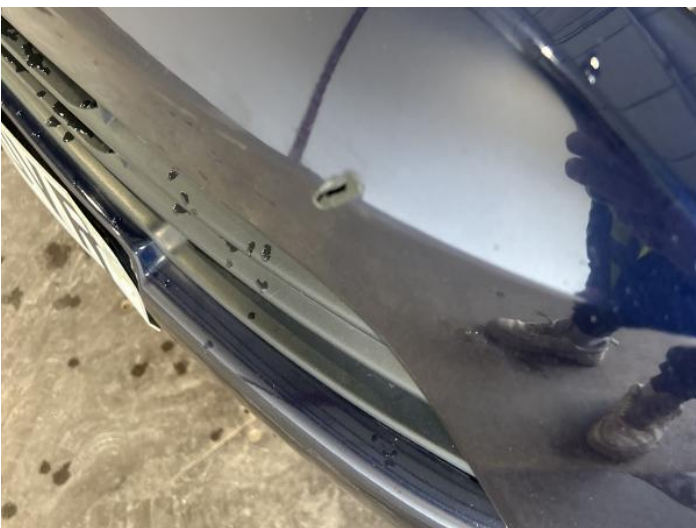
19: Bumper Front  
Hole  
UpTo 25mm

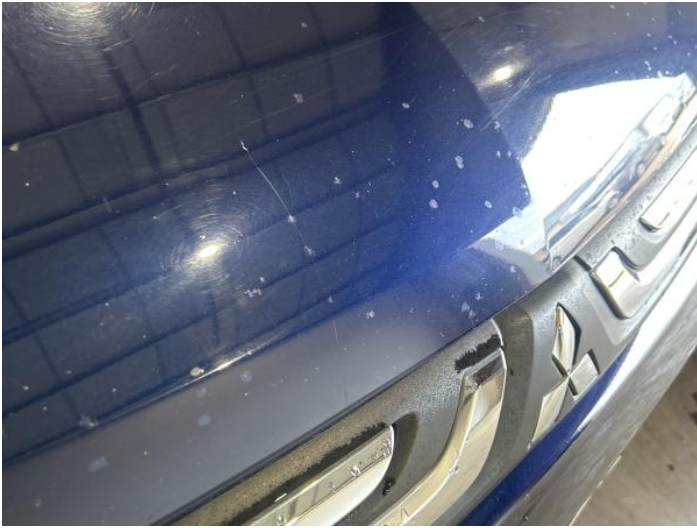
21: Bonnet  
Chipped  
Multiple Chips

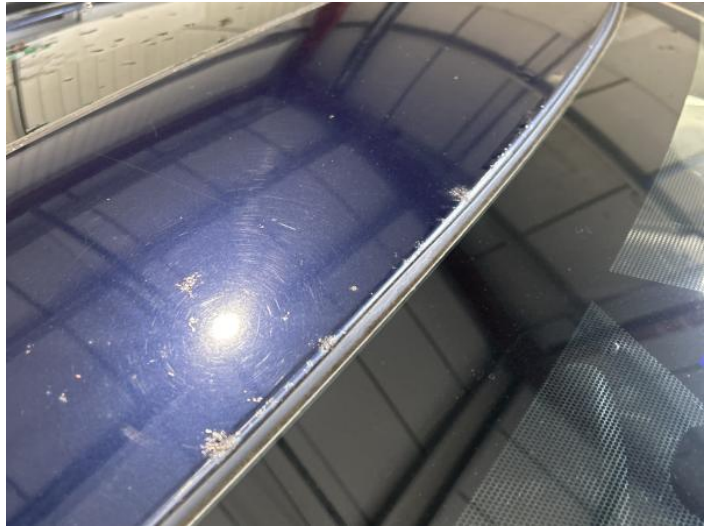
22: Roof  
Rusted  
Over 5mm

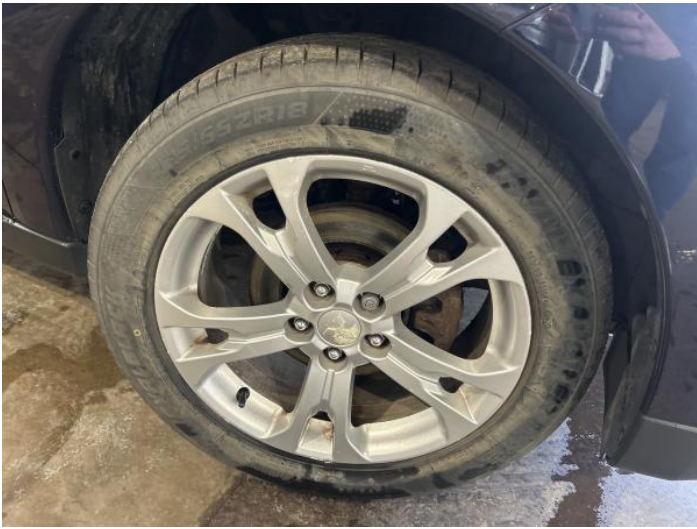
23: Wheel ofsf  
Scratched  
Over 50mm

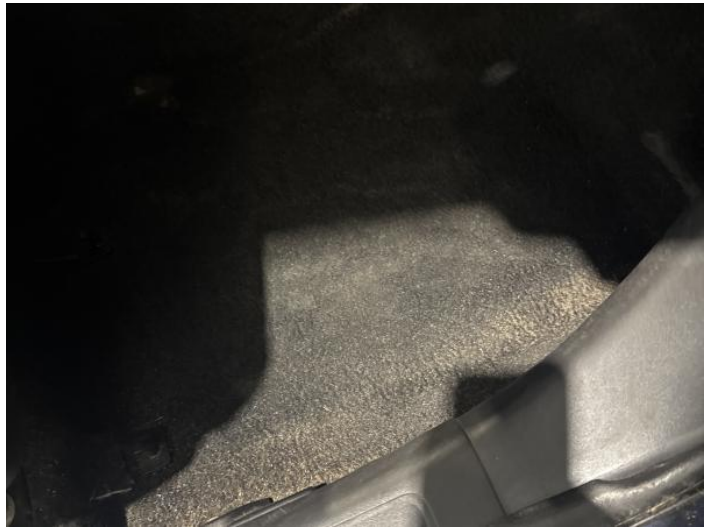
24: Carpets Front  
Soiled  
Light

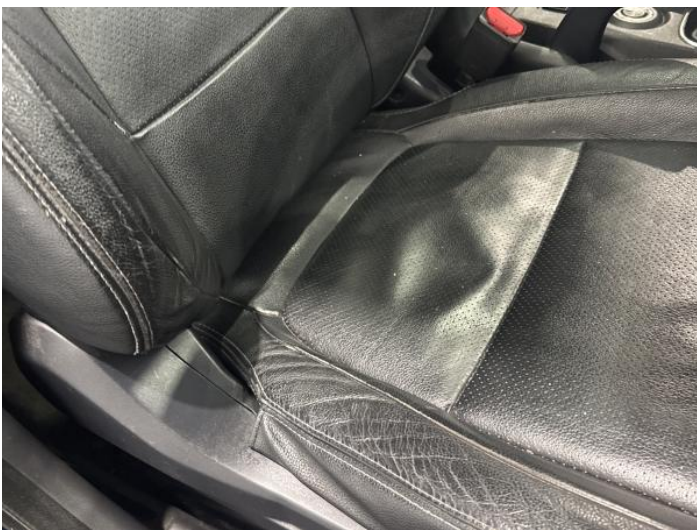
25: Seat Back Cover ofsf  
Scuffed  
Over 25mm

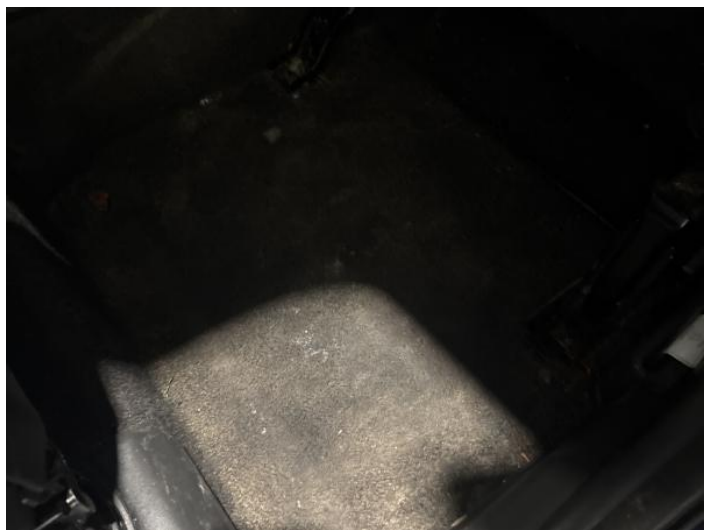
26: Carpets Rear  
Soiled  
Heavy

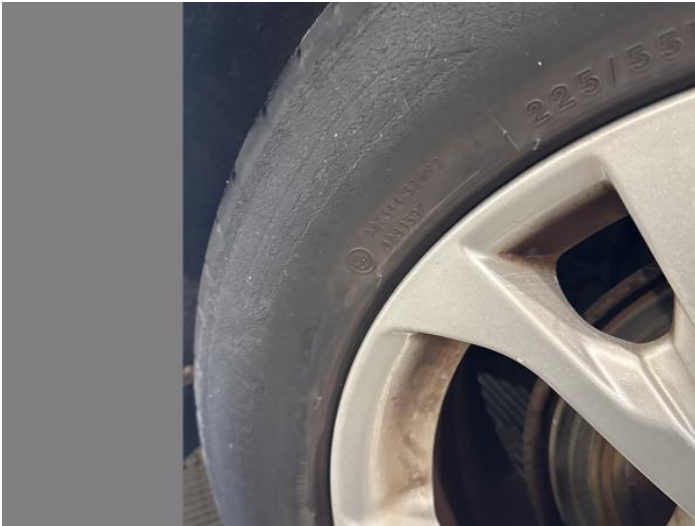
NSF	ROYALBLACK	5.0mm
NSR	BUDGET	Damaged
OSF	ROYALBLACK	5.0mm
OSR	ROTALLA	5.0mm
Spare

27: Tyre nsr  
 Damaged  
 Replace
