# VEHICLE INSPECTION REPORT

LL66PDK

## Renault Captur 0.9 TCE 90 Dynamique S Nav 5dr

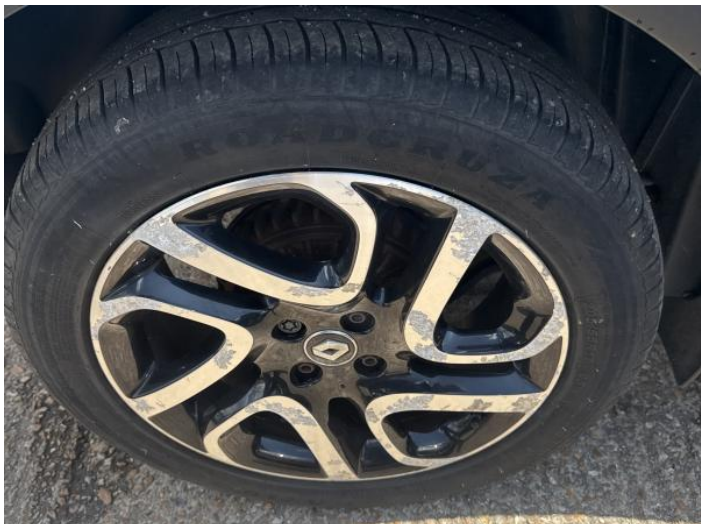
3: Wheel osr  
Corroded  
Light

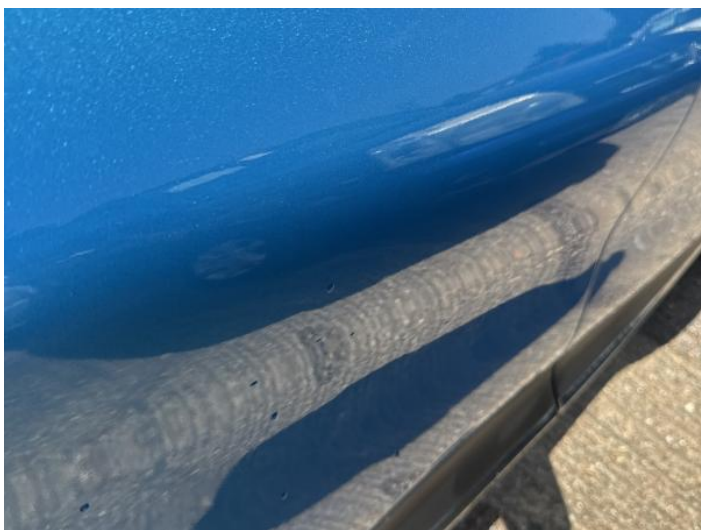
5: Door osr  
Dented  
Over 2 UpTo 10mm

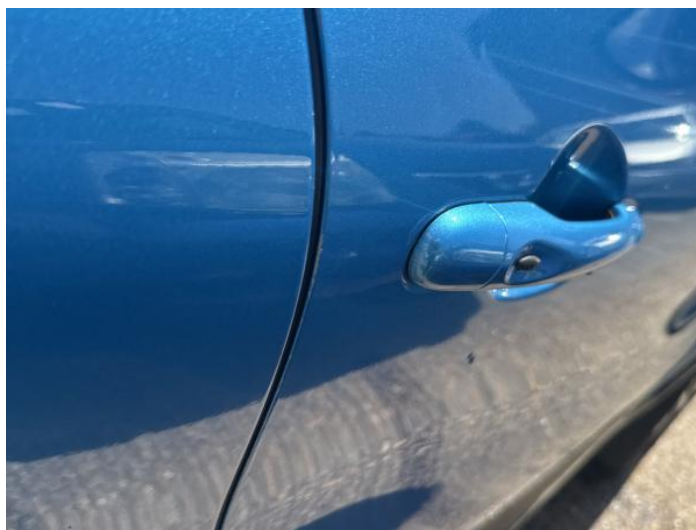
6: Door osr  
Dented  
Over 2 UpTo 10mm

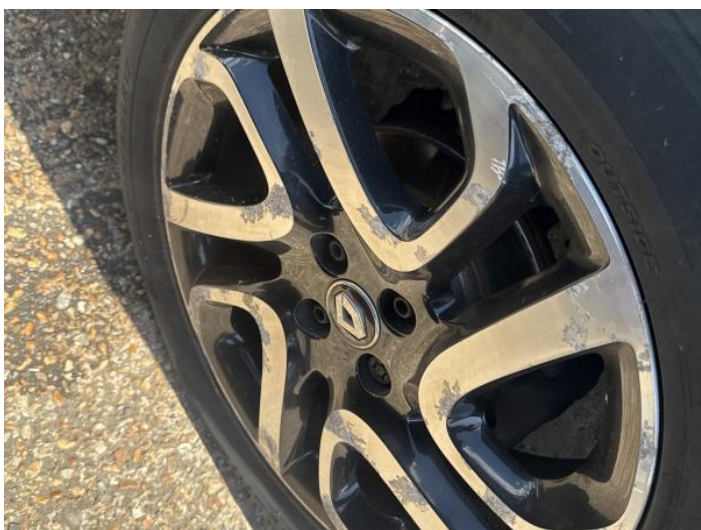
7: Wheel osf  
Corroded  
Light

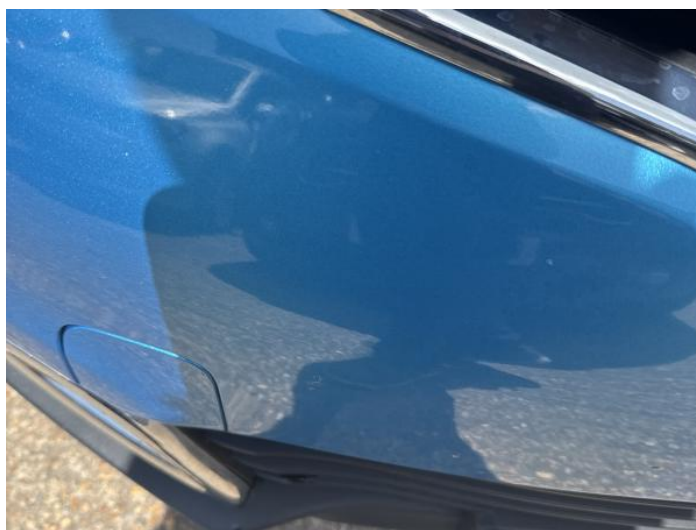
8: Bumper Front  
Chipped  
Multiple Chips

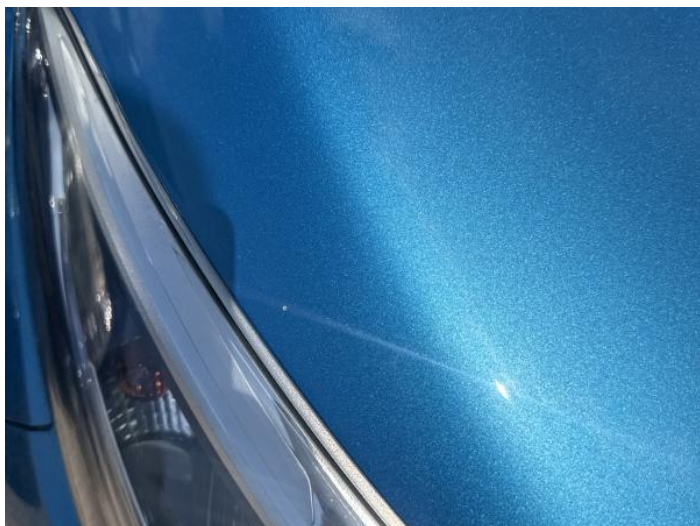
9: Bonnet  
Chipped  
1 To 5

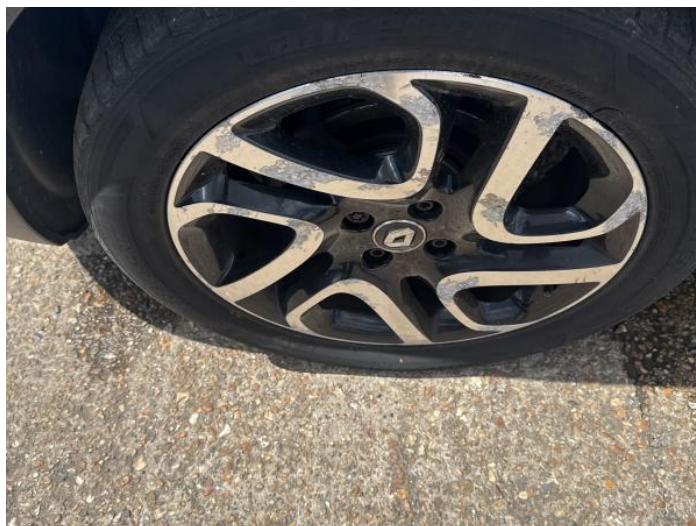
10: Wheel nsf  
Corroded  
Light

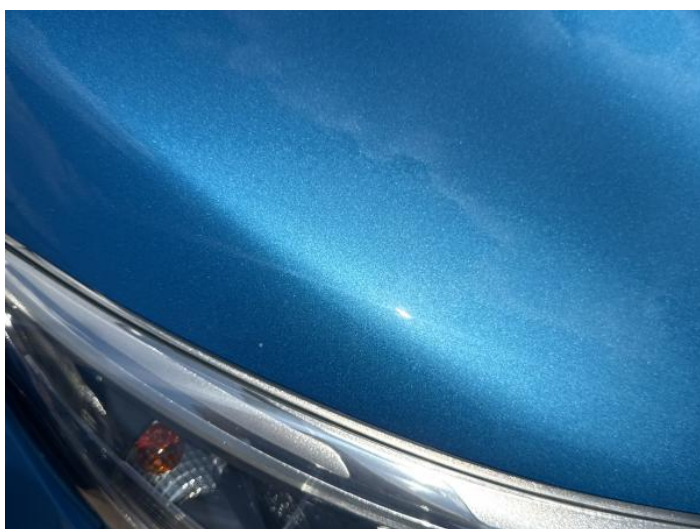
11: Bonnet  
Chipped  
1 To 5

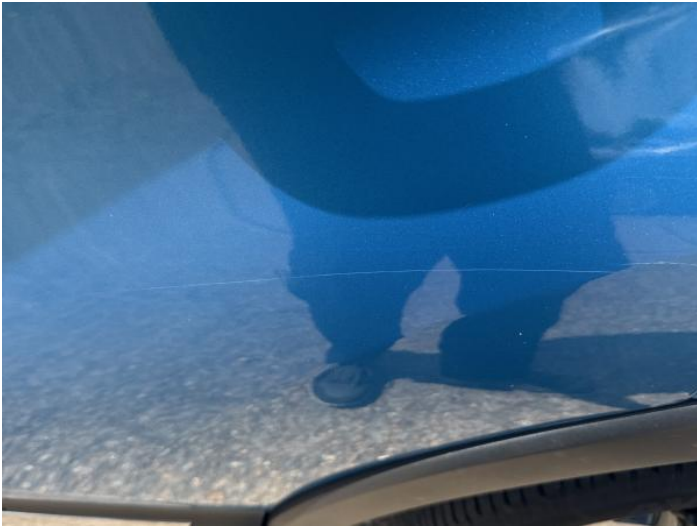
15: Door nsr  
Scratched  
Over 25mm Thru Paint

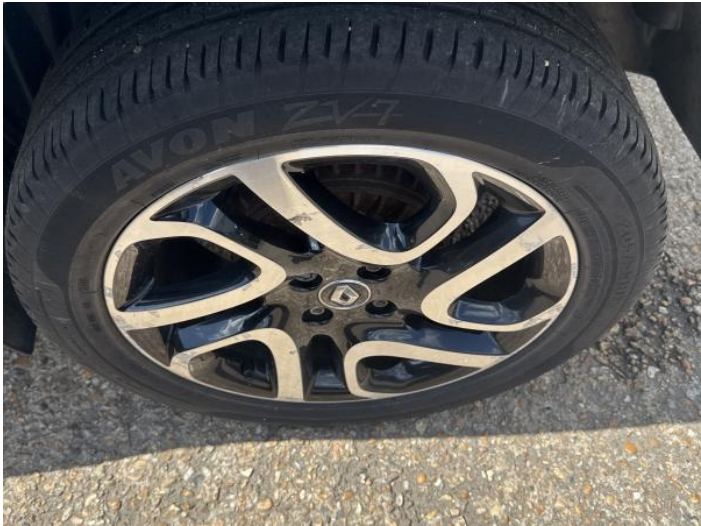
16: Wheel nsr  
Scratched  
Over 50mm

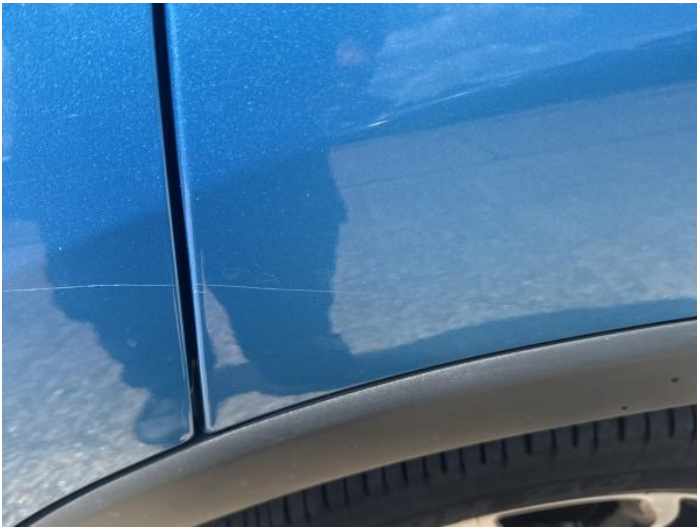
17: Qtr Panel nsr  
Scratched  
Over 25mm Thru Paint
