VEHICLE INSPECTION REPORT

LG20SVV

Land Rover Range Rover Evoque 2.0 P250 SE 5dr Auto

nama
GRADE
3

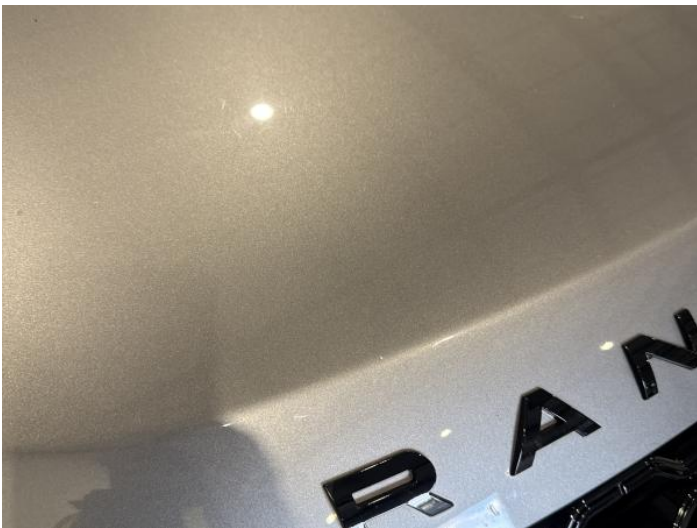
1: Bonnet
Chipped
1 To 5

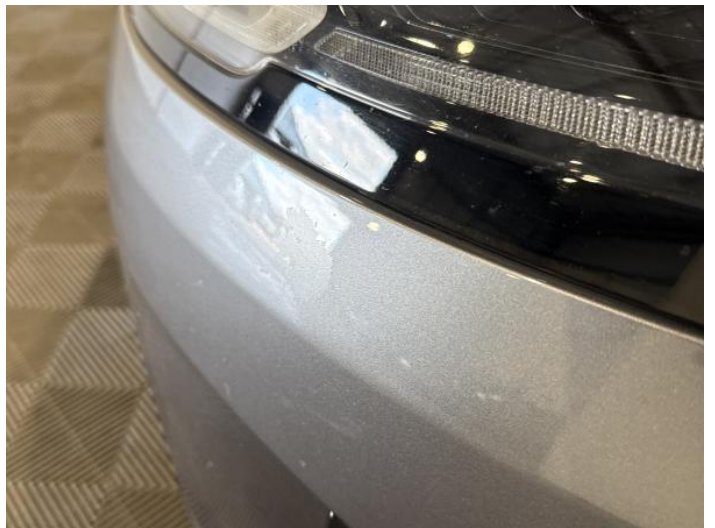
2: Bumper Front
Scratched
25 to 100mm Thru Paint

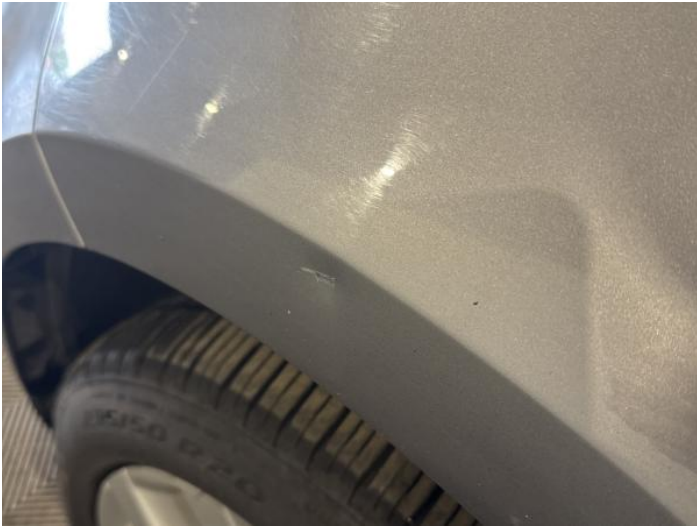
3: Wing nsf
Dented
Between 10mm + 30mm

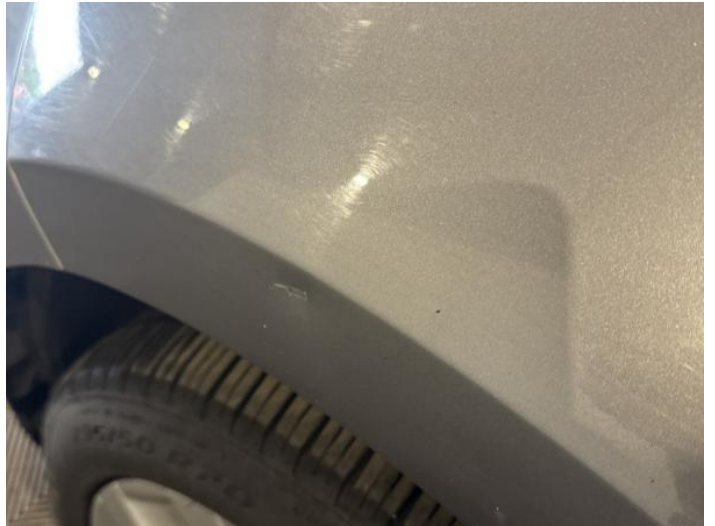
4: Wing nsf
Scratched
UpTo 25mm Thru Paint

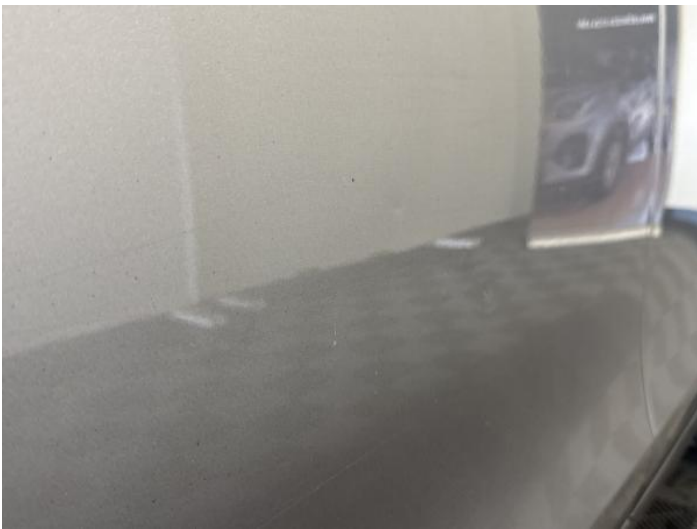
5: Door nsf
Dented
Between 10mm + 30mm

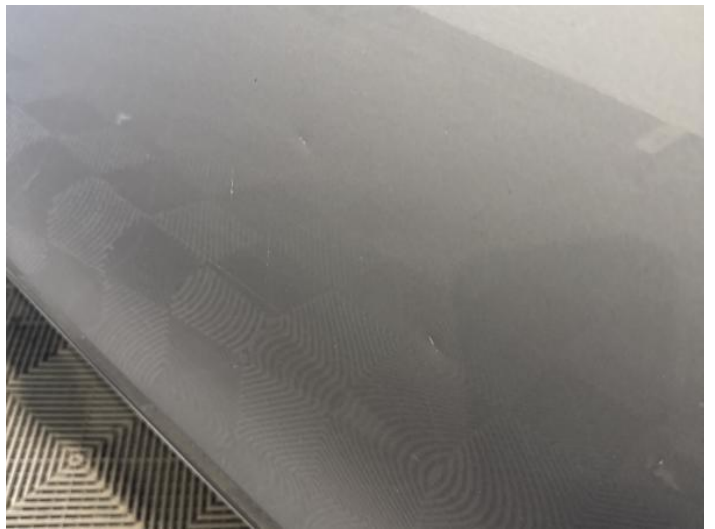
6: Door nsf
Chipped
1 To 5

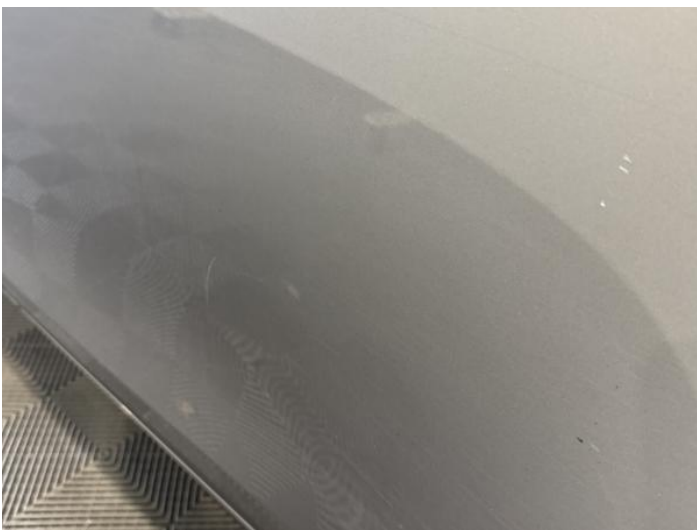
7: Door nsr
Scratched
Over 25mm Thru Paint

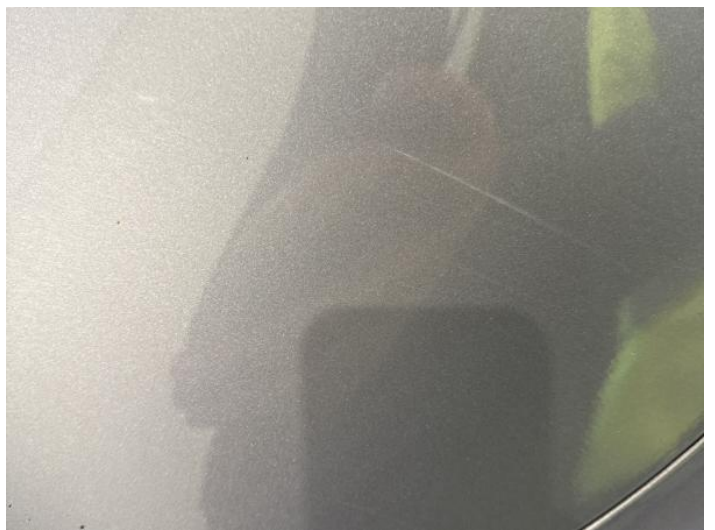
8: Qtr Panel nsr
Scratched
Over 25mm Thru Paint

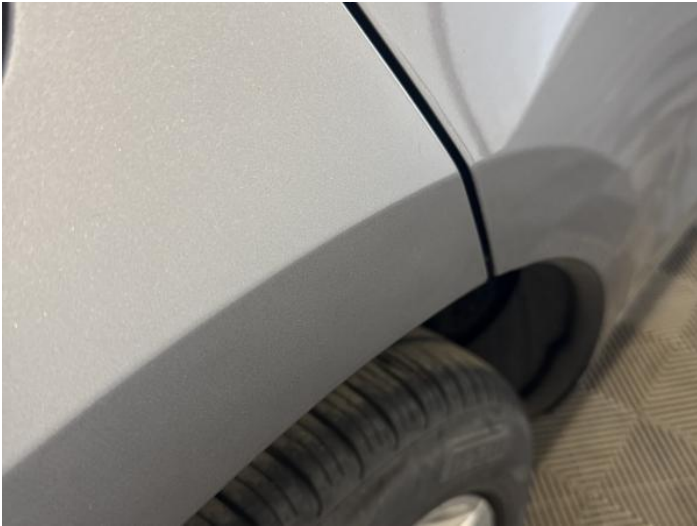
9: Qtr Panel osr
Dented
Between 10mm + 30mm

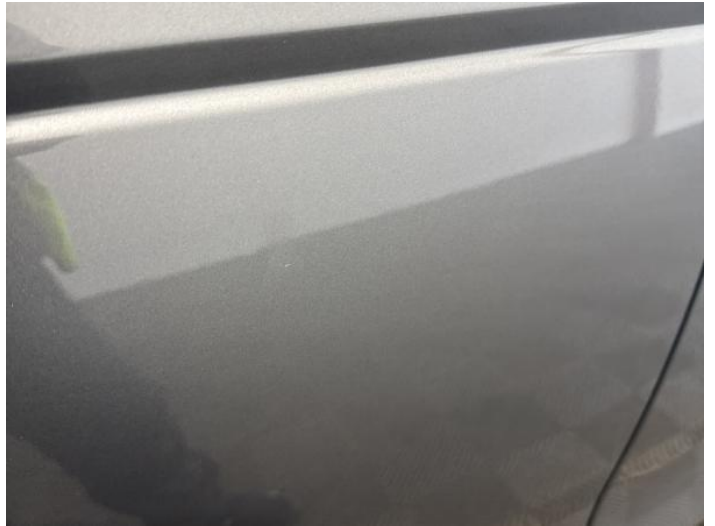
10: Door osr
Chipped
1 To 5

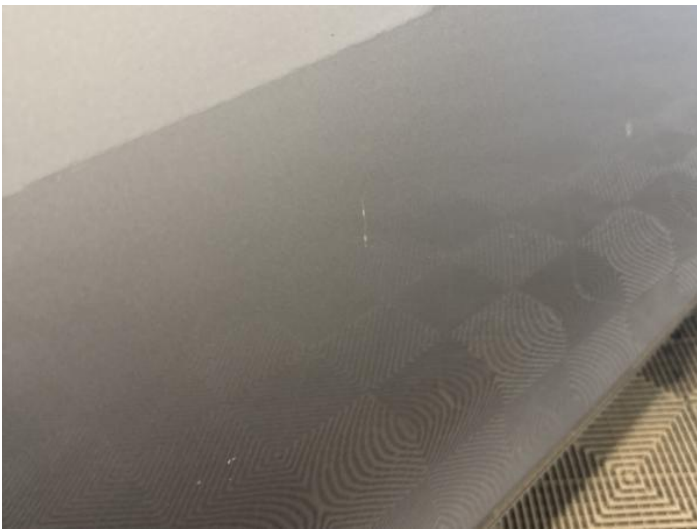
11: Door osf
Scratched
UpTo 25mm Thru Paint

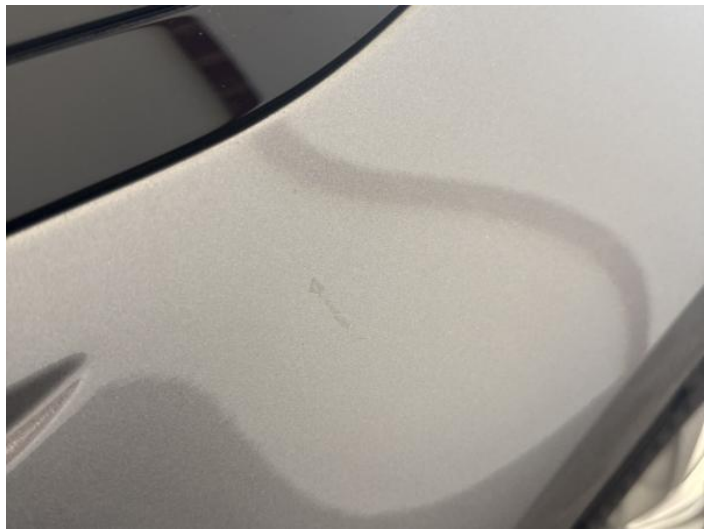
12: Wing osf
Scratched
UpTo 25mm Thru Paint

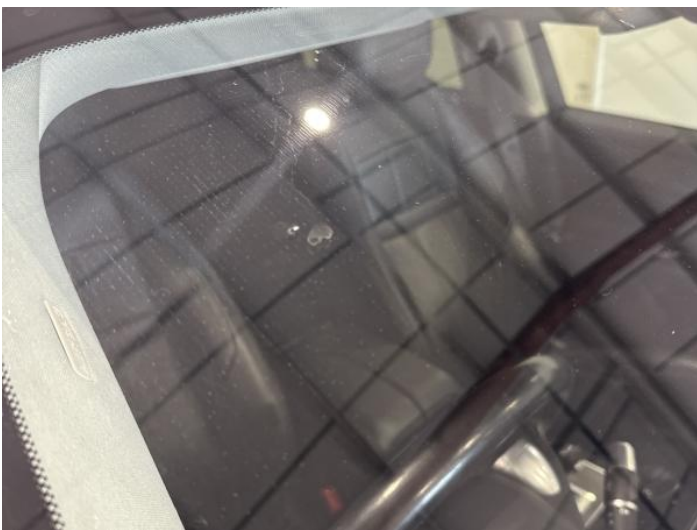
13: Screen Front
Chipped
UpTo 10mm
