# VEHICLE INSPECTION REPORT

**YH67XOV**

## Suzuki Sx4 S-Cross 1.0 Boosterjet SZ4 5dr

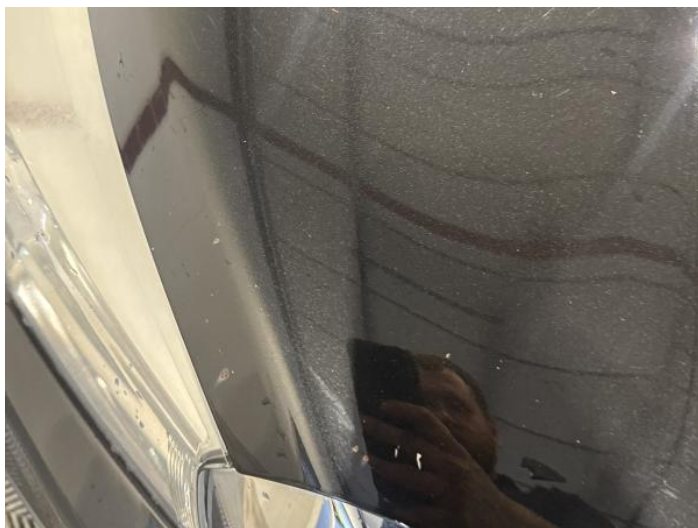
1: Bonnet  
Chipped  
Multiple Chips

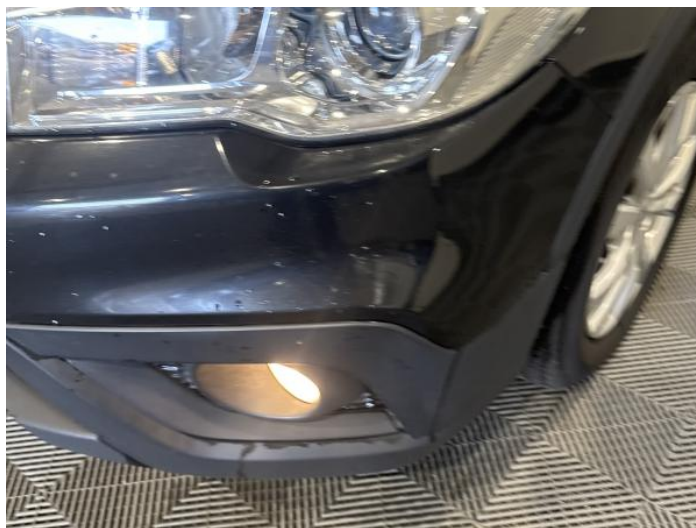
2: Bumper Front  
Scratched  
25 to 100mm Thru Paint

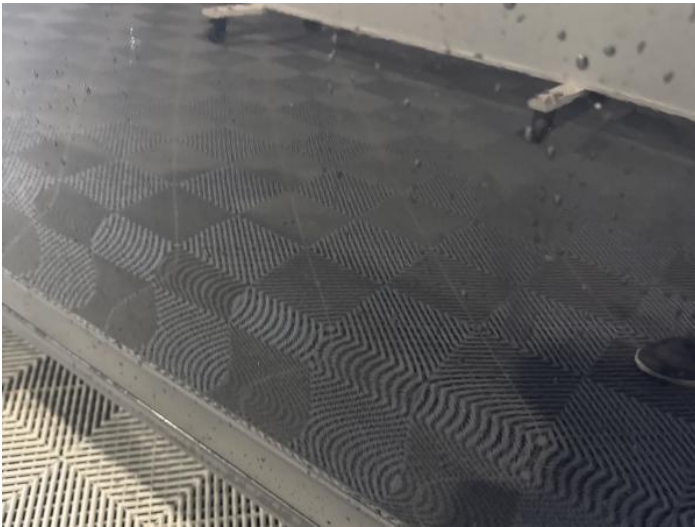
5: Door nsf  
Chipped  
1 To 5

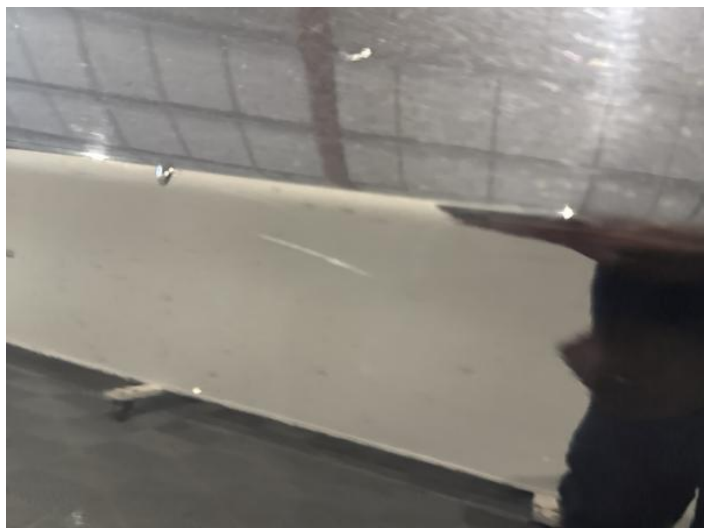
7: Wing nsf  
Scratched  
Over 25mm Not Thru Paint

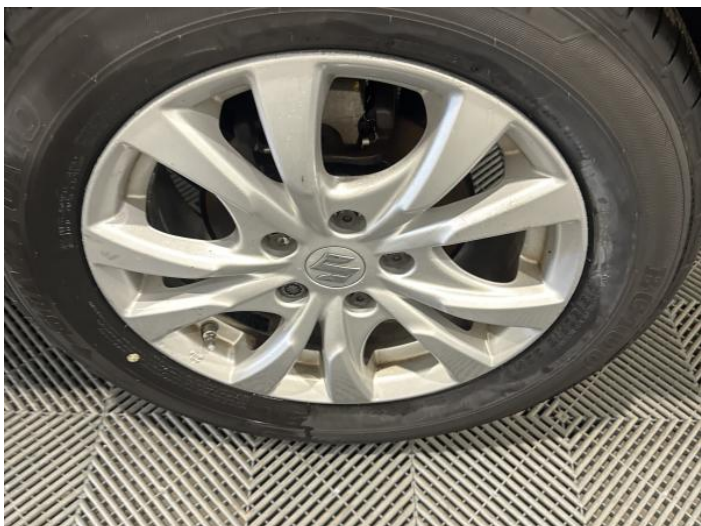
9: Wheel nsr  
Scratched  
Over 50mm

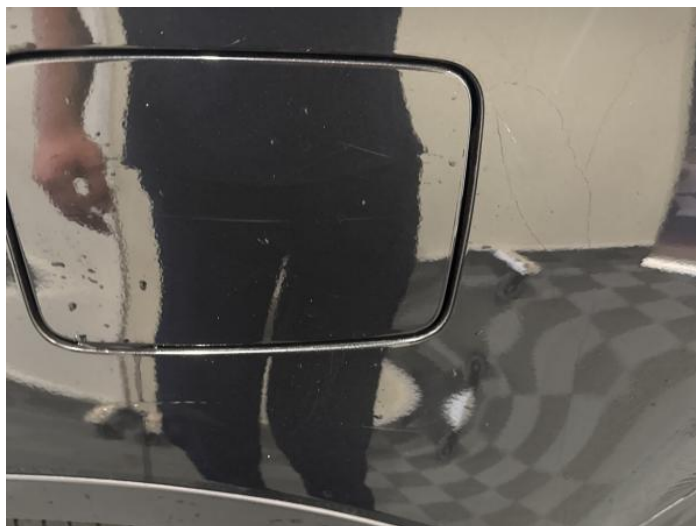
10: Qtr Panel nsr  
Dented  
With Paint Damage

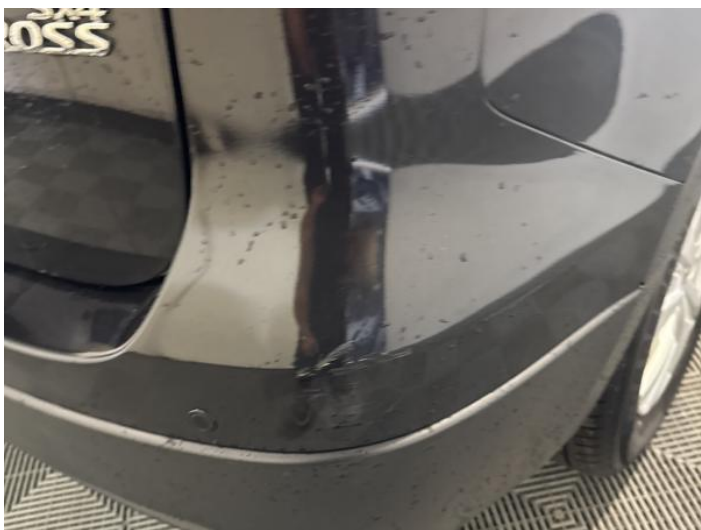
11: Bumper Rear  
Scratched  
Over 100mm Thru Paint

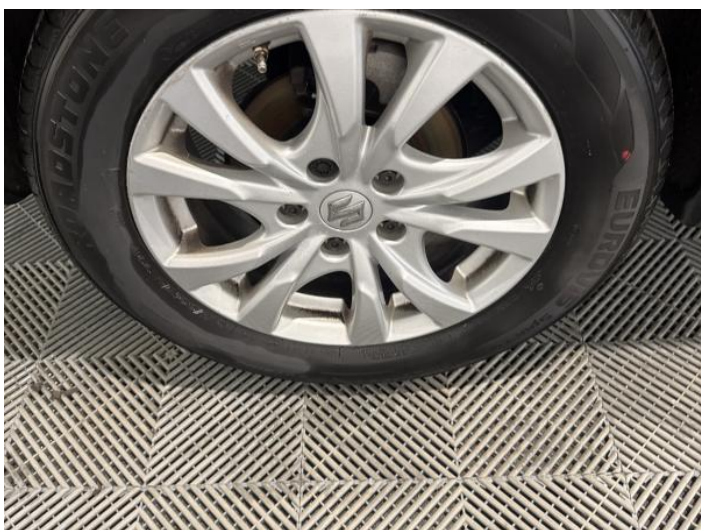
13: Wheel osr  
Scratched  
Over 50mm

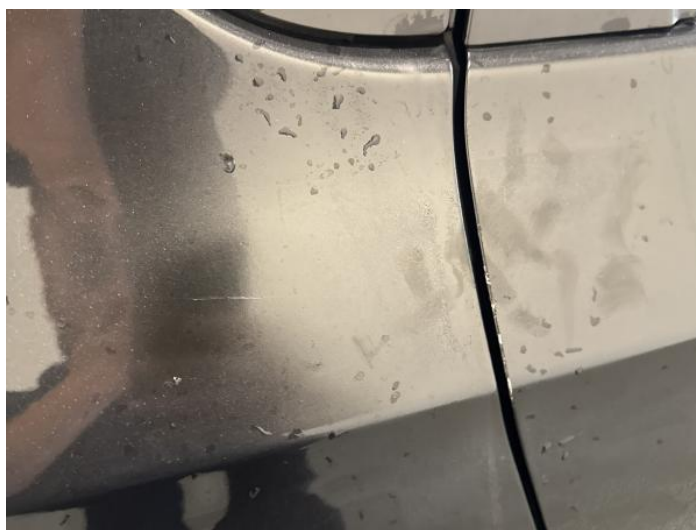
14: Qtr Panel osr  
Poor Previous Repair  
Poor Paint

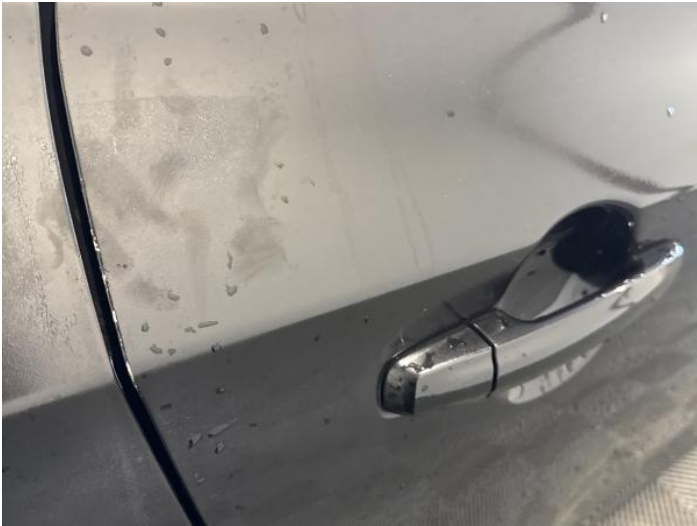
15: Door osr  
Poor Previous Repair  
Poor Paint

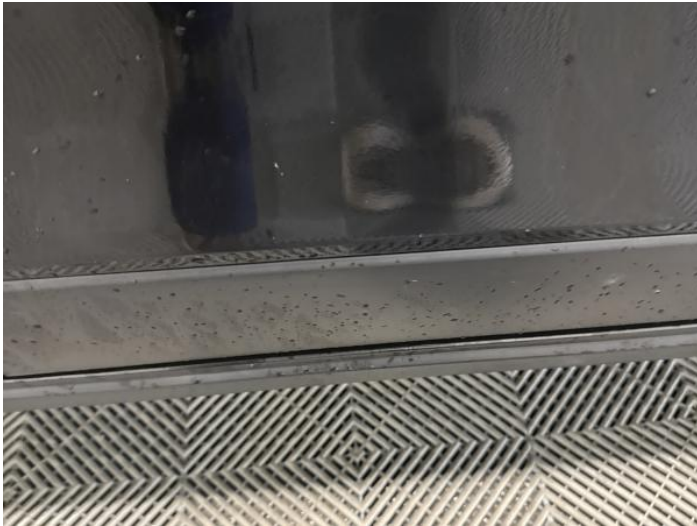
16: Door osf  
Chipped  
1 To 5

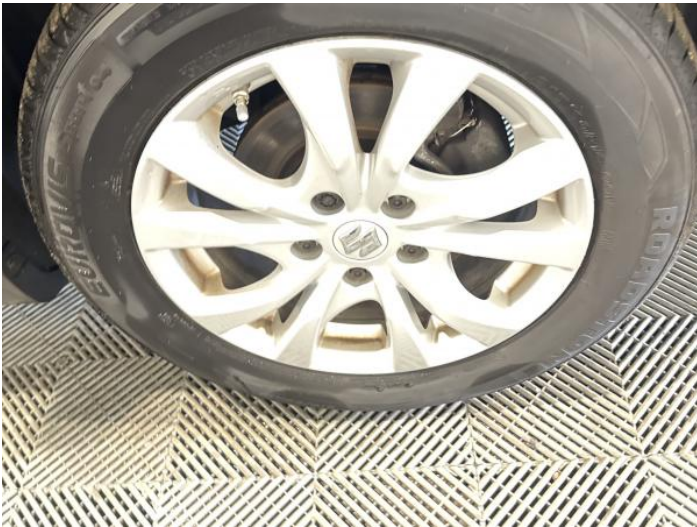
17: Wheel osf  
Scratched  
Over 50mm
