VEHICLE INSPECTION REPORT

GX13NLC

Honda CR-V 2.0 i-VTEC SE-T 5dr

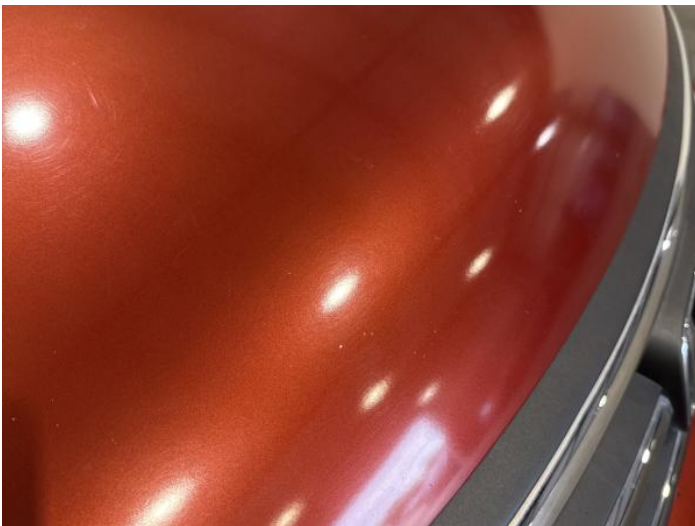
1: Bonnet
Chipped
Multiple Chips

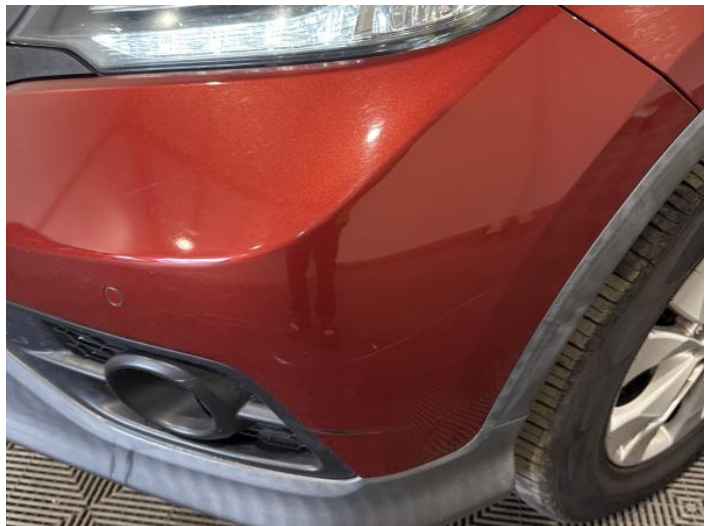
2: Bumper Front
Scratched
Over 100mm Thru Paint

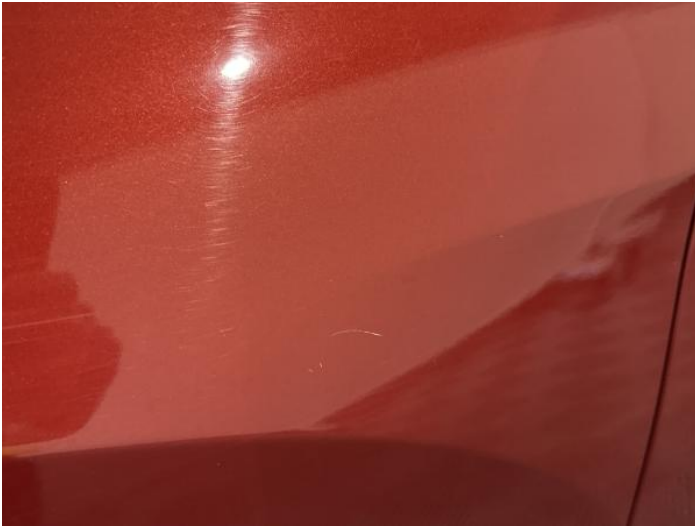
3: Wing nsf
Scratched
UpTo 25mm Thru Paint

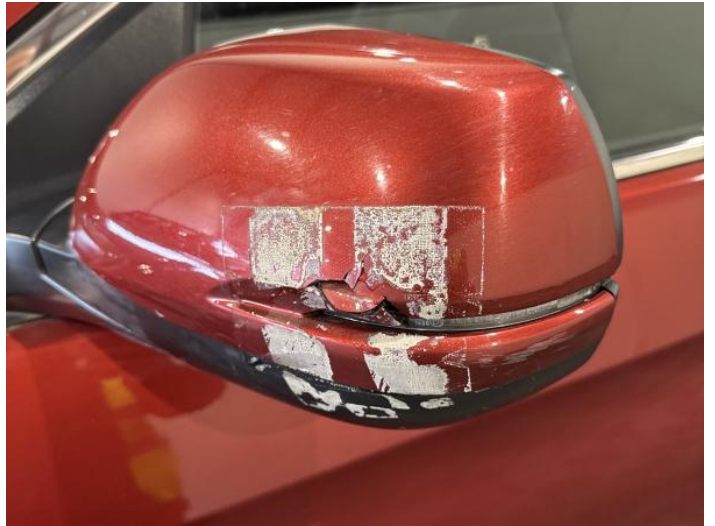
4: Door Mirror Assy nsf
Broken
Replace

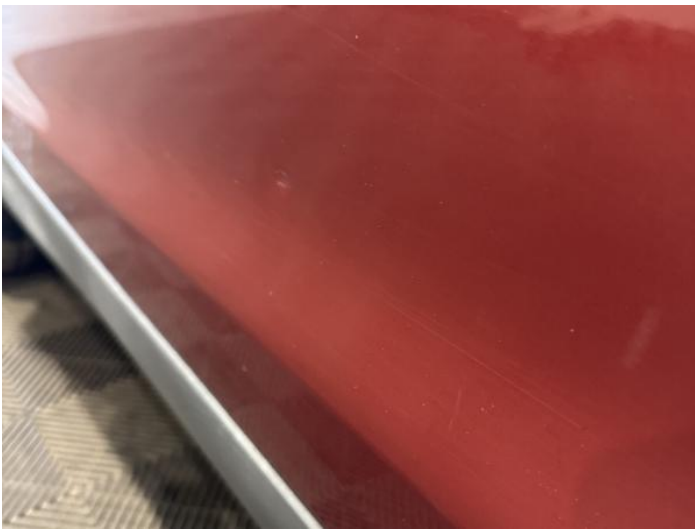
5: Door nsf
Dented
Between 10mm + 30mm

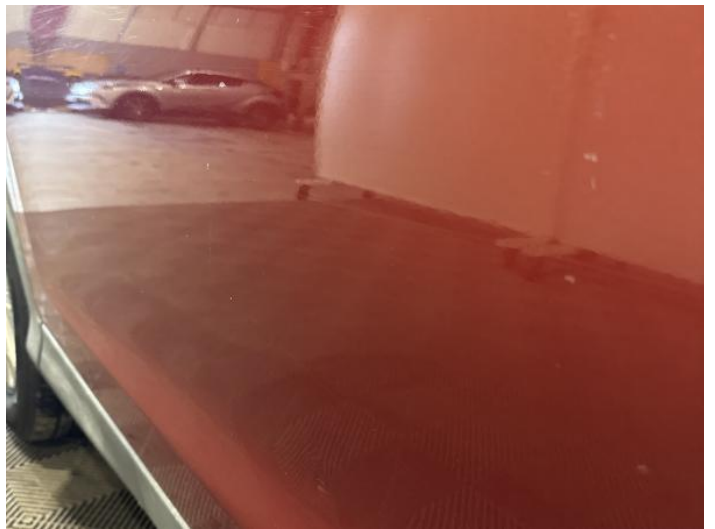
6: Door nsf
Scratched
Over 25mm Thru Paint

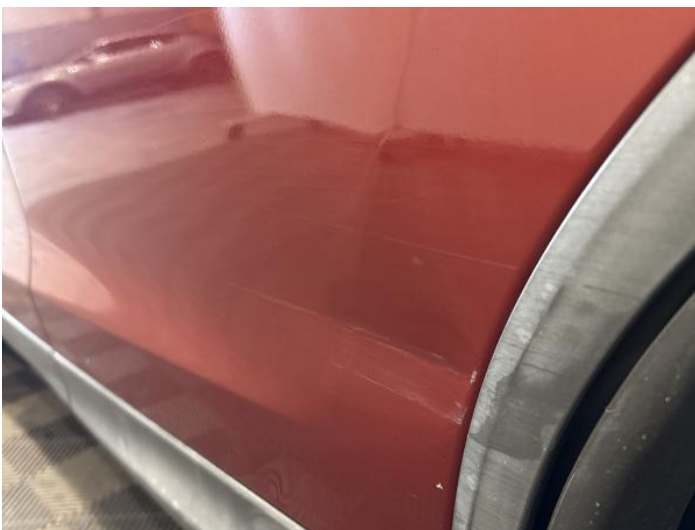
7: Door nsr
Dented
With Paint Damage

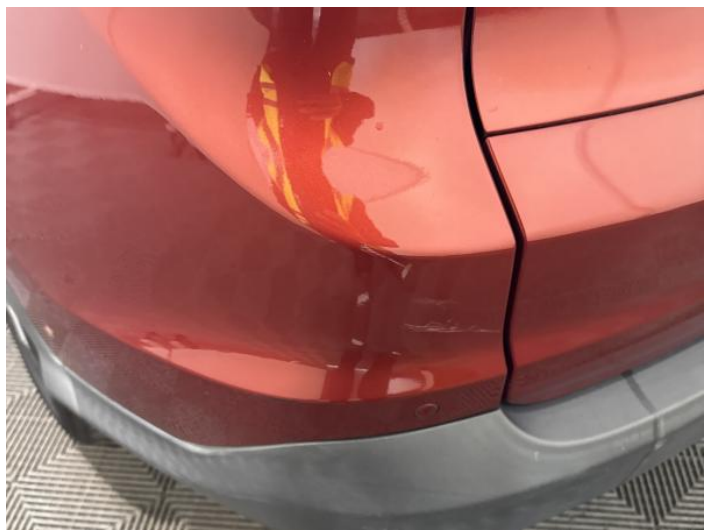
8: Bumper Rear
Scratched
25 to 100mm Thru Paint

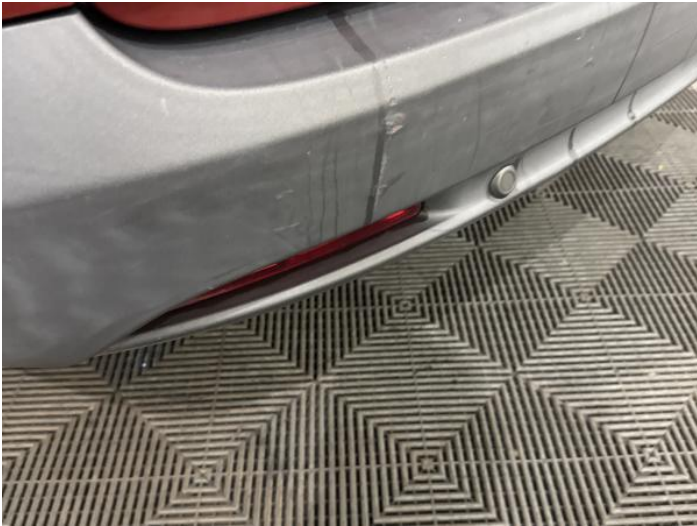
9: Bumper Rear Moulding
Scuffed (Unpainted)
Over 100mm

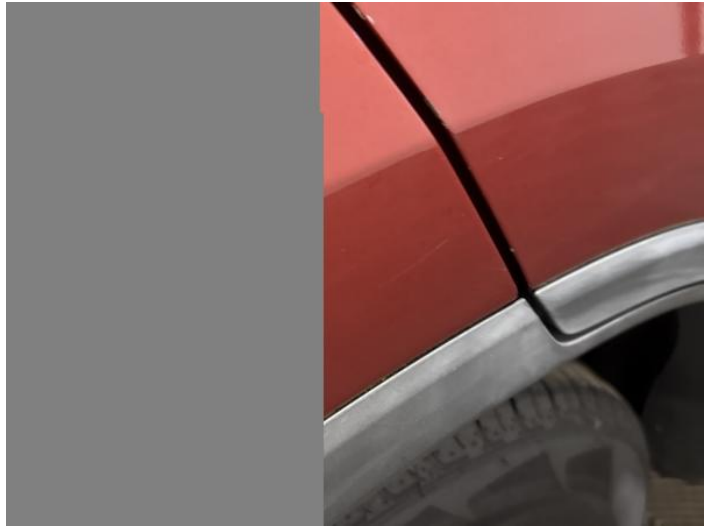
10: Qtr Panel osf
Scratched
UpTo 25mm Thru Paint

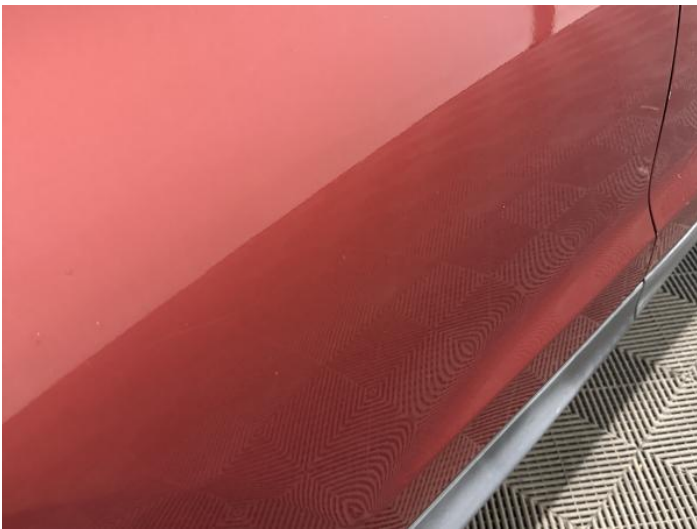
11: Door osf
Scratched
Over 25mm Thru Paint

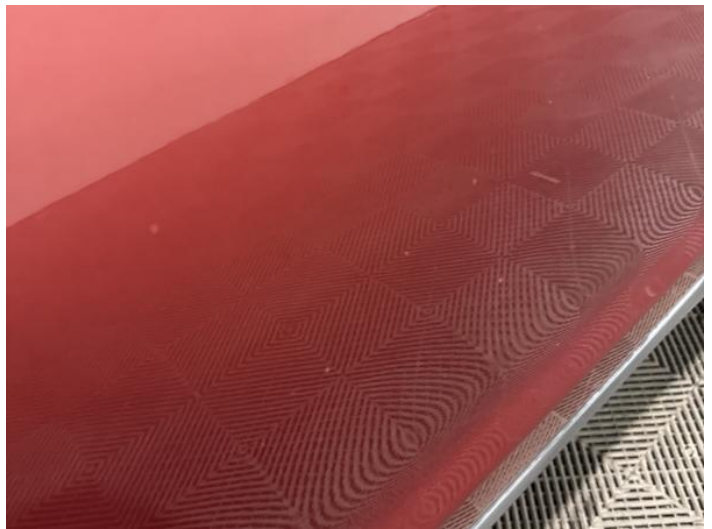
12: Door osf
Chipped
Multiple Chips

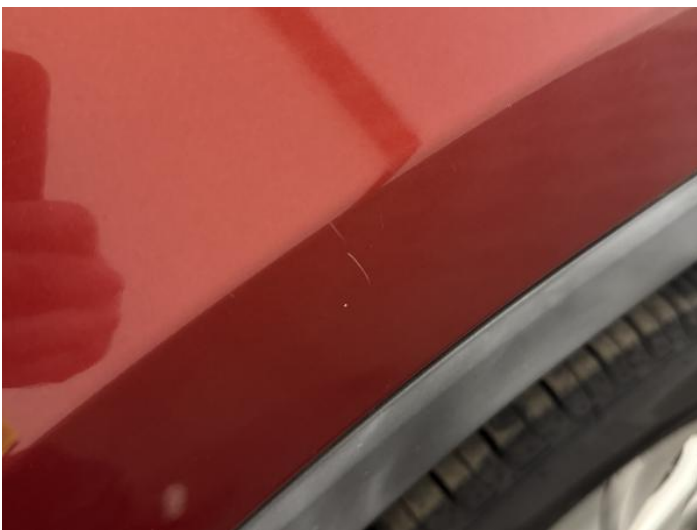
13: Wing osf
Scratched
UpTo 25mm Thru Paint

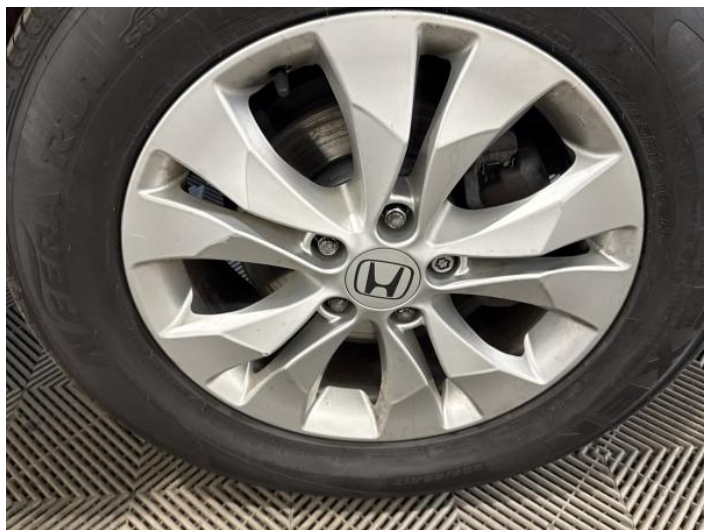
14: Wheel osf
Scratched
Up To 50mm
