VEHICLE INSPECTION REPORT

GD18YGJ

Skoda Karoq 1.0 TSI SE 5dr

nama
GRADE
4

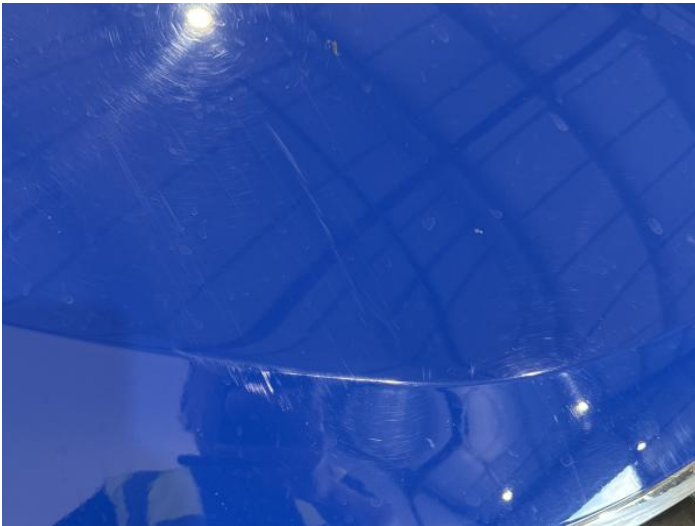
1: Bonnet
Scratched
Over 25mm Thru Paint

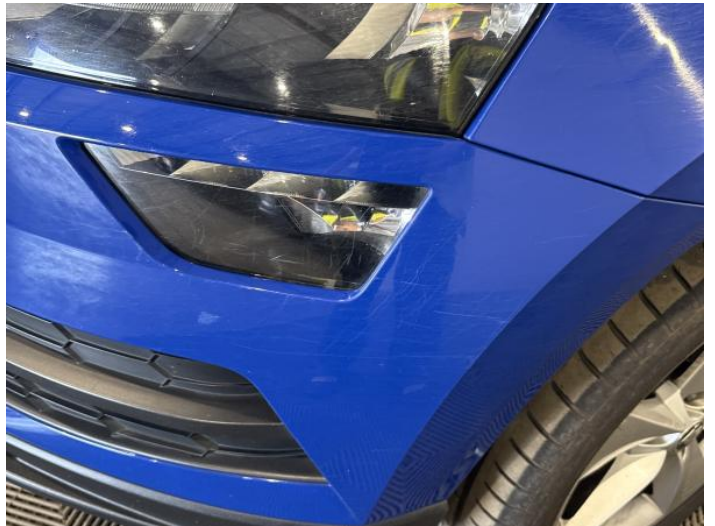
2: Bumper Front
Scratched
25 to 100mm Thru Paint

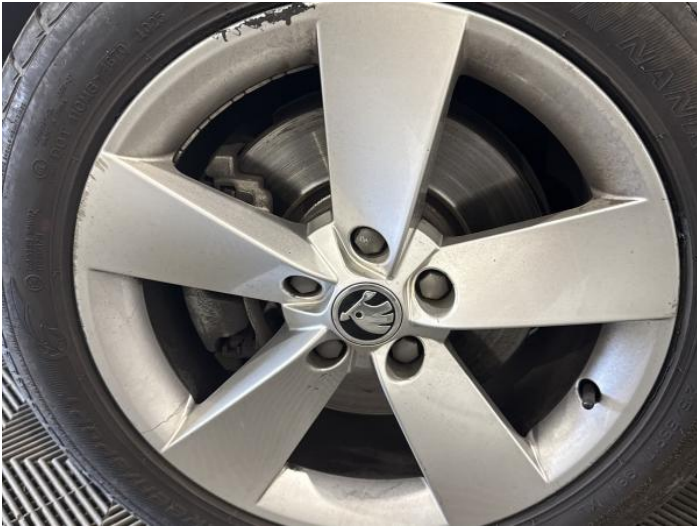
3: Wheel nsf
Scratched
Up To 50mm

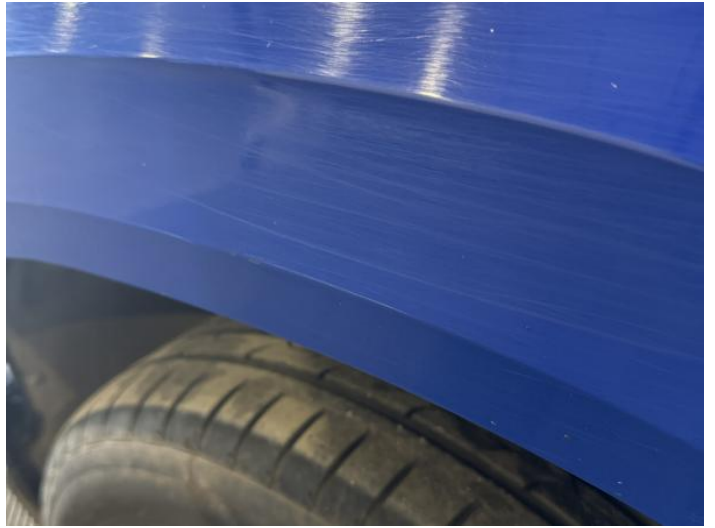
4: Wing nsf
Scratched
Over 25mm Thru Paint

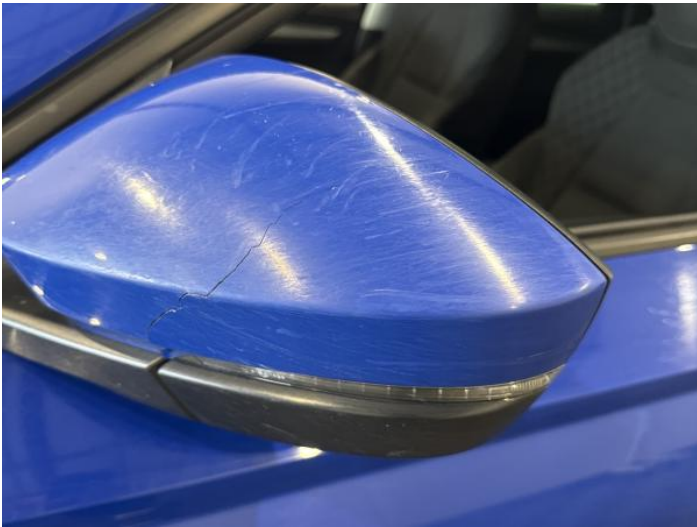
5: Door Mirror Assy nsf
Broken
Replace

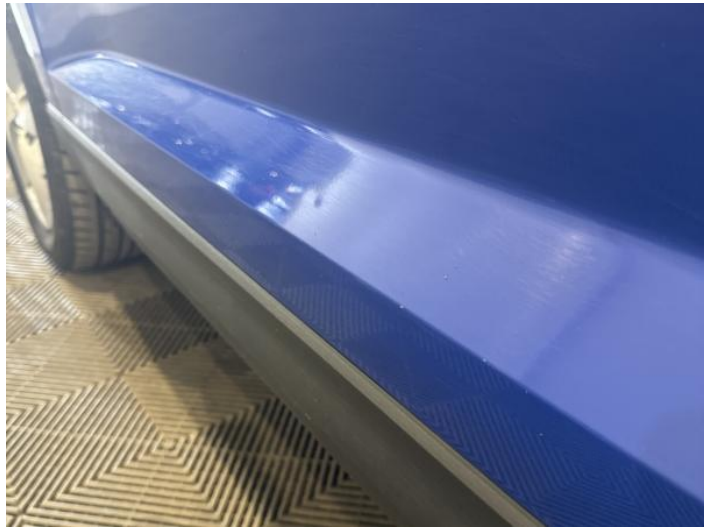
6: Door nsf
Dented
Between 10mm + 30mm

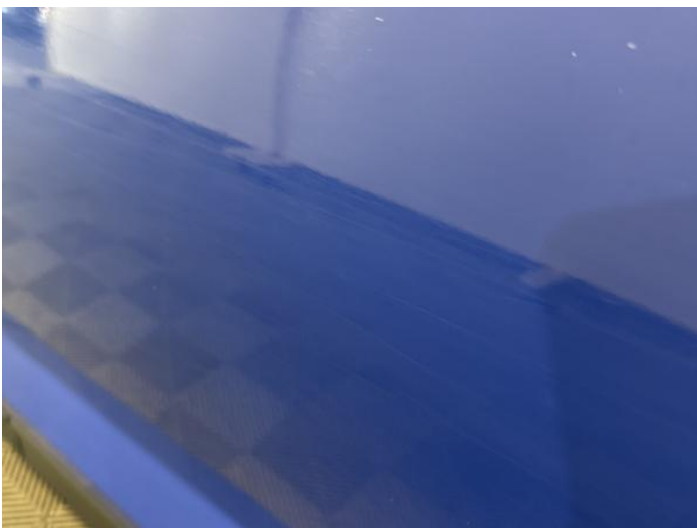
7: Door nsr
Dented
2 Or Less Up To 10mm

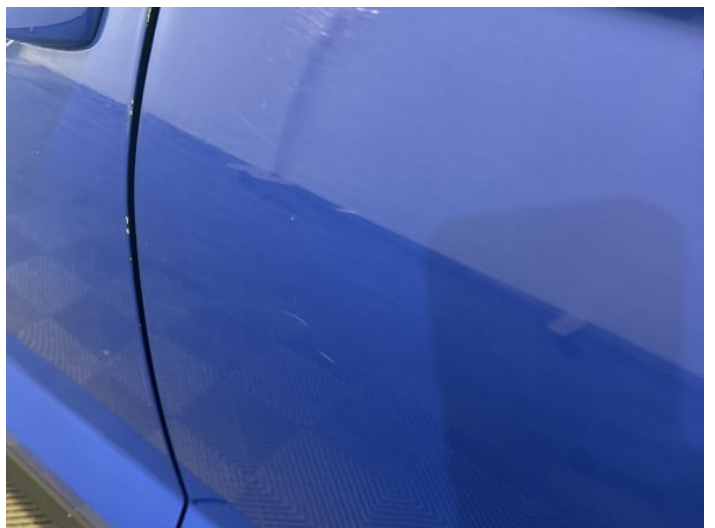
8: Door nsr
Scratched
Over 25mm Thru Paint

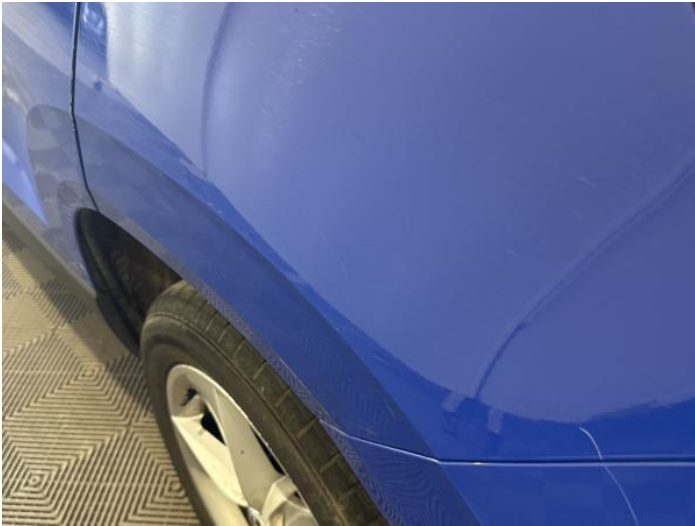
9: Qtr Panel nsr
Scratched
Over 25mm Thru Paint

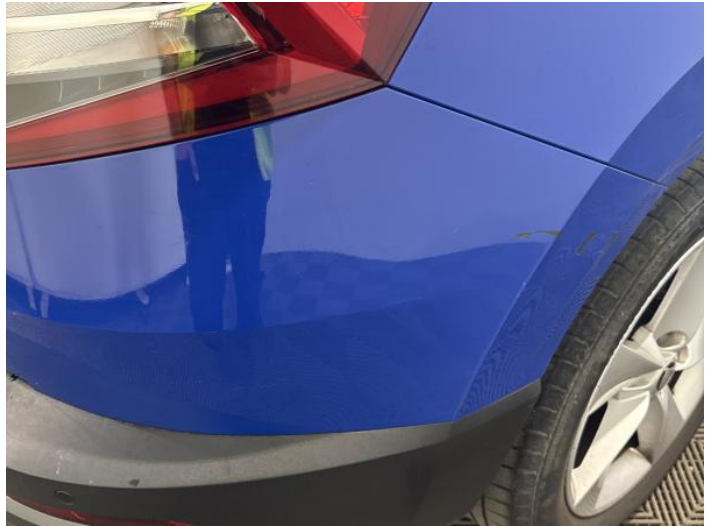
10: Bumper Rear
Scratched
25 to 100mm Thru Paint

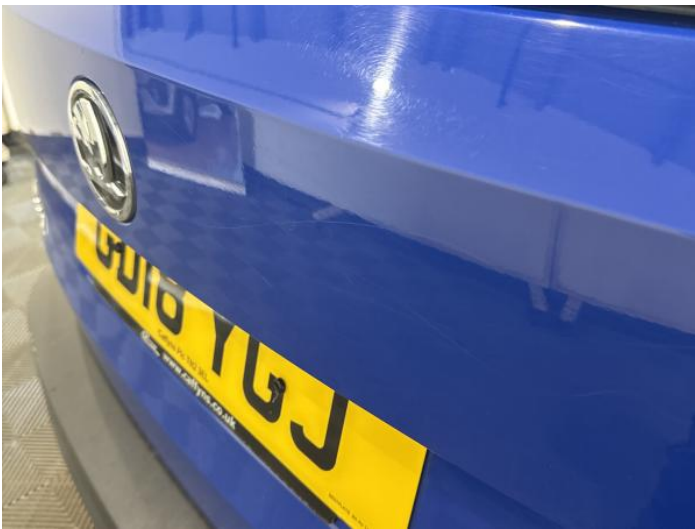
11: Tailgate
Scratched
Over 25mm Thru Paint

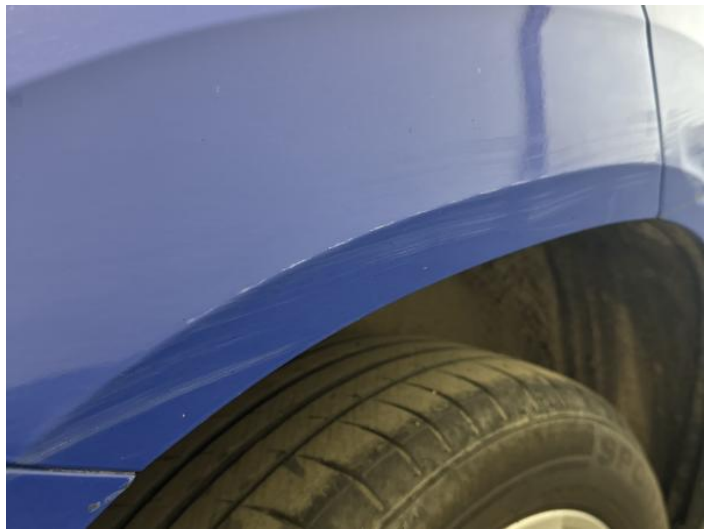
12: Qtr Panel osr
Scratched
Over 25mm Thru Paint

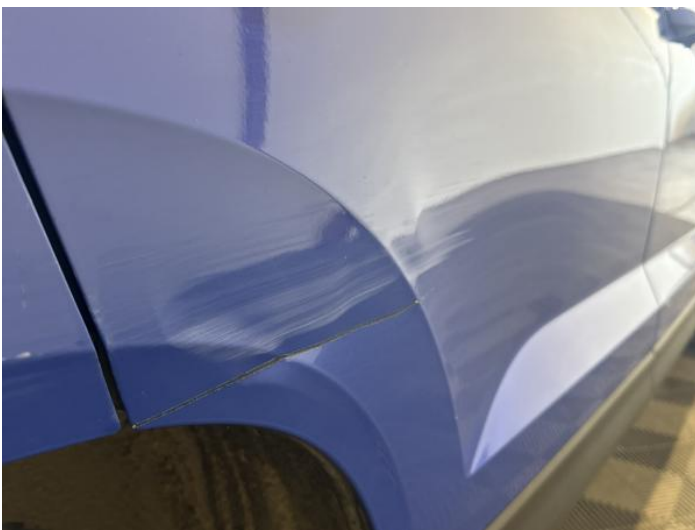
13: Door osr
Dented
With Paint Damage

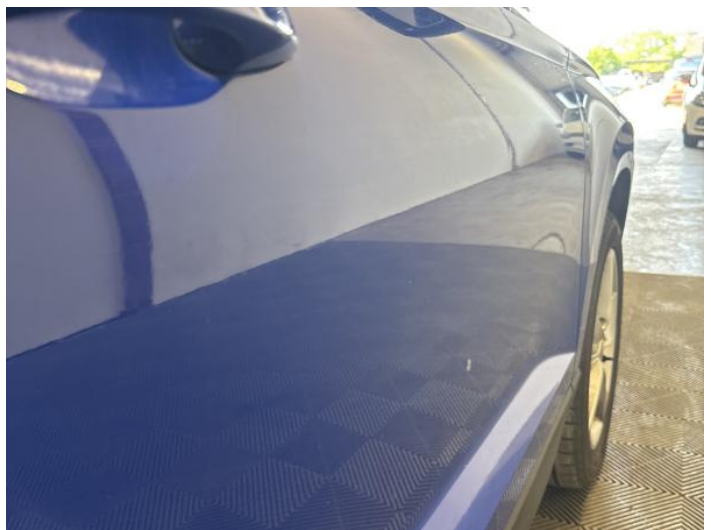
14: Door osf
Dented
Over 30mm

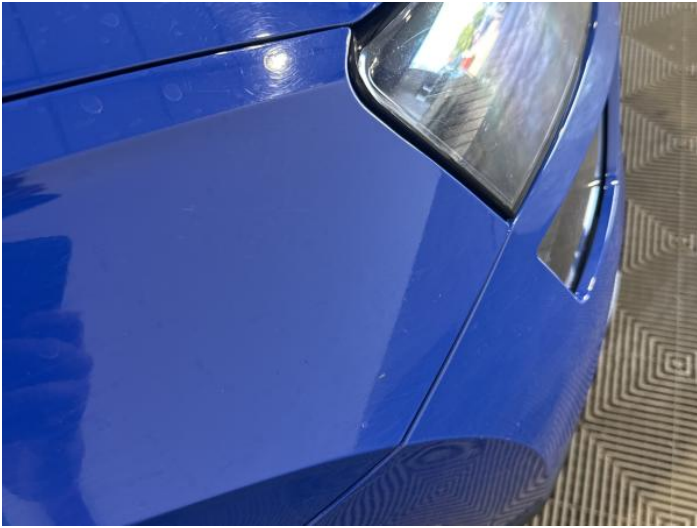
15: Wing osf
 Chipped
 1 To 5
