VEHICLE INSPECTION REPORT

YB61WCZ

Ford S-Max 1.6 EcoBoost Zetec 5dr [Start Stop]

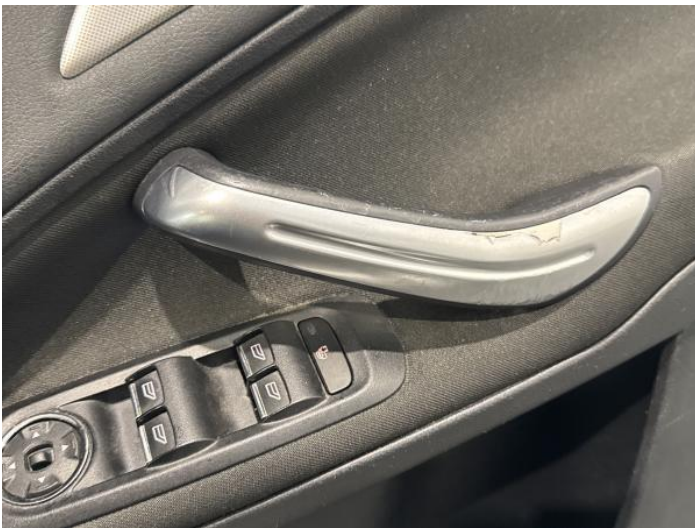
1: Handle Inner osf
Damaged
Replace

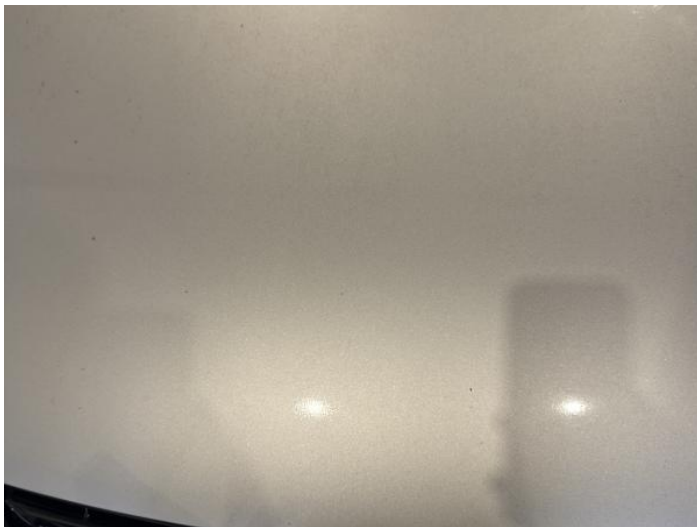
3: Bonnet
Chipped
1 To 5

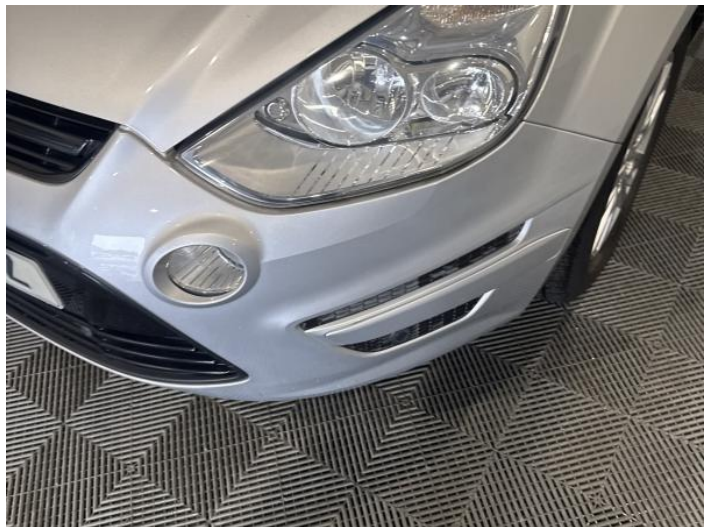
4: Bumper Front
Scratched
Over 100mm Thru Paint

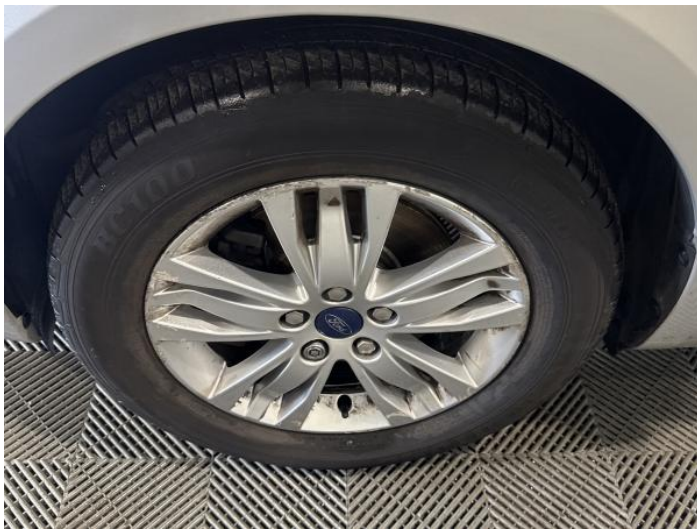
5: Wheel nsf
Scratched
Over 50mm

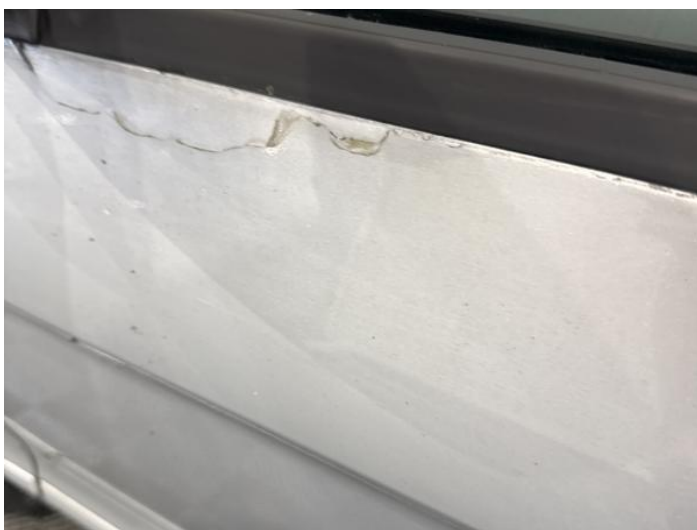
7: Door nsf
Poor Previous Repair
Paint Flake

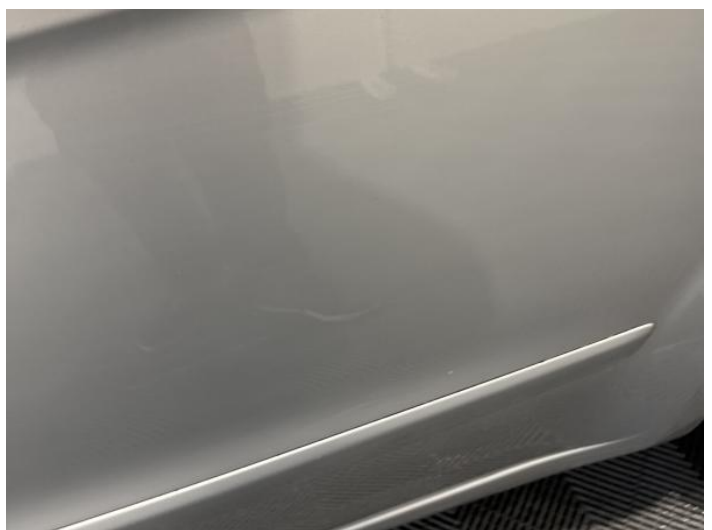
8: Door nsr
Dented
With Paint Damage

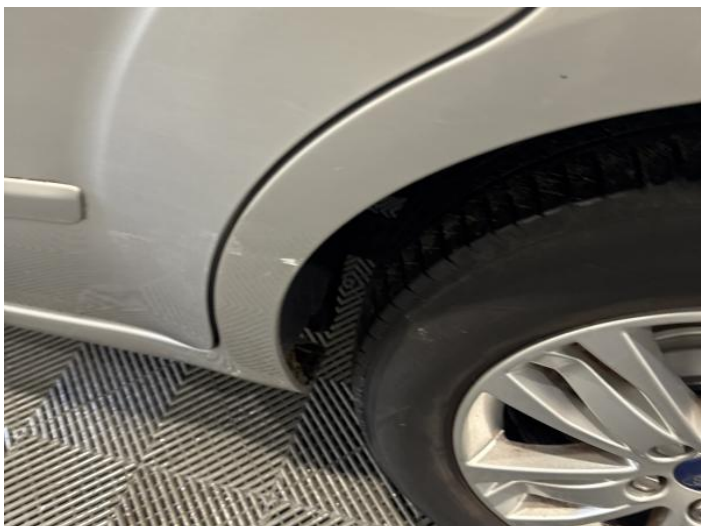
9: Qtr Panel nsr
Scratched
Over 25mm Thru Paint

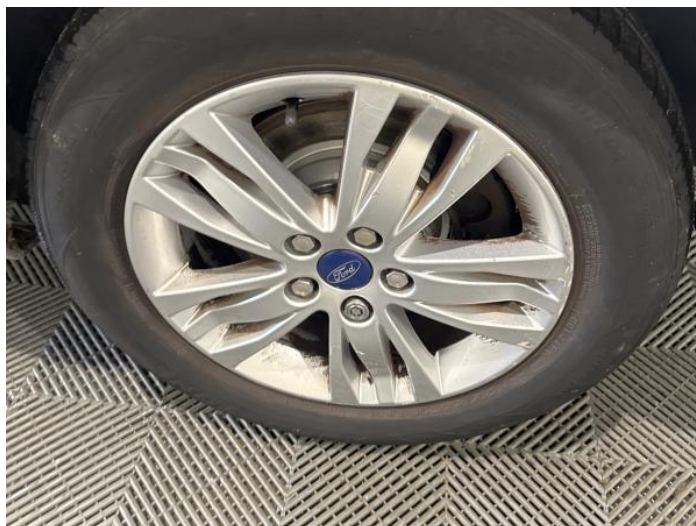
10: Wheel nsr
Scratched
Over 50mm

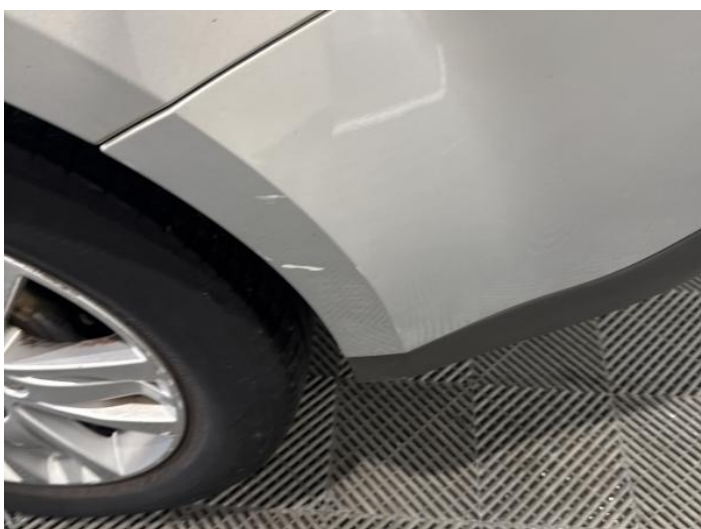
11: Bumper Rear
Scratched
Over 100mm Thru Paint

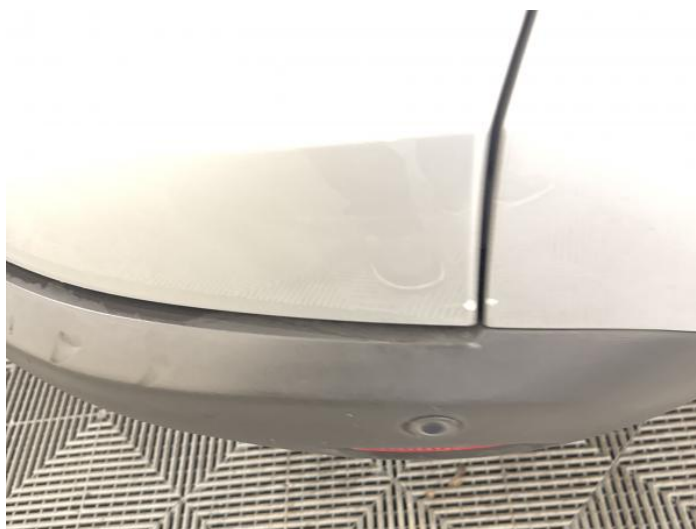
12: Boot Lid
Chipped
1 To 5

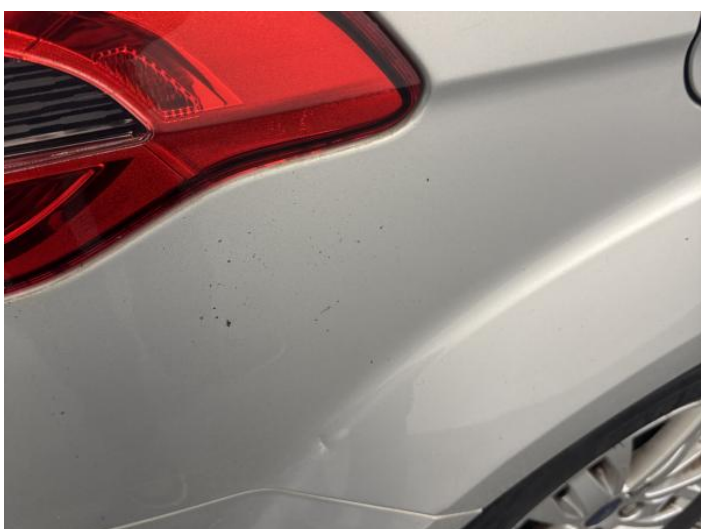
13: Qtr Panel osr
Dented
2 Or Less UpTo 10mm

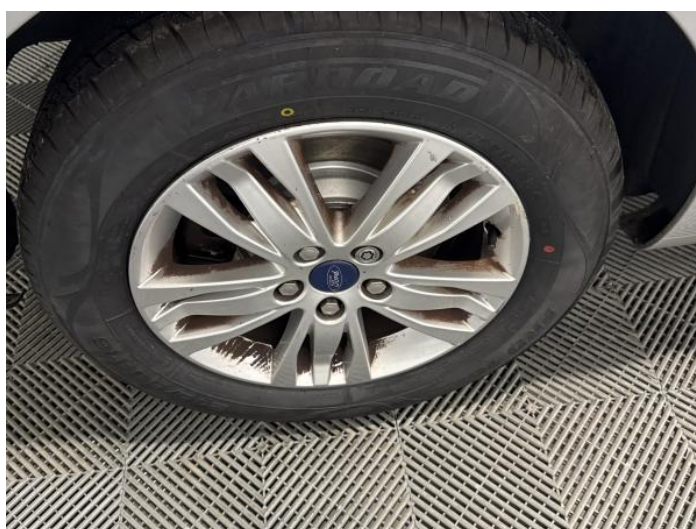
14: Wheel osr
Scratched
Over 50mm

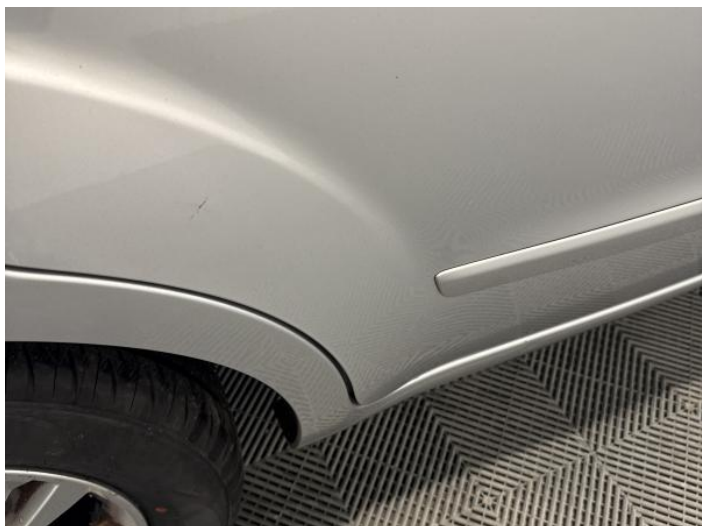
15: Door osr
Scratched
UpTo 25mm Thru Paint

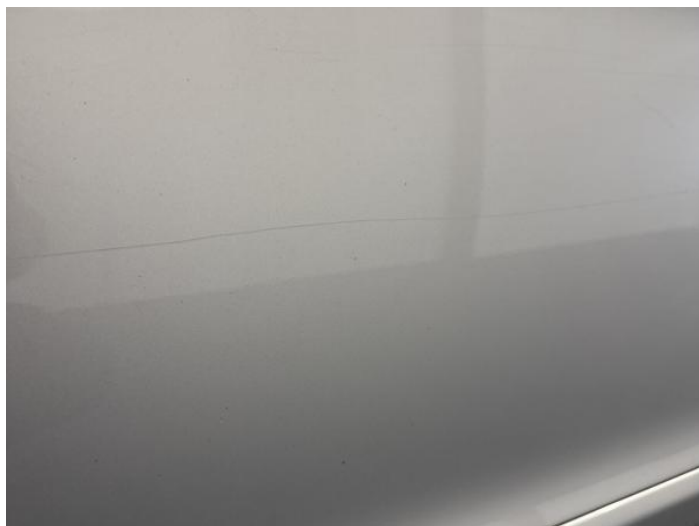
16: Door osf
Scratched
Over 25mm Thru Paint

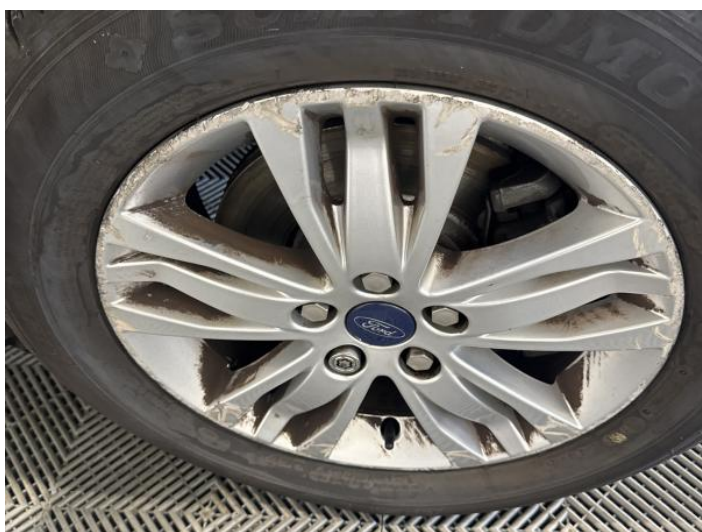
17: Wheel osf
Scratched
Over 50mm
