VEHICLE INSPECTION REPORT

KF15BYV

Volvo V40 D2 [120] R DESIGN Lux Nav 5dr Geartronic

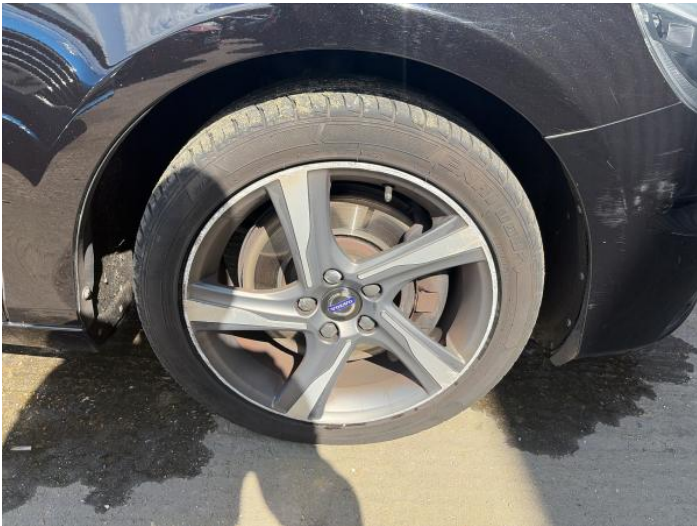
1: Wheel of
Scratched
Over 50mm

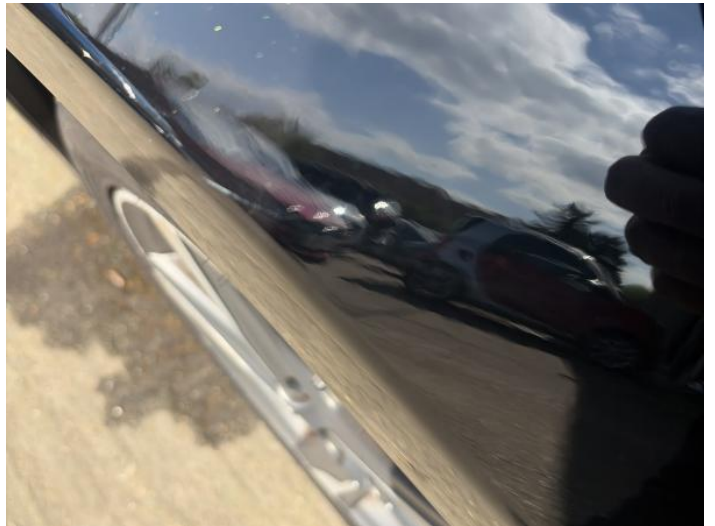
2: Wing of
Scratched
Up To 25mm Thru Paint

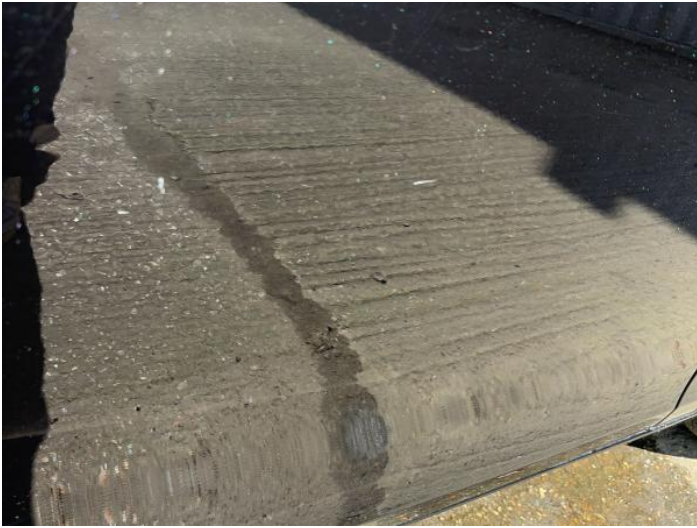
3: Door osf
Chipped
1 To 5

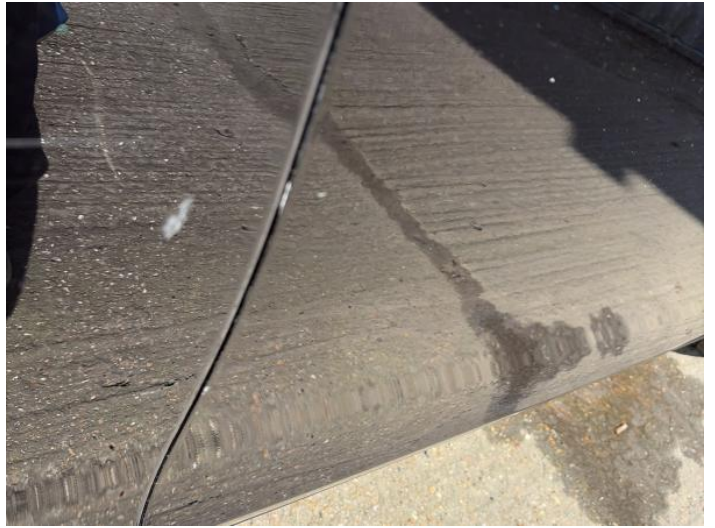
4: Door osf
Chipped
Edge Chip

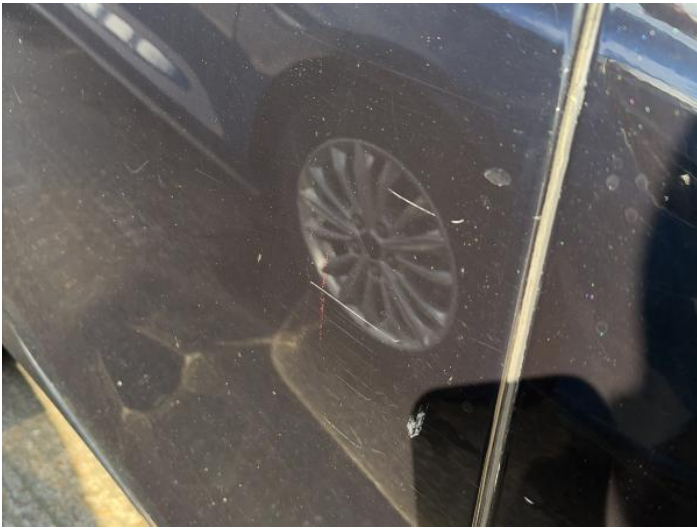
5: Door osr
Scratched
Over 25mm Thru Paint

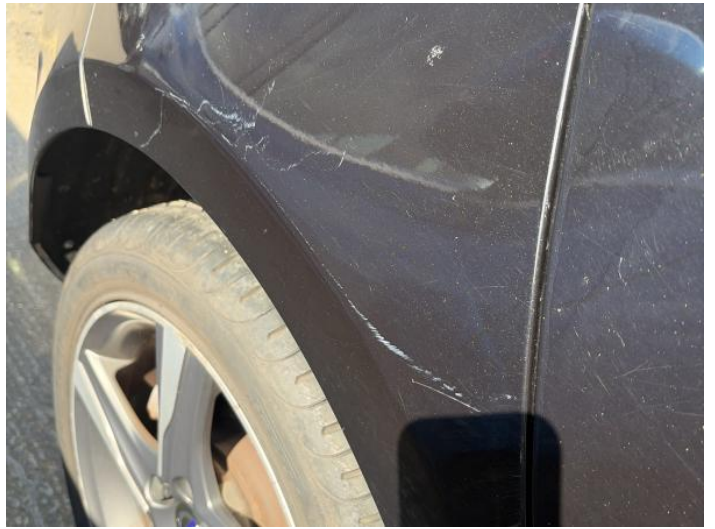
6: Qtr Panel osr
Scratched
Over 25mm Thru Paint

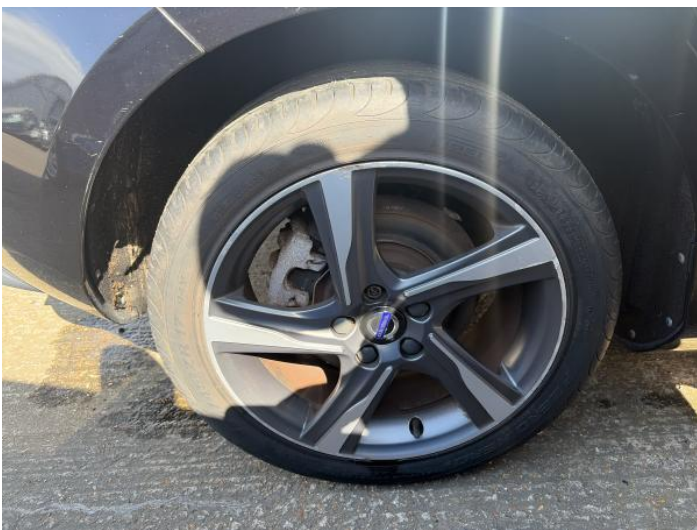
7: Wheel osr
Corroded
Light

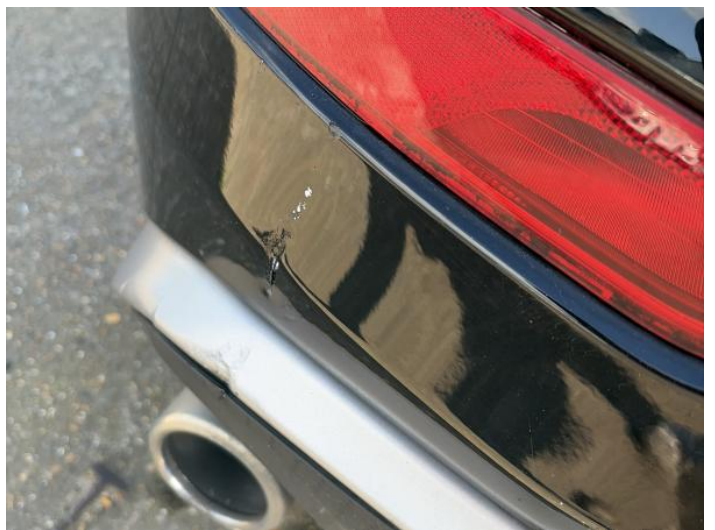
8: Bumper Rear
Dented
With Paint Damage

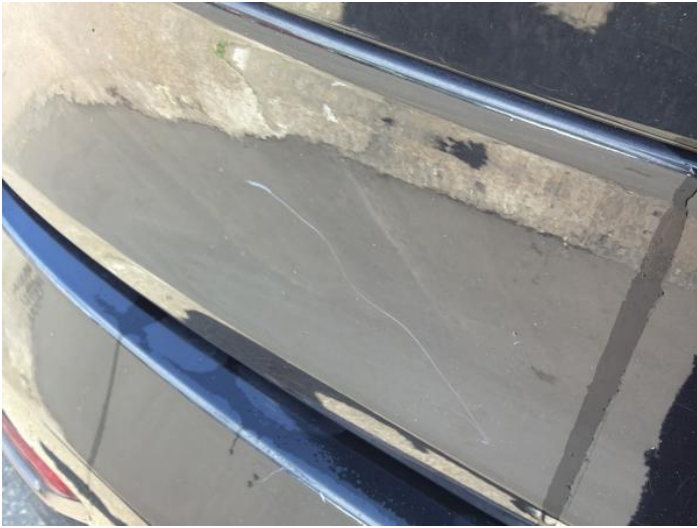
9: Tailgate
Scratched
Over 25mm Thru Paint

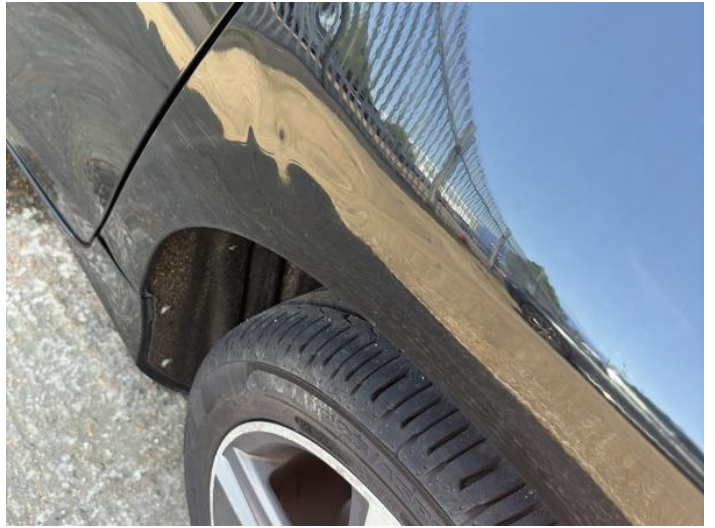
10: Qtr Panel nsr
Dented
Over 30mm

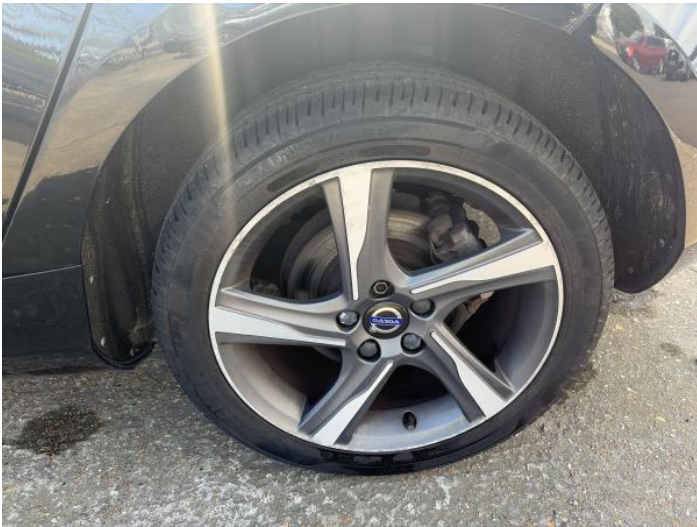
11: Wheel nsr
Corroded
Light

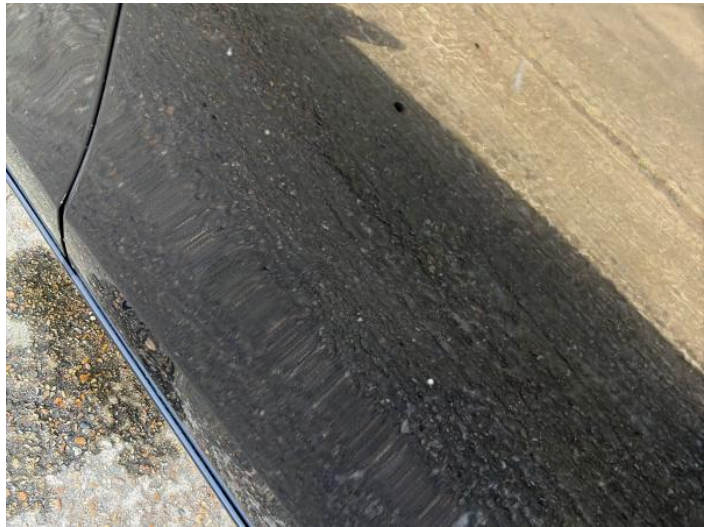
12: Door nsr
Chipped
1 To 5

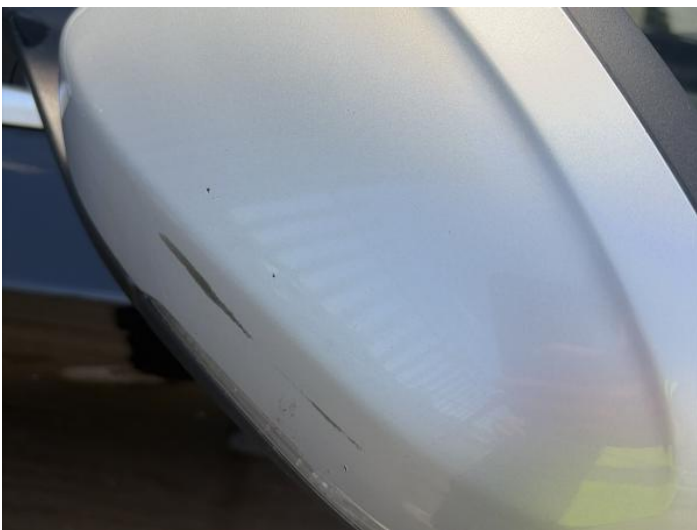
13: Door Mirror Assy nsf
Scratched (Painted)
Up To 25mm Thru Paint

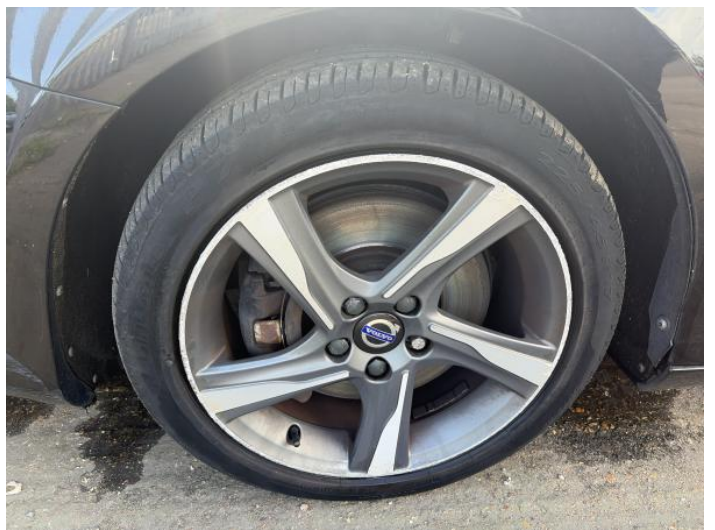
14: Wheel nsf
Scratched
Over 50mm

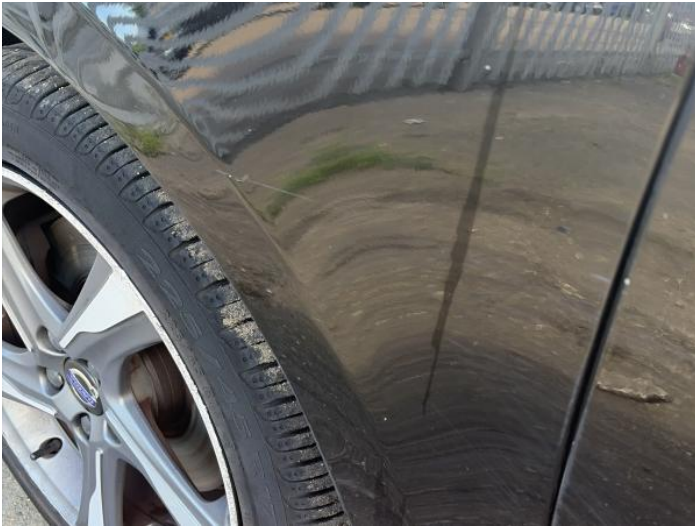
15: Wing nsf
 Scratched
 Over 25mm Thru Paint

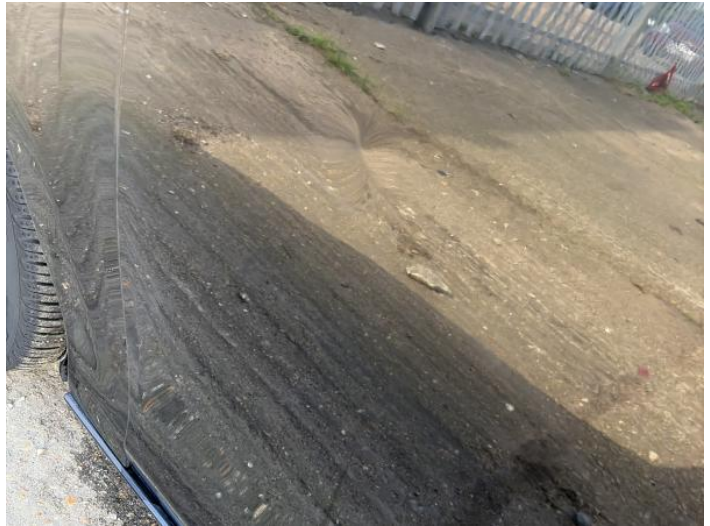
16: Door nsf
 Dented
 With Paint Damage

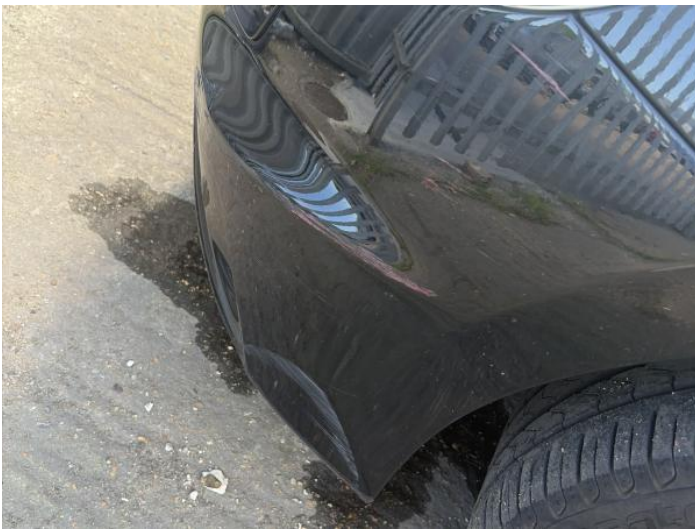
17: Bumper Front
 Scratched
 Over 100mm Thru Paint

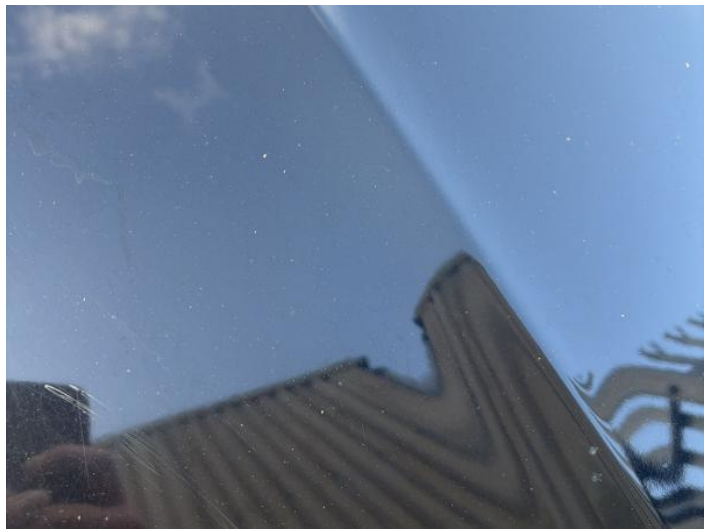
18: Bonnet
 Chipped
 1 To 5
