VEHICLE INSPECTION REPORT

GJ13VBC

Kia Carens 1.7 CRDi 3 5dr

nama
GRADE
4

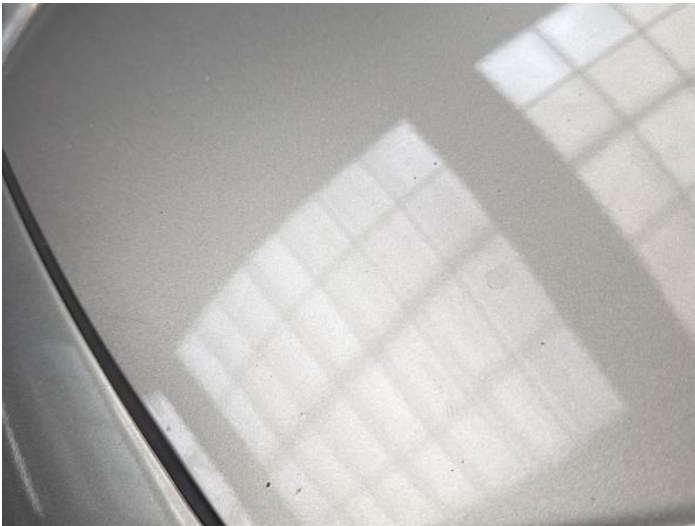
1: Bonnet
Chipped
1 To 5

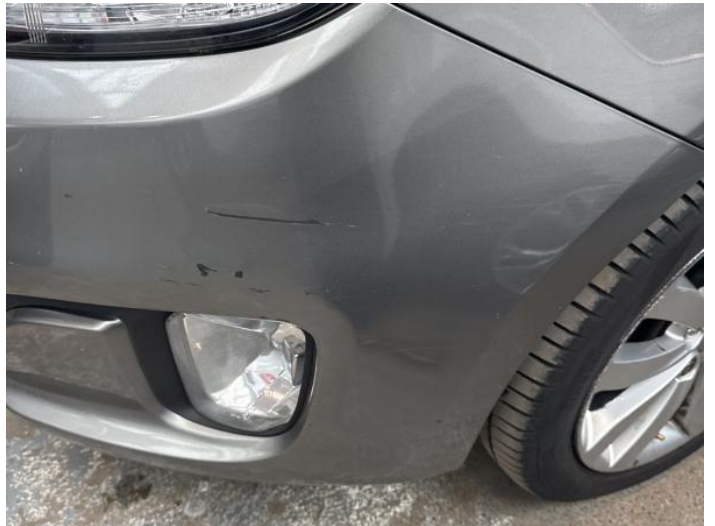
2: Bumper Front
Scratched
Over 100mm Thru Paint

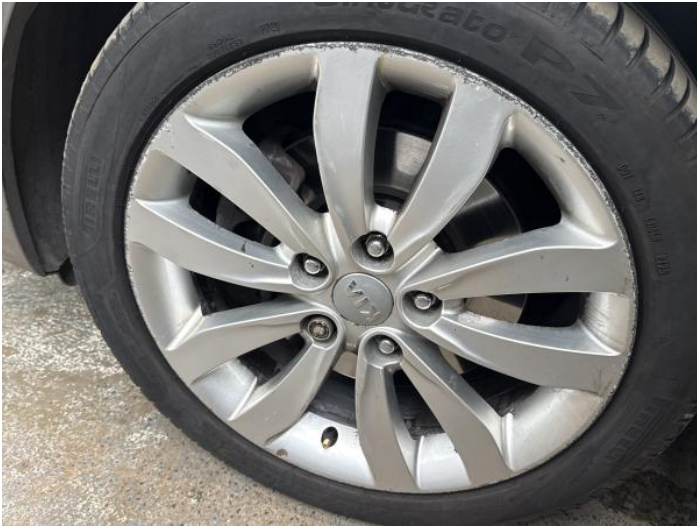
3: Wheel nsf
Scratched
Over 50mm

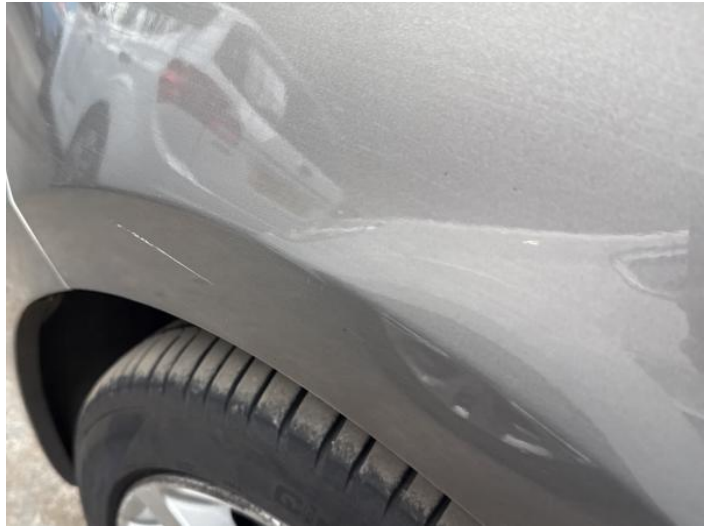
4: Wing nsf
Scratched
Over 25mm Thru Paint

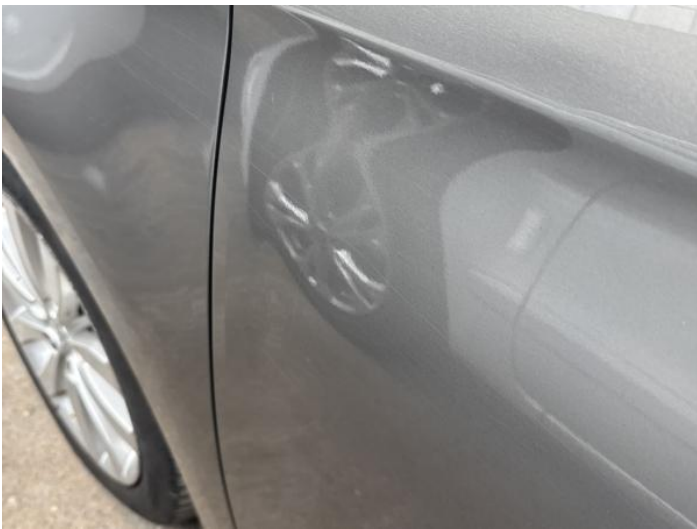
5: Door nsf
Dented
Over 30mm

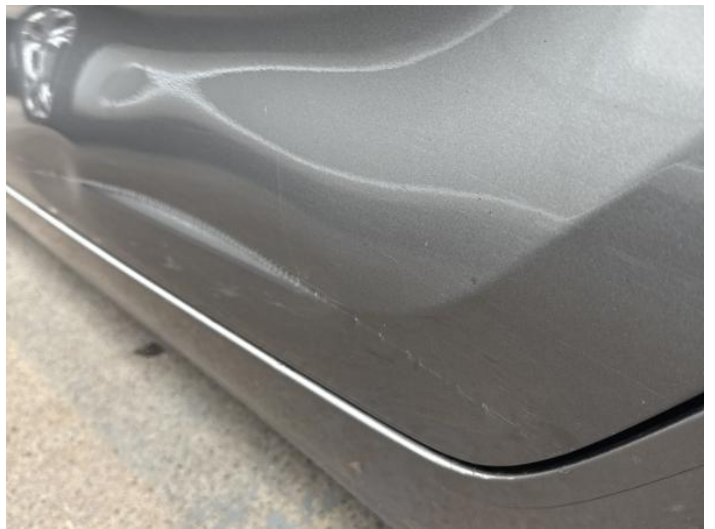
6: Door nsr
Dented
With Paint Damage

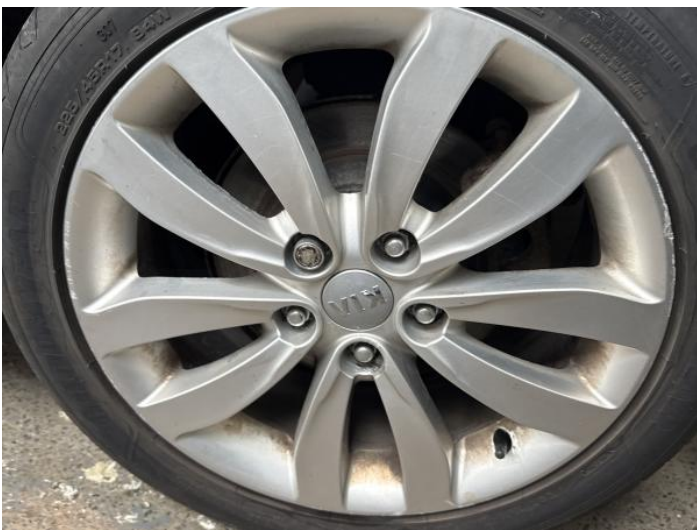
7: Wheel nsr
Scratched
Over 50mm

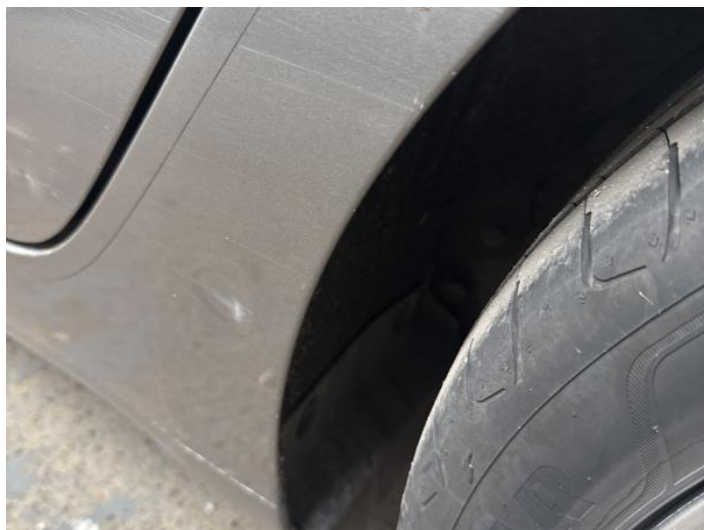
8: Qtr Panel nsr
Dented
With Paint Damage

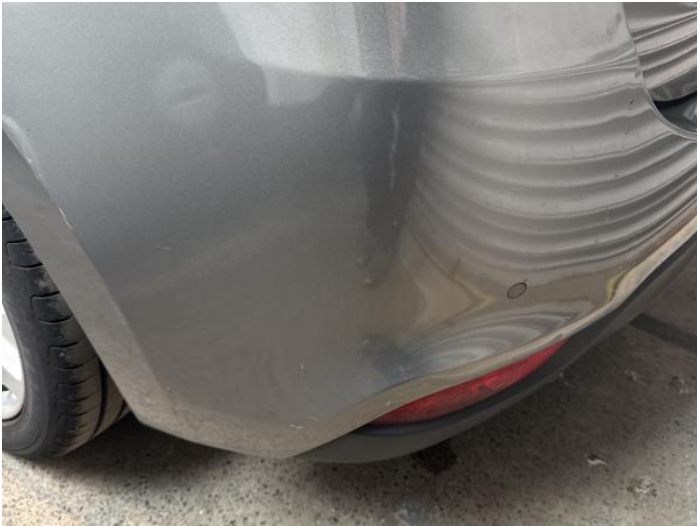
9: Bumper Rear
Scratched
Over 100mm Thru Paint

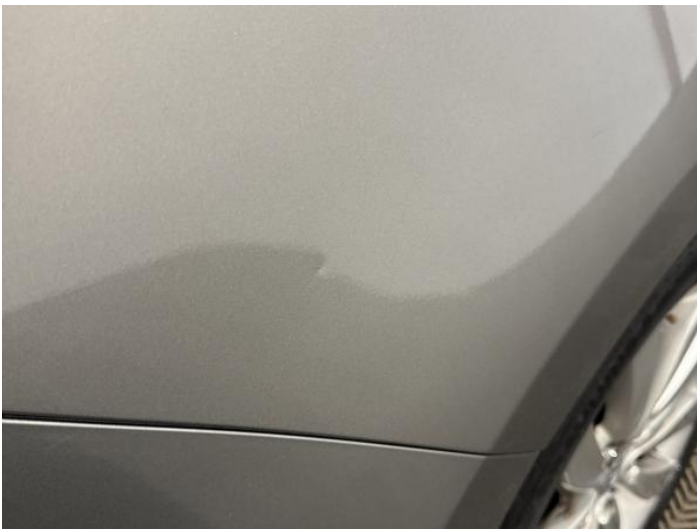
11: Qtr Panel osr
Chipped
1 To 5

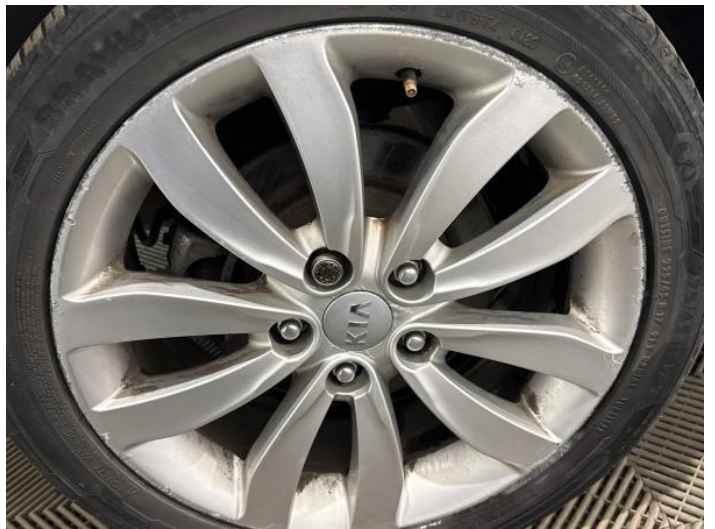
12: Wheel osr
Scratched
Over 50mm

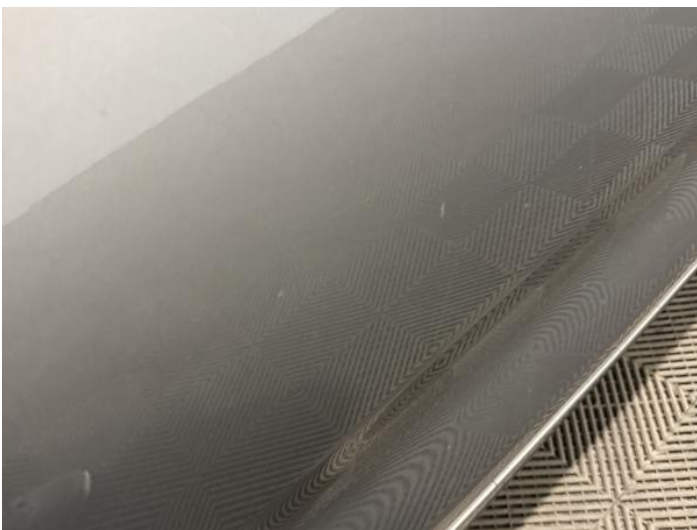
13: Door osr
Chipped
1 To 5

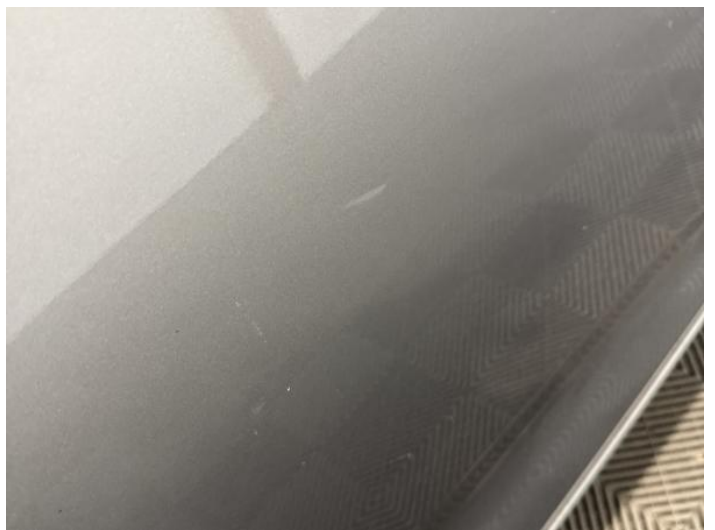
14: Door osf
Scratched
Up To 25mm Thru Paint

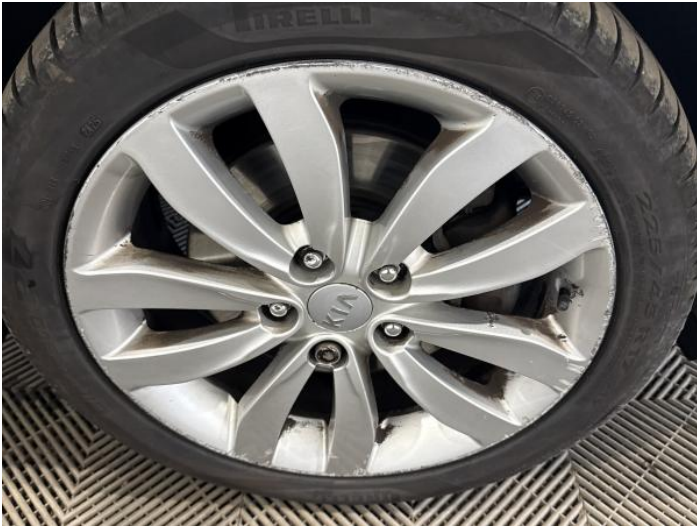
15: Wheel of
Scratched
Over 50mm
