VEHICLE INSPECTION REPORT

MH18OHG

Hyundai Kona 1.0T GDi Blue Drive Premium SE 5dr

nama
GRADE
2

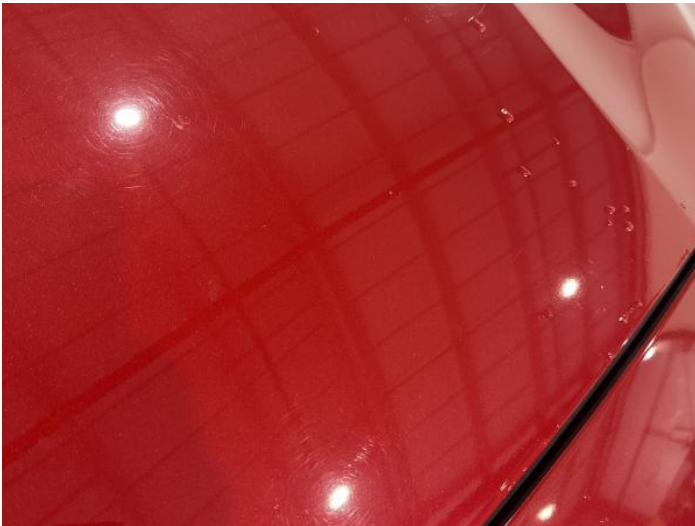
1: Bonnet
Chipped
1 To 5

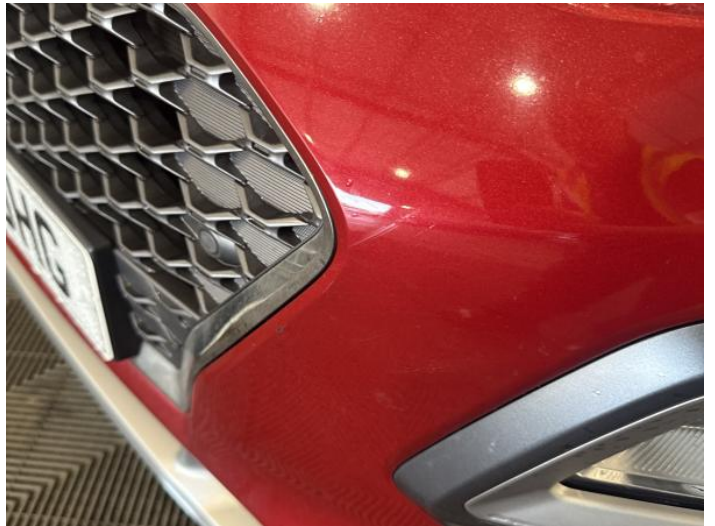
2: Bumper Front
Scratched
25 to 100mm Thru Paint

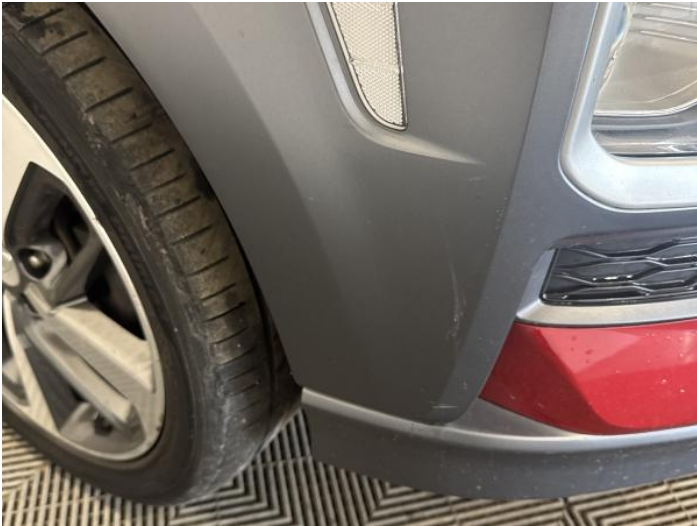
3: Bumper Front Moulding
Scuffed (Unpainted)
UpTo 100mm

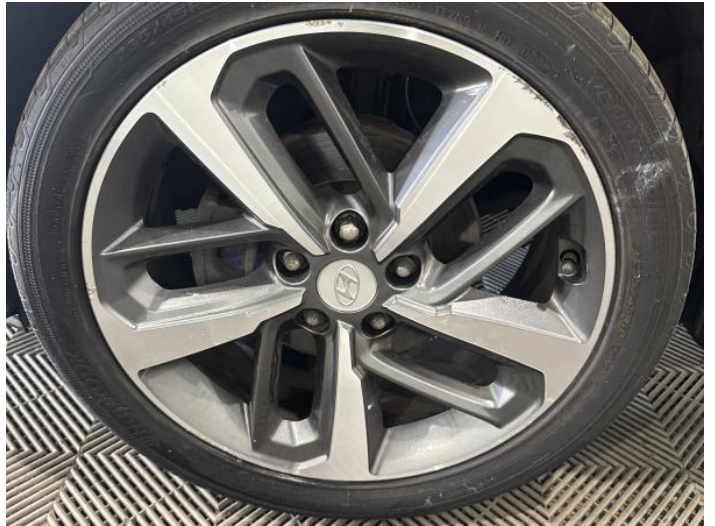
4: Wheel nsf
Scratched
Over 50mm

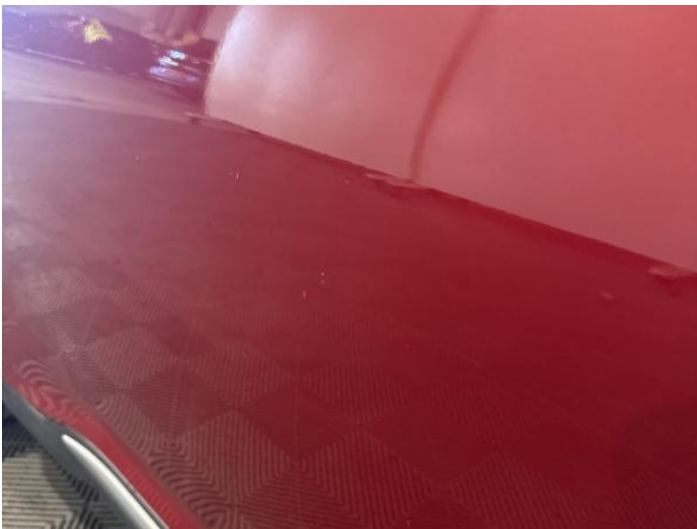
5: Door nsf
Chipped
1 To 5

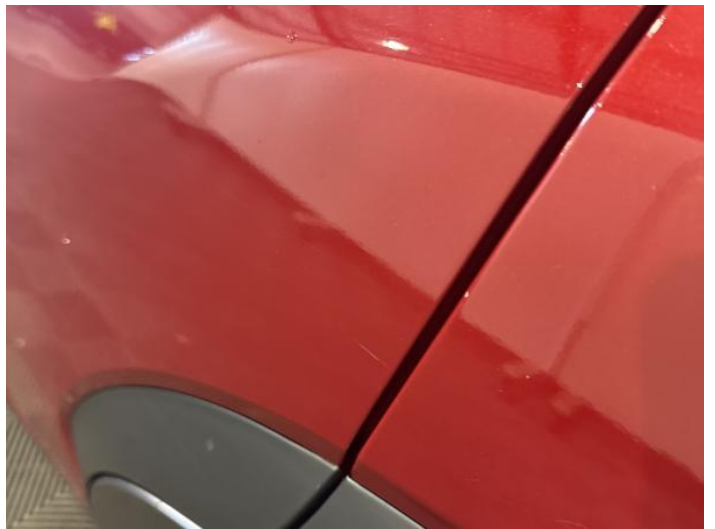
6: Door nsr
Scratched
UpTo 25mm Thru Paint

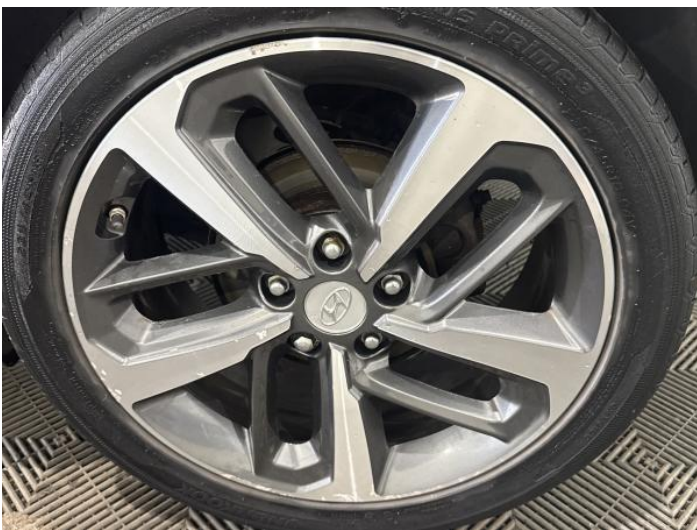
7: Wheel nsr
Scratched
Over 50mm

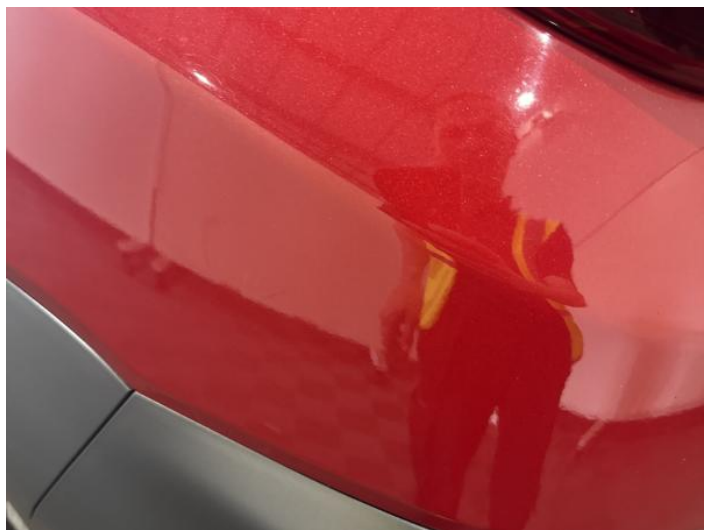
8: Qtr Panel nsr
Scratched
UpTo 25mm Thru Paint

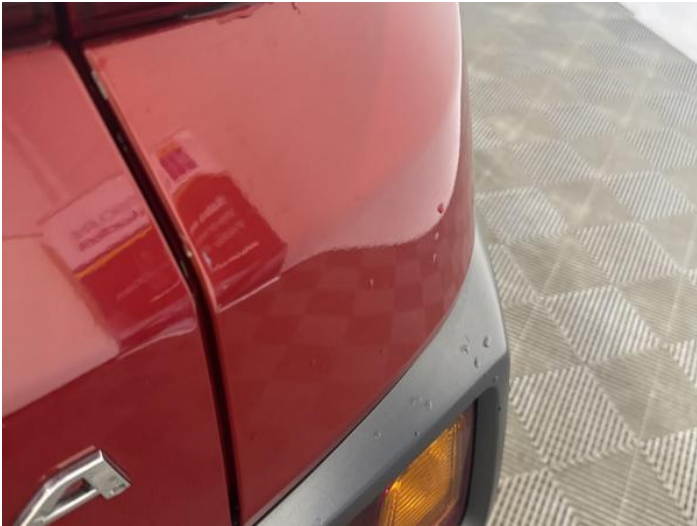
9: Qtr Panel osr
Chipped
1 To 5

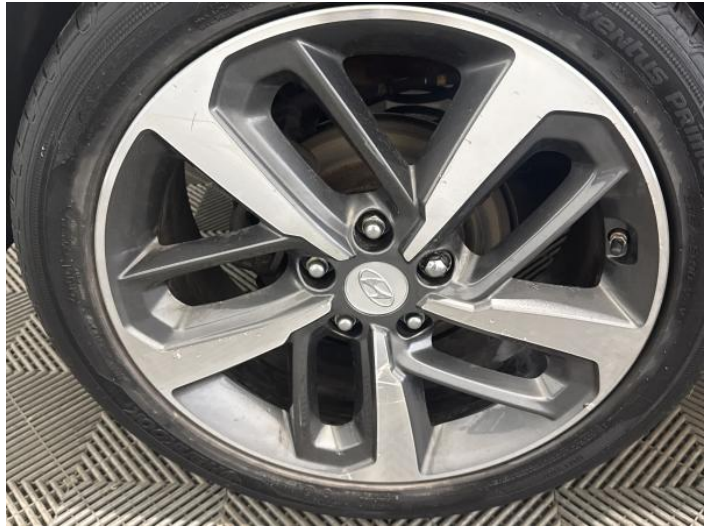
10: Wheel osr
Scratched
Up To 50mm

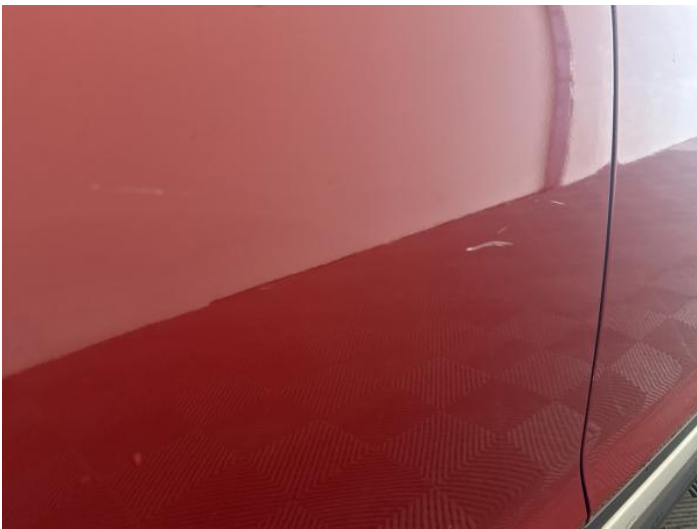
11: Door osr
Scratched
Over 25mm Thru Paint

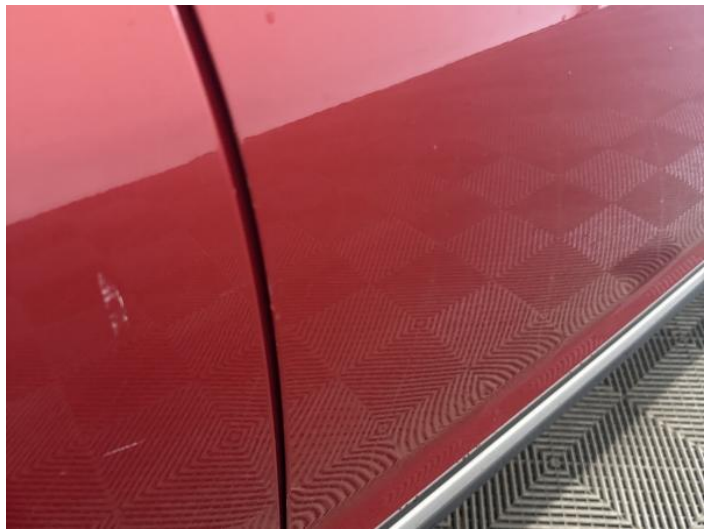
12: Door osf
Chipped
Edge Chip

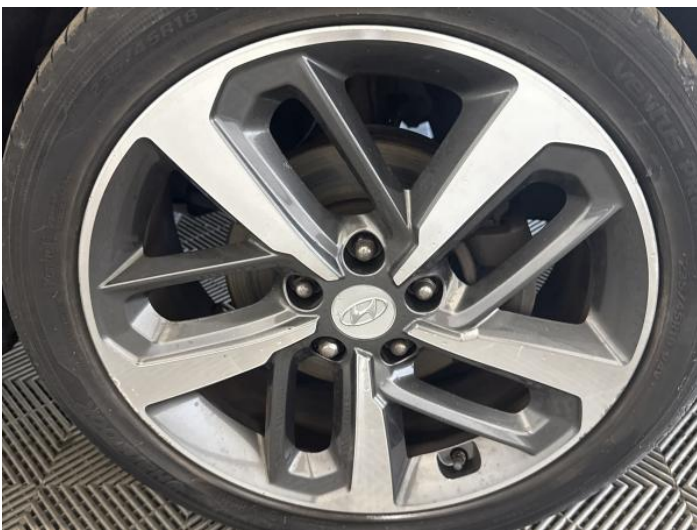
13: Wheel osf
Scratched
Over 50mm
