VEHICLE INSPECTION REPORT

LD73XYE

Honda E Ny1 150kW Elegance 69kWh 5dr Auto

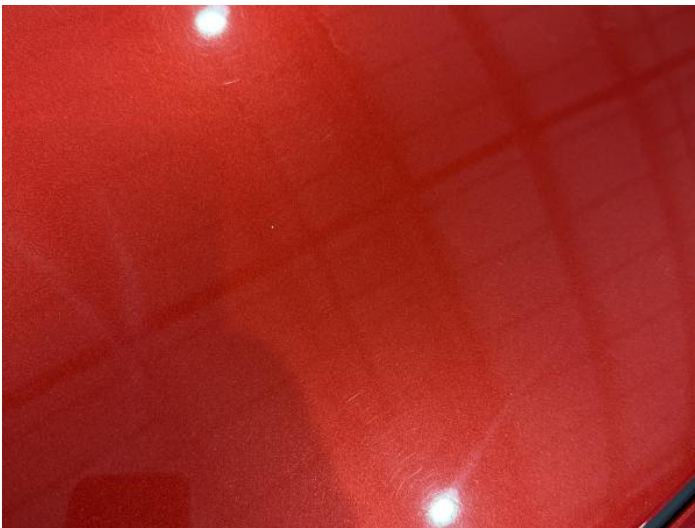
1: Bonnet
Chipped
1 To 5

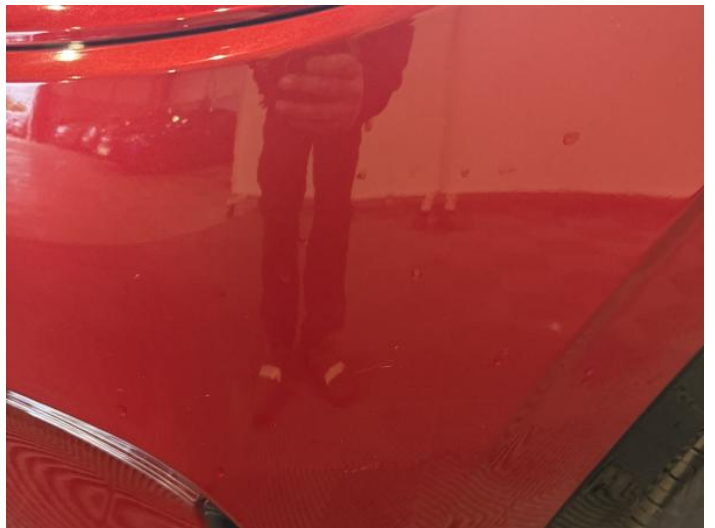
2: Bumper Front
Scratched
UpTo 25mm Thru Paint

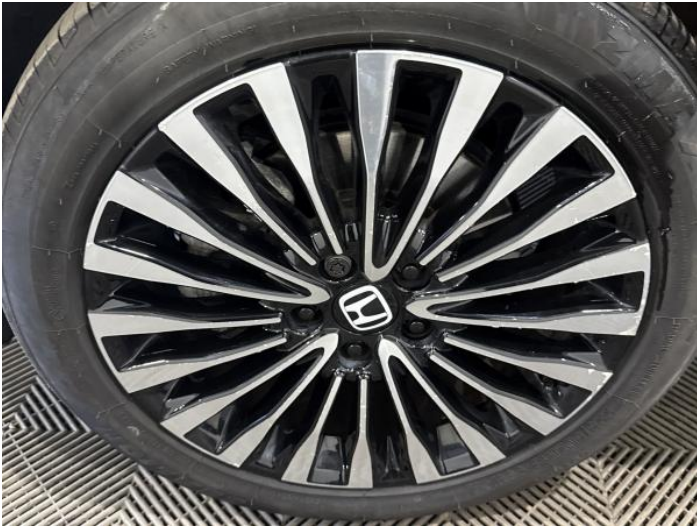
3: Wheel nsf
Scratched
Over 50mm

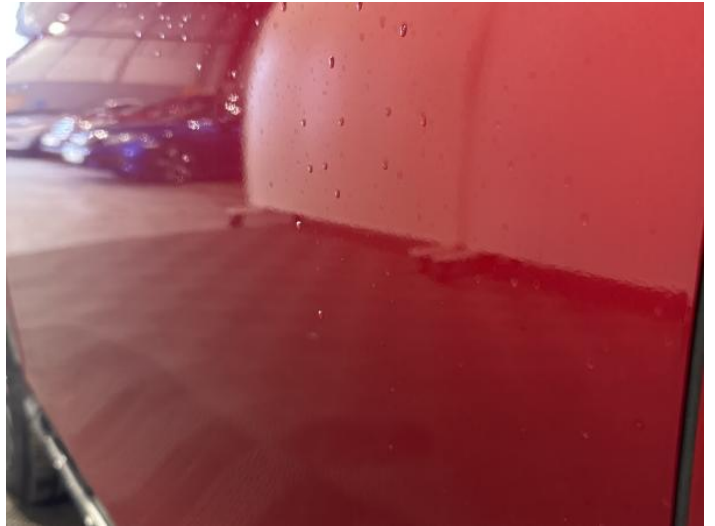
4: Door nsf
Poor Previous Repair
Poor Paint

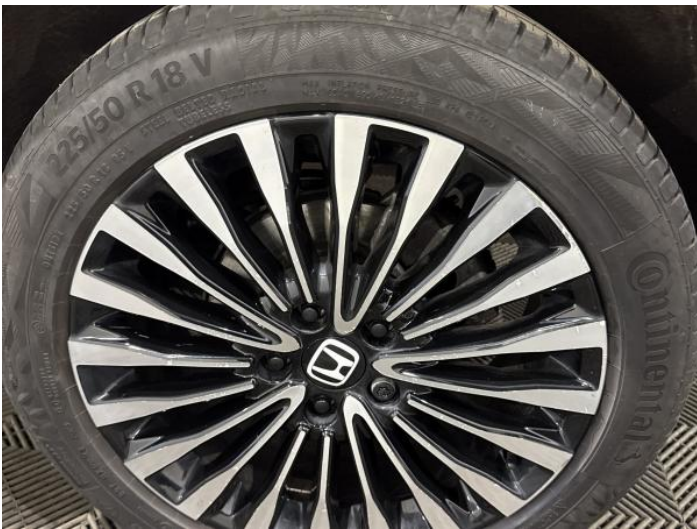
5: Wheel nsr
Scratched
Over 50mm

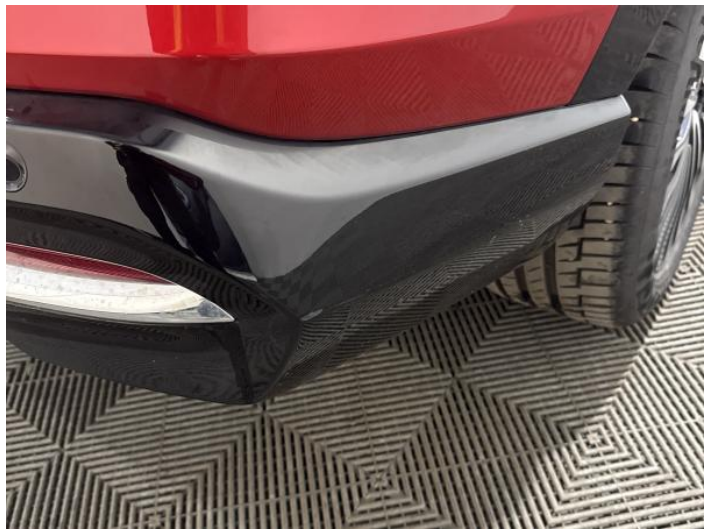
6: Bumper Rear Moulding
Scratched (Painted)
Over 25mm Thru Paint

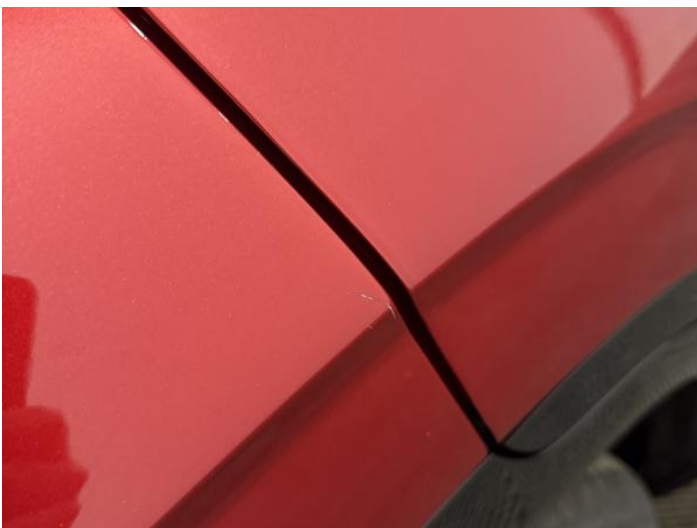
7: Qtr Panel osr
Scratched
UpTo 25mm Thru Paint

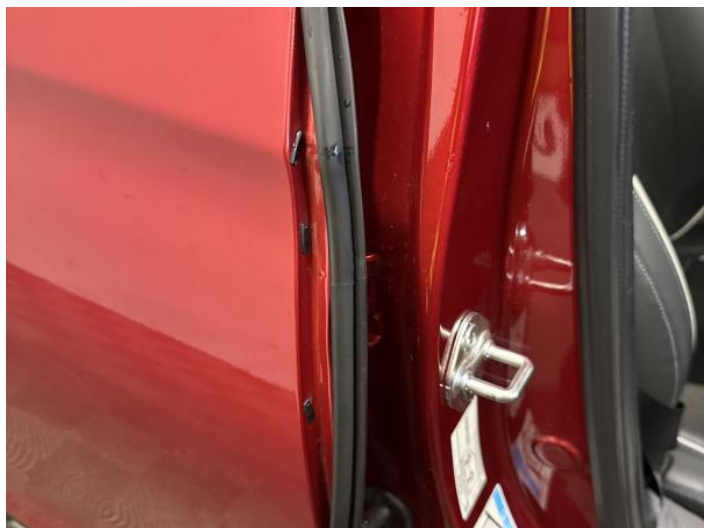
8: Aperture Seal osr
Broken
Replace

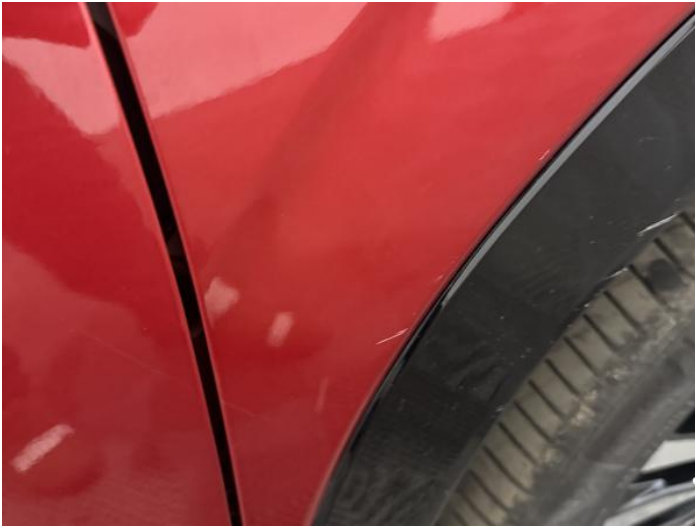
9: Wing osf
Scratched
UpTo 25mm Thru Paint

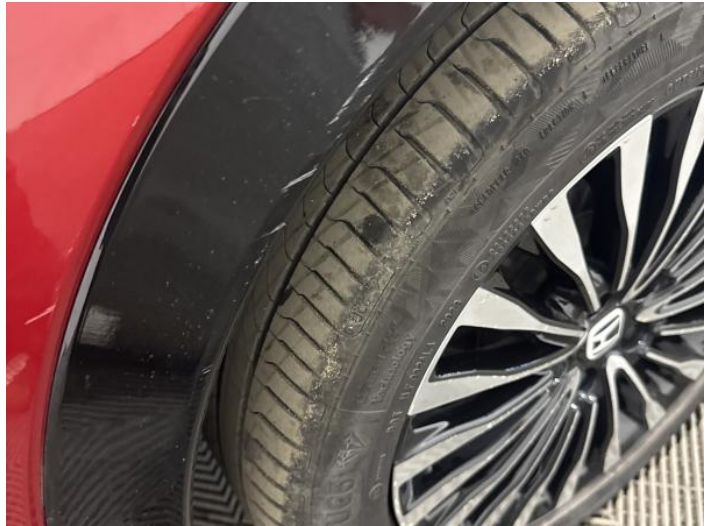
10: Qtr Panel Arch Extension os
Scratched (Painted)
Over 25mm Thru Paint

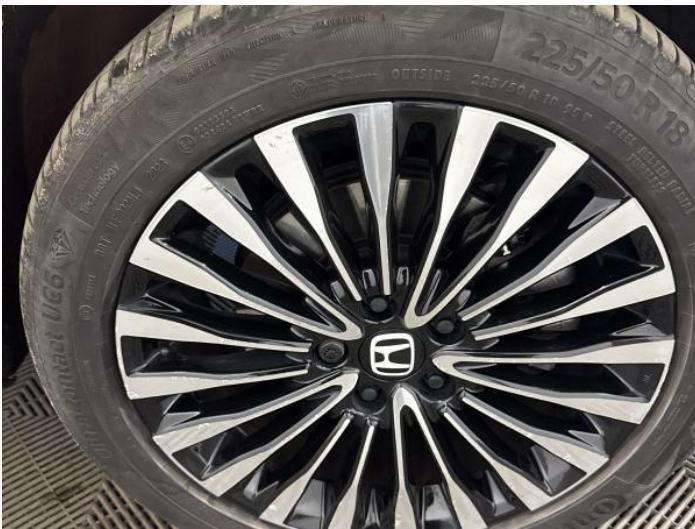
11: Wheel osf
Scratched
Over 50mm
