VEHICLE INSPECTION REPORT

EO66JWG

Ford Ranger Pick Up Double Cab Wildtrak 3.2 TDCi 200 Auto

nama
GRADE
4

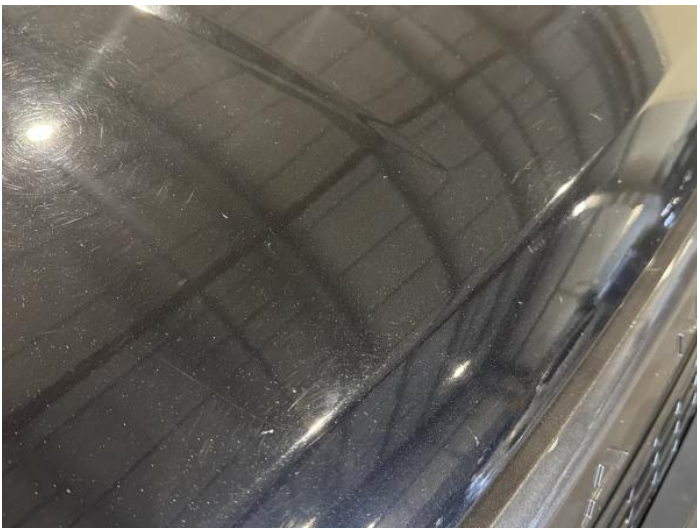
1: Bonnet
Chipped
Multiple Chips

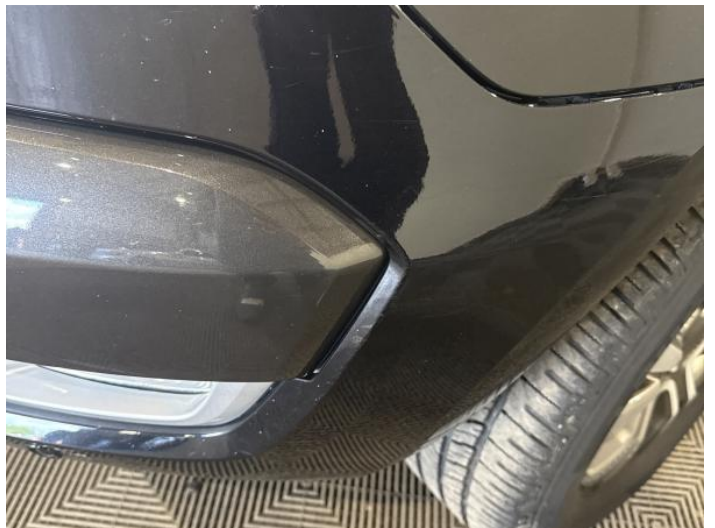
2: Bumper Front
Scratched
25 to 100mm Thru Paint

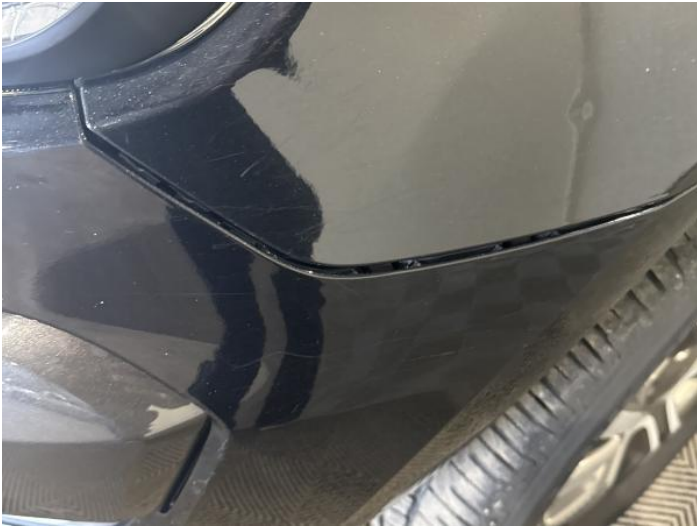
3: Bumper Front
Insecure
Action Required

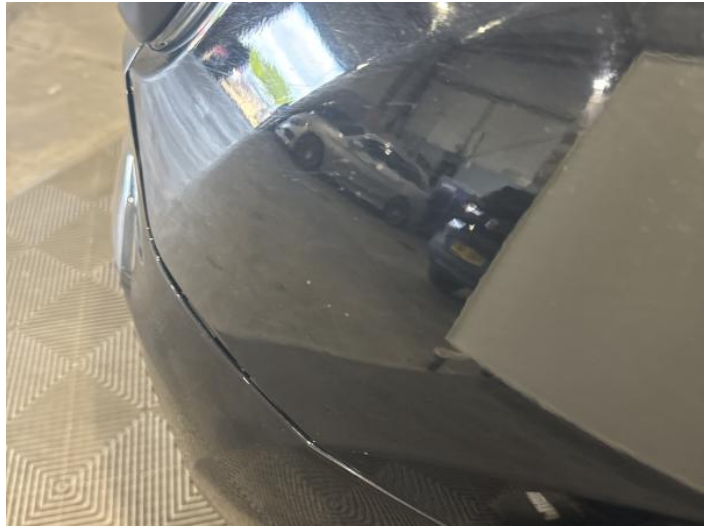
4: Wing nsf
Dented
Between 10mm + 30mm

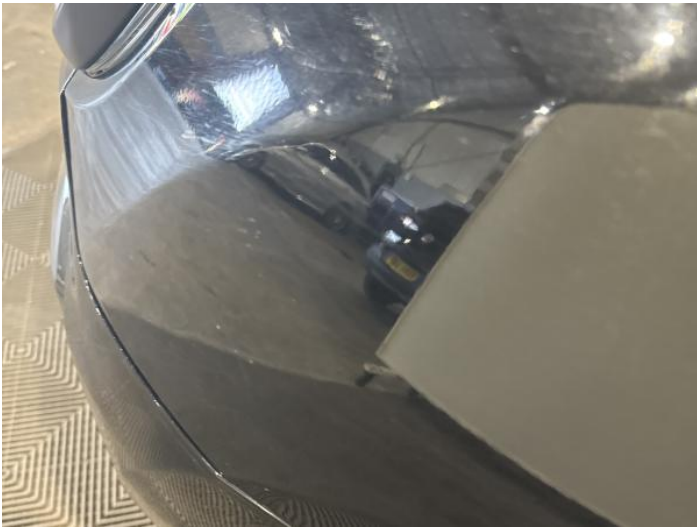
5: Wing nsf
Chipped
1 To 5

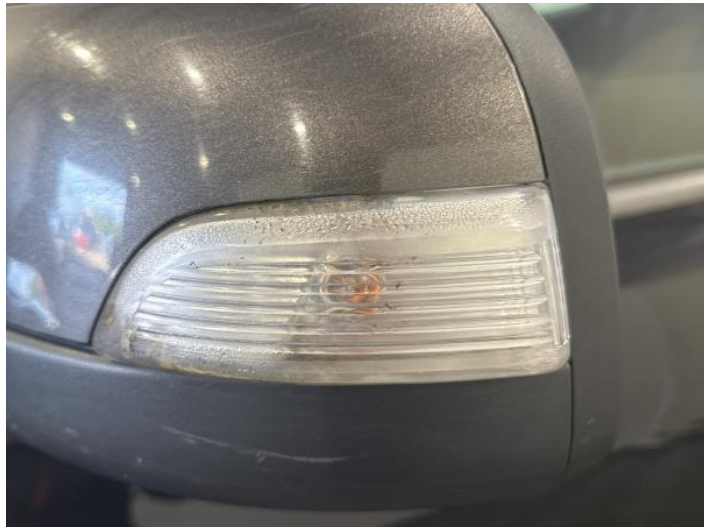
6: Flasher Side Repeater ns
Broken
Replace

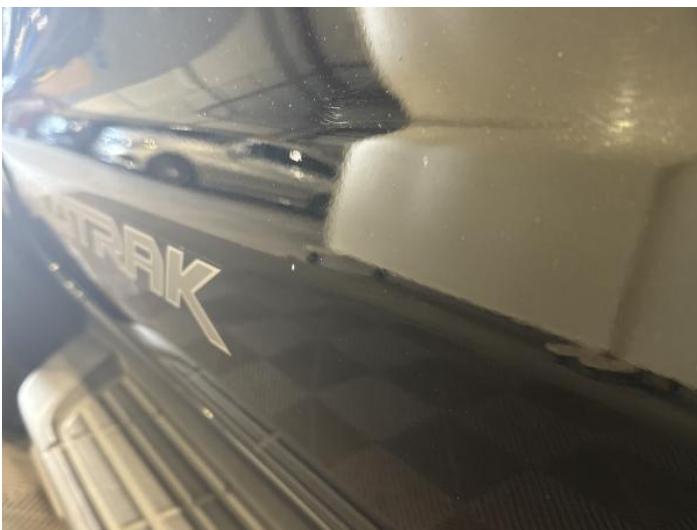
7: Door nsf
Dented
2 Or Less UpTo 10mm

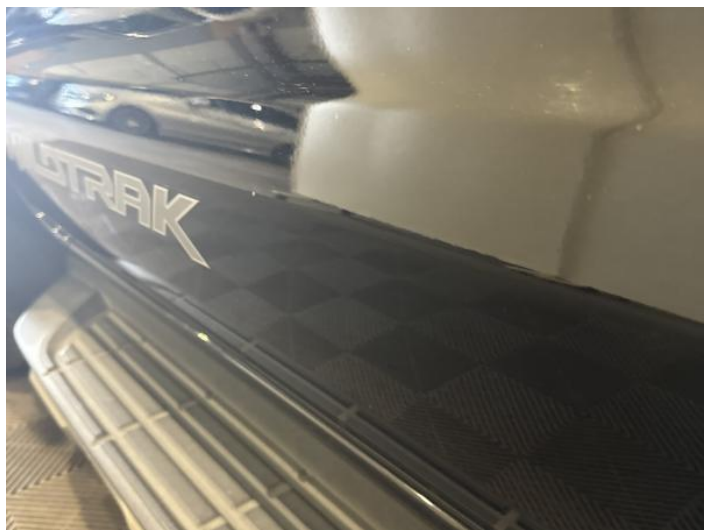
8: Door nsf
Chipped
1 To 5

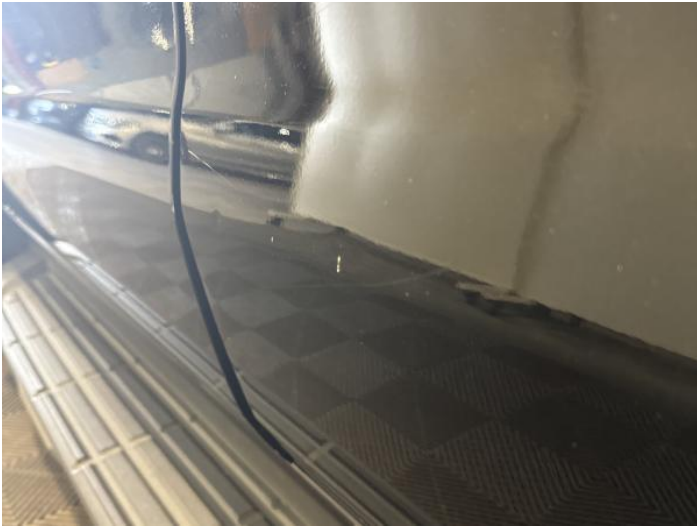
9: Door nsr
Dented
Between 10mm + 30mm

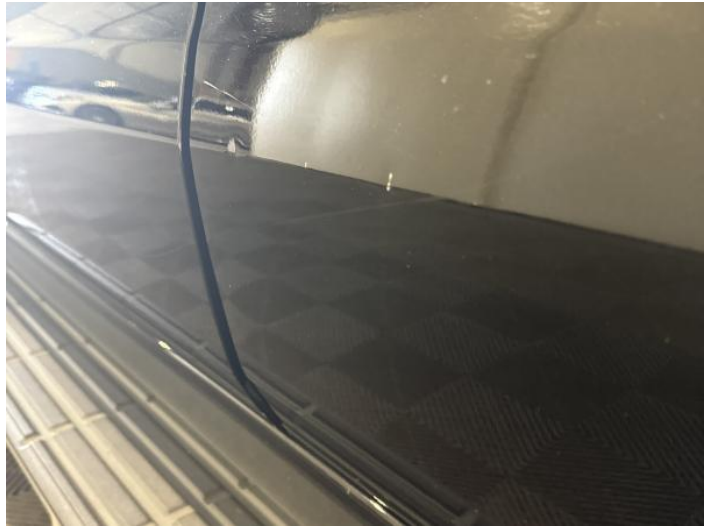
10: Door nsr
Scratched
Over 25mm Thru Paint

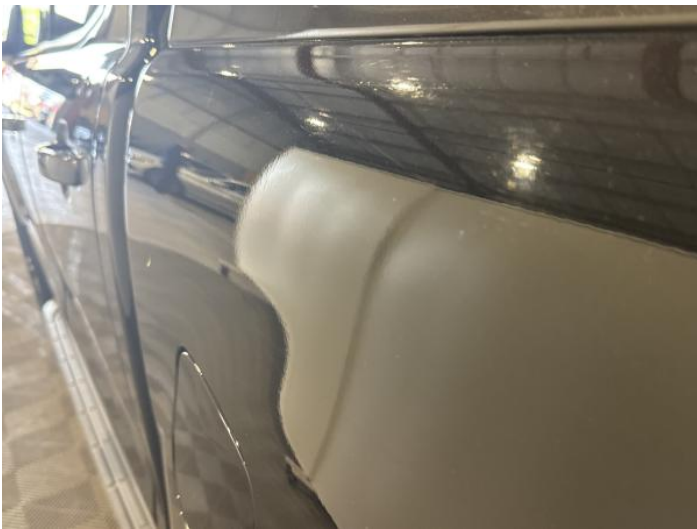
11: Qtr Panel nsr
Dented
Over 30mm

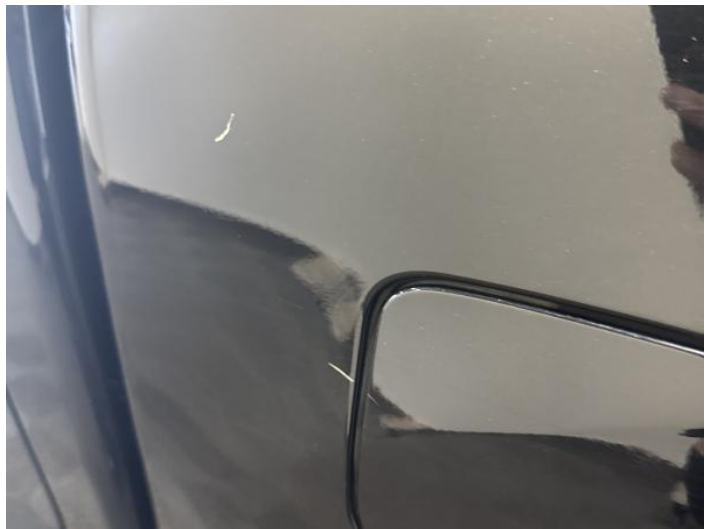
12: Qtr Panel nsr
Scratched
Over 25mm Thru Paint

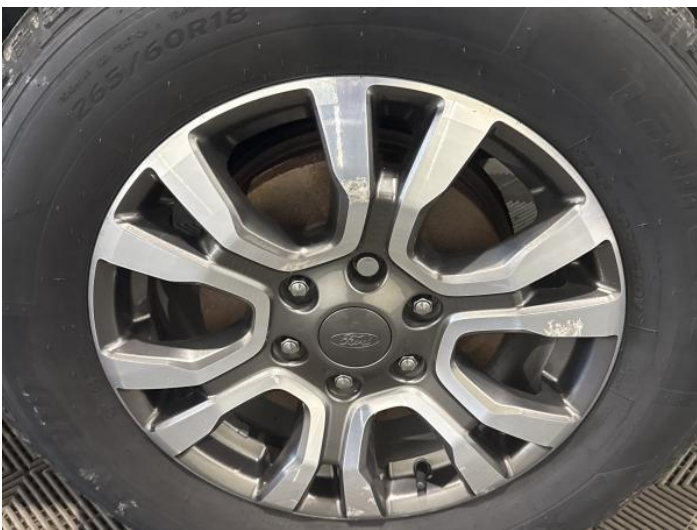
13: Wheel nsr
Corroded
Light

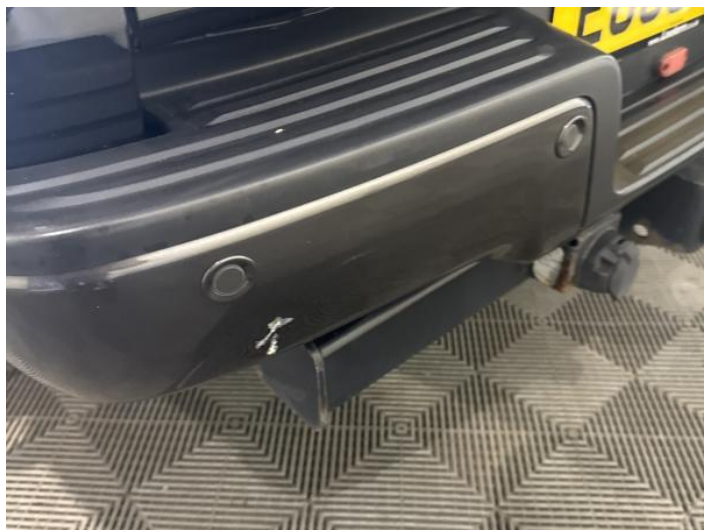
14: Bumper Rear
Dented
With Paint Damage

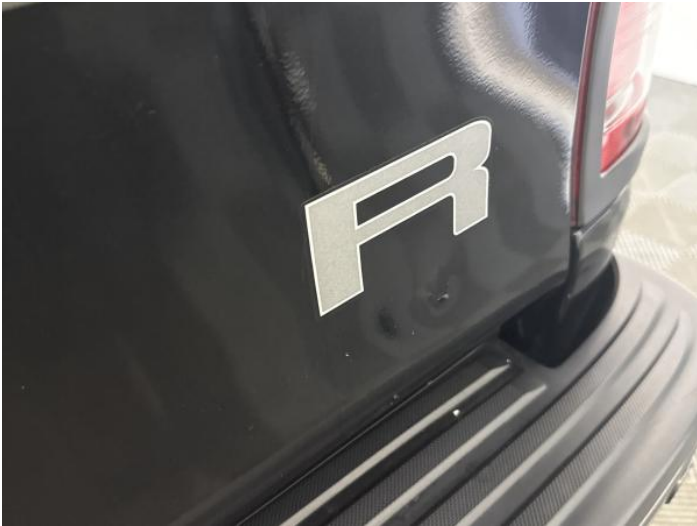
15: Tailgate
Dented
With Paint Damage

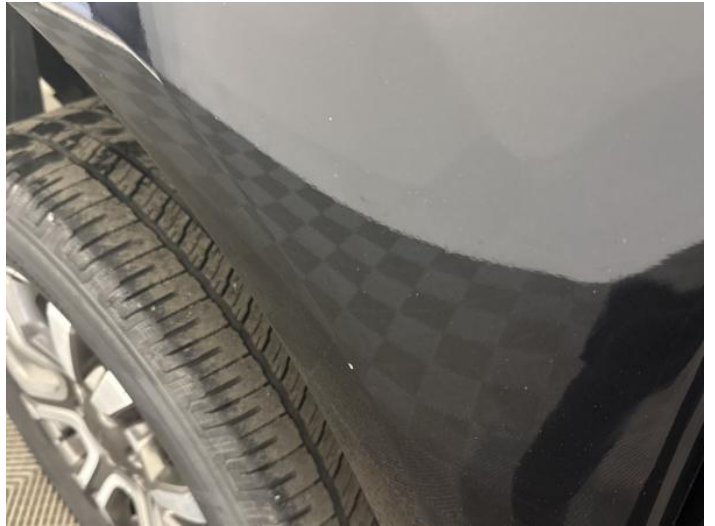
16: Qtr Panel osr
Chipped
1 To 5

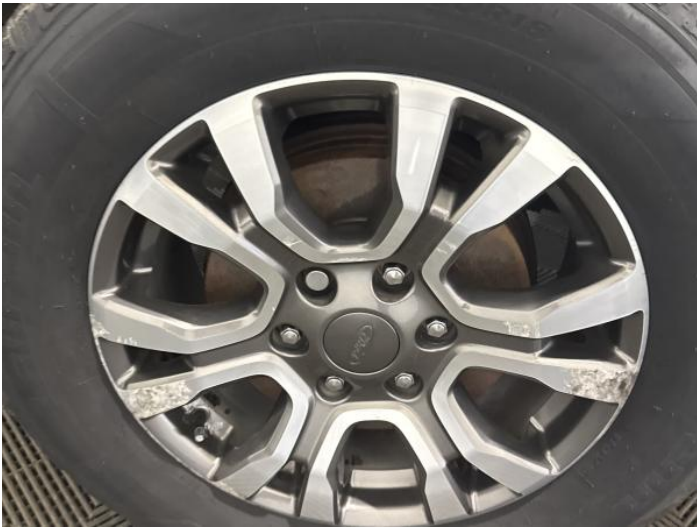
17: Wheel osr
Corroded
Light

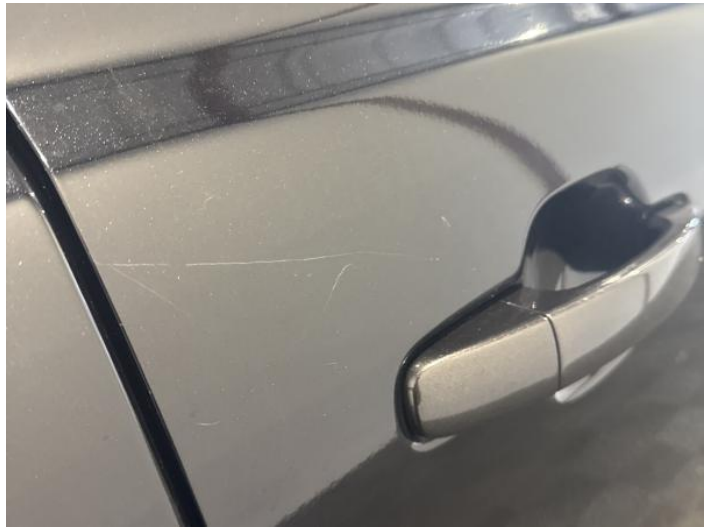
18: Door osr
Dented
With Paint Damage

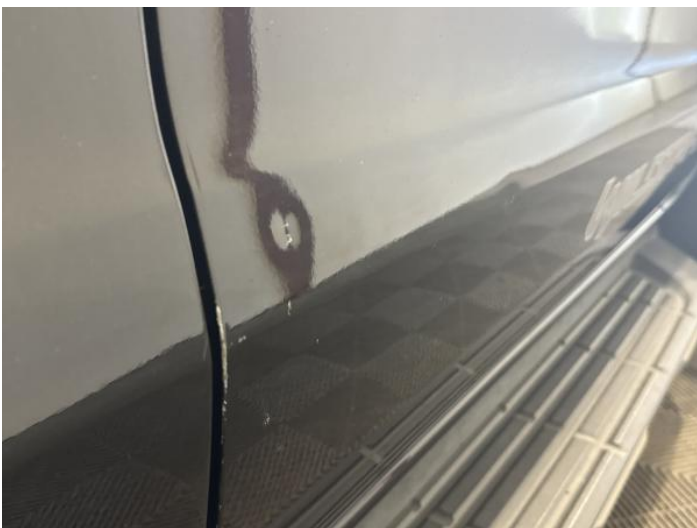
19: Door osf
Dented
With Paint Damage

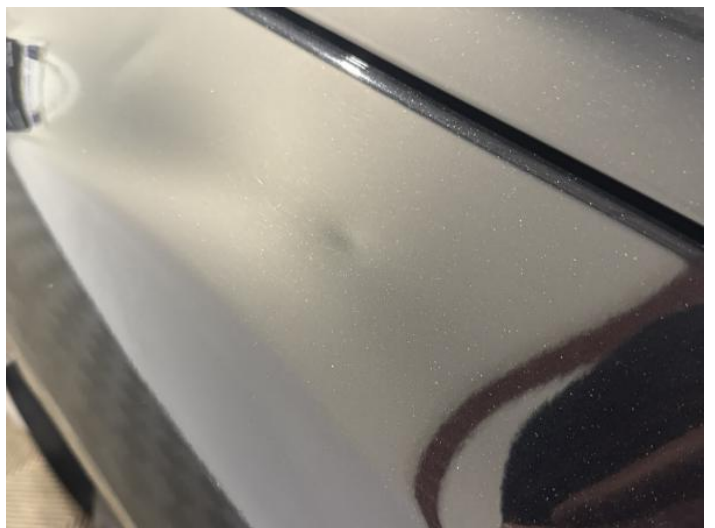
20: Wing osf
Dented
Between 10mm + 30mm

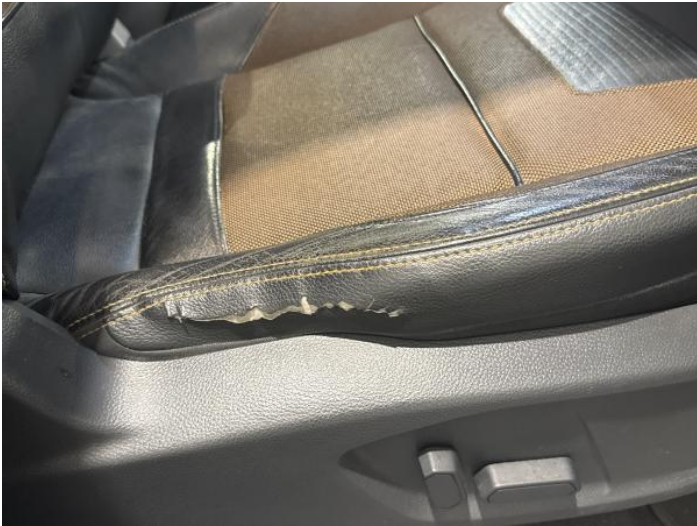
21: Seat Base Cover osf
Torn
Over 3mm

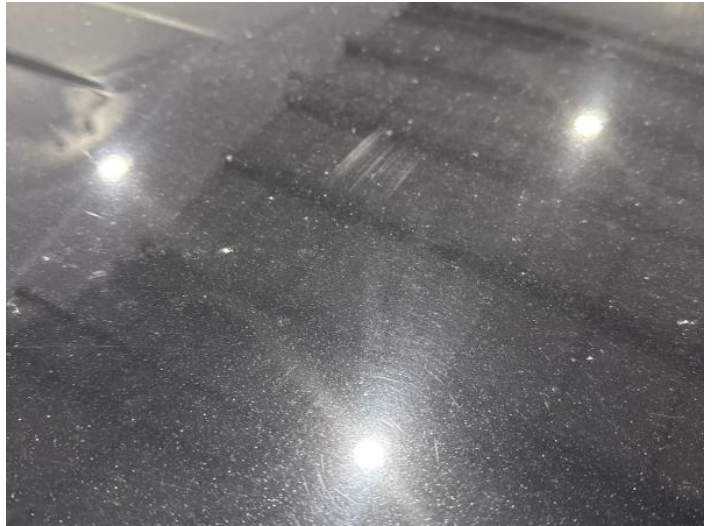
22: Roof
Scratched
Over 25mm Thru Paint

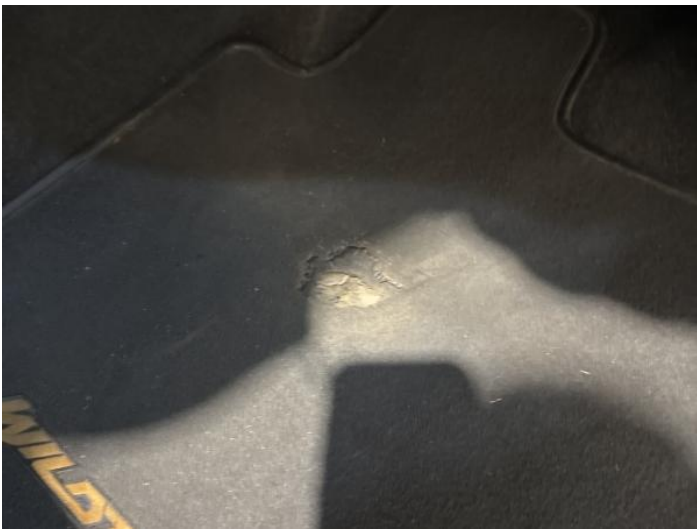
23: Carpets Front
Holed
Over 3mm

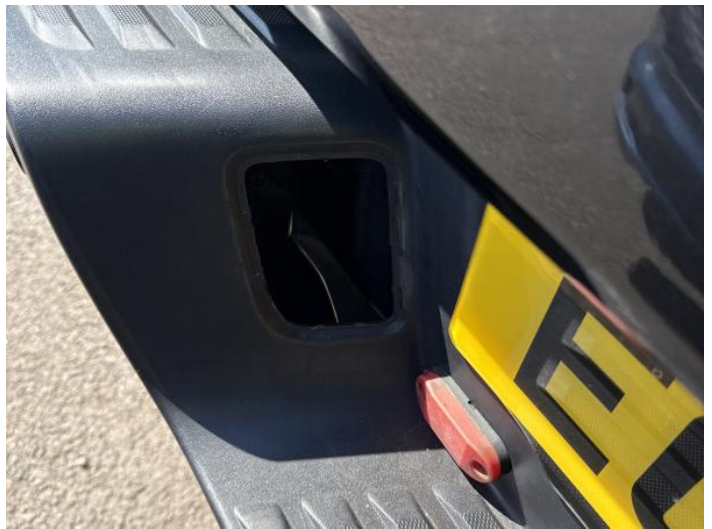
24: Bumper Rear Moulding
Missing
Replace
