VEHICLE INSPECTION REPORT

LD15MRO

Kia Venga 1.6 CRDi ISG 3 5dr

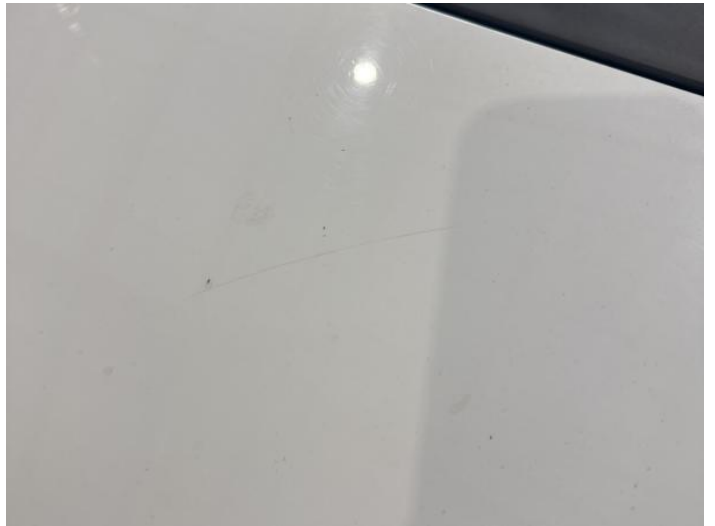
2: Bonnet
Scratched
Over 25mm Thru Paint

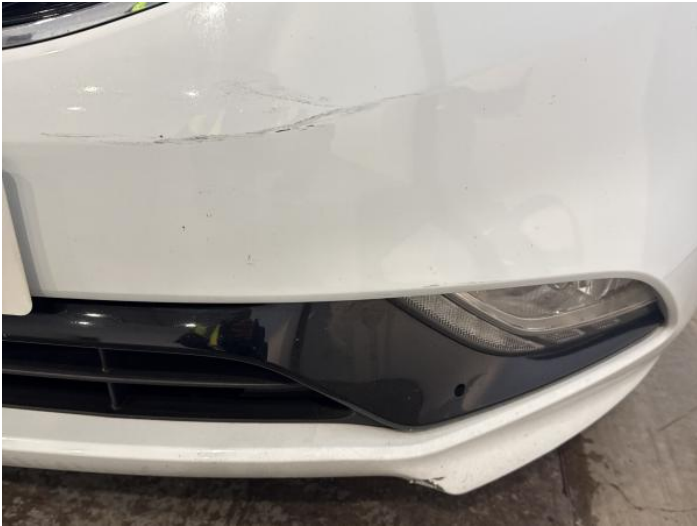
3: Bumper Front
Scratched
25 to 100mm Thru Paint

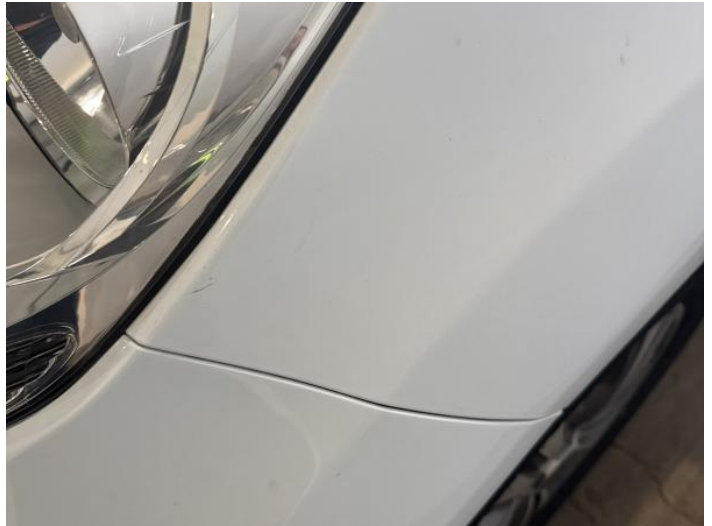
4: Wing nsf
Scratched
UpTo 25mm Thru Paint

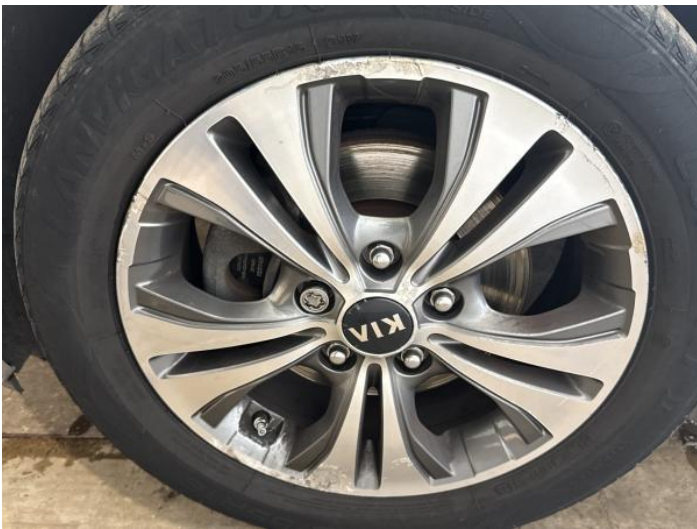
5: Wheel nsf
Scratched
Over 50mm

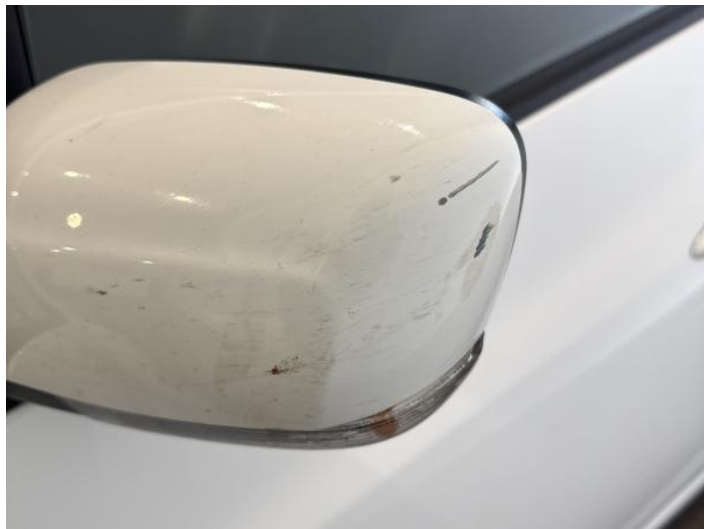
6: Door Mirror Assy nsf
Scratched (Painted)
Over 25mm Thru Paint

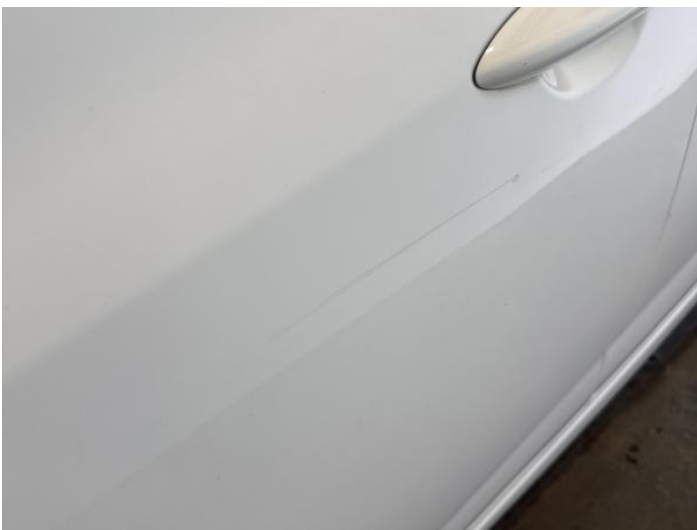
7: Door nsf
Dented
With Paint Damage

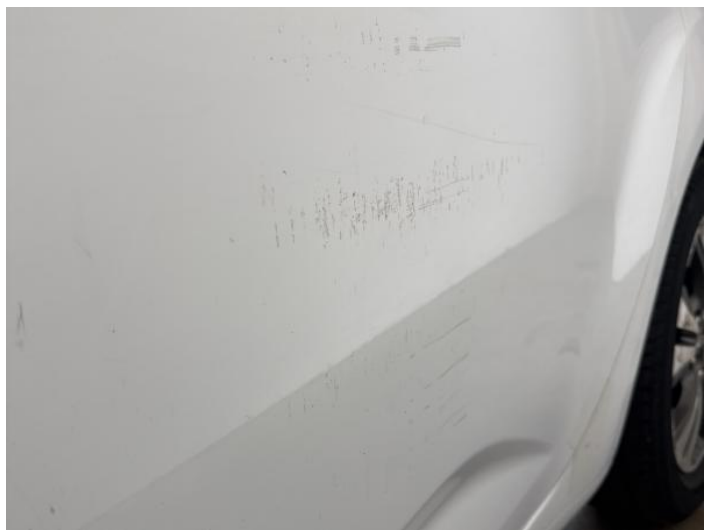
8: Door nsr
Dented
With Paint Damage

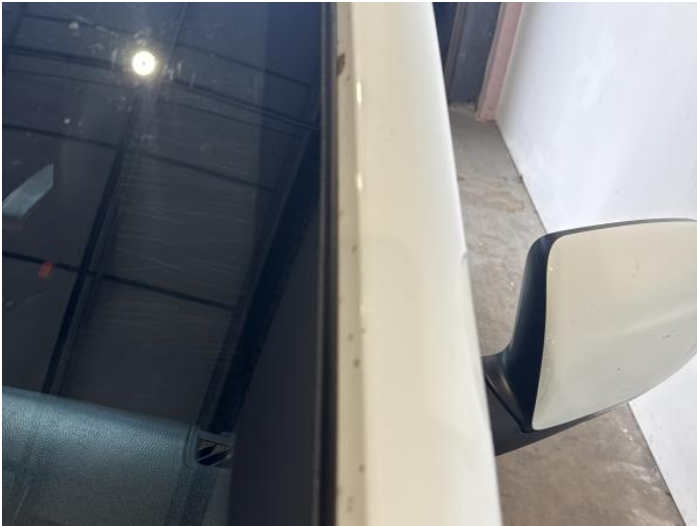
9: A Post ns
Scratched
Over 25mm Thru Paint

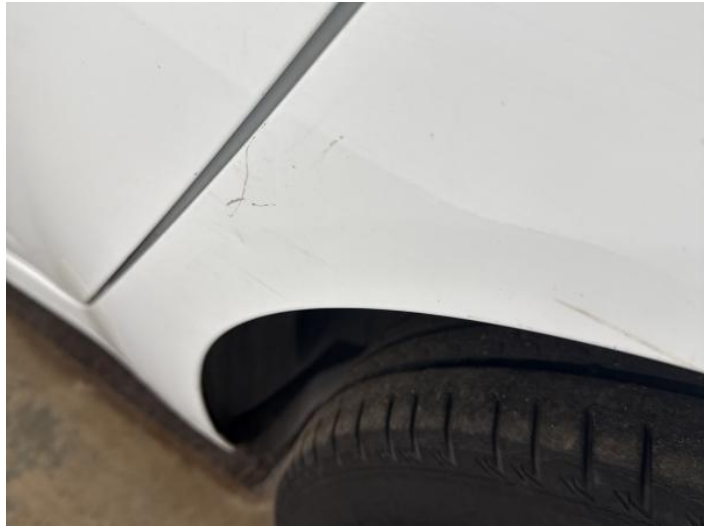
10: Qtr Panel nsr
Dented
Between 10mm + 30mm

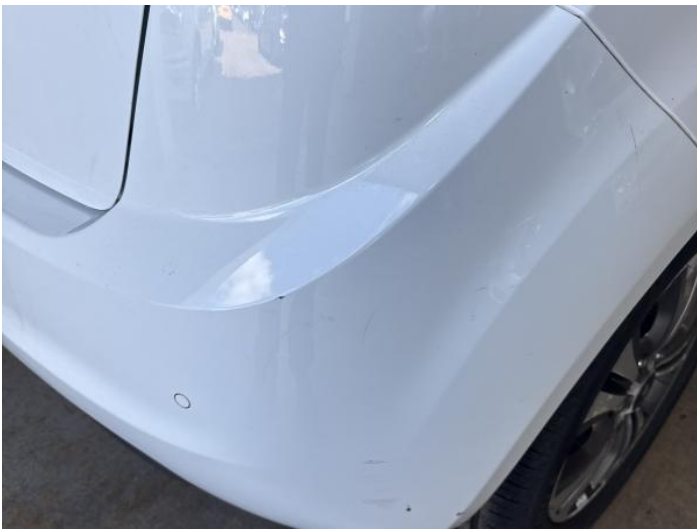
11: Bumper Rear
Scratched
25 to 100mm Thru Paint

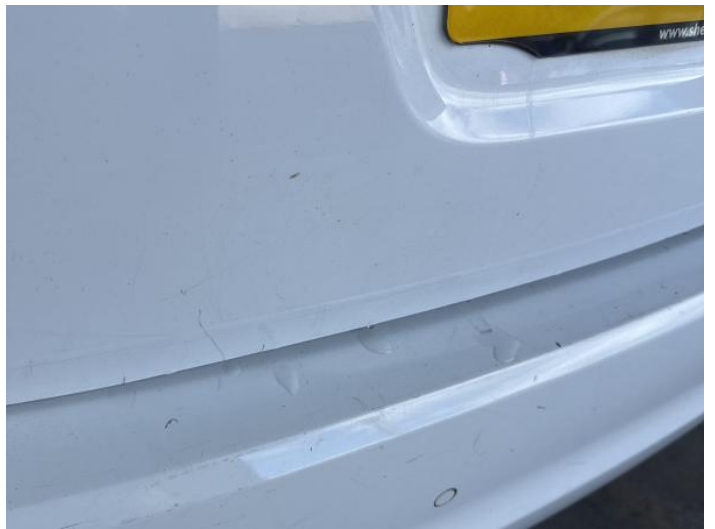
12: Tailgate
Scratched
Over 25mm Thru Paint

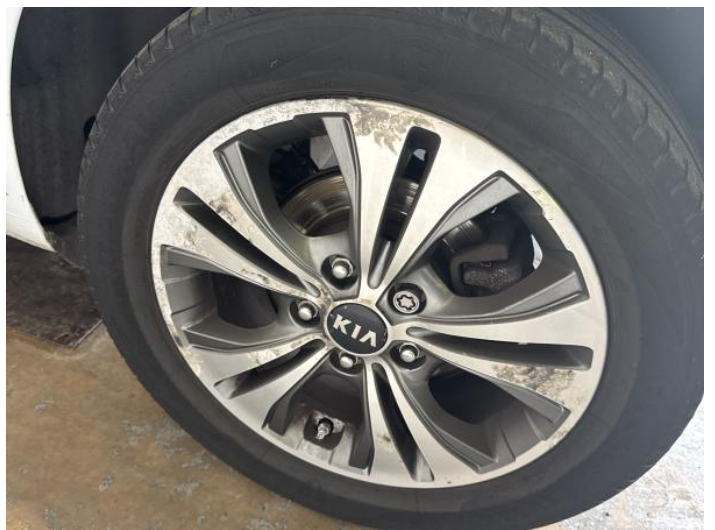
14: Wheel nsr
Scratched
Over 50mm

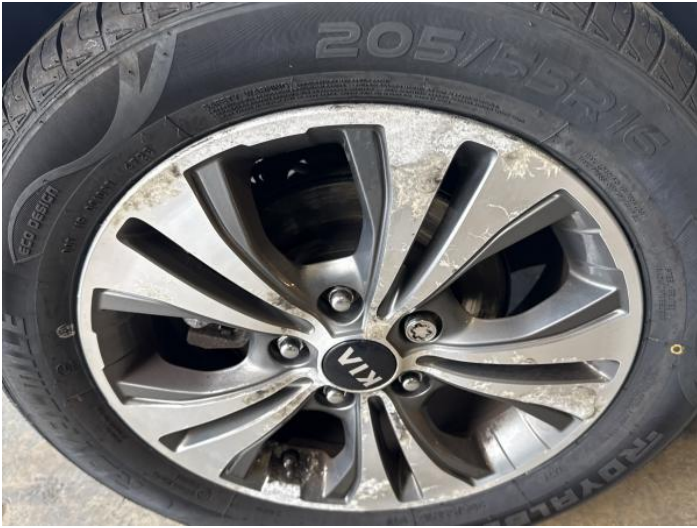
15: Wheel osr
Scratched
Over 50mm

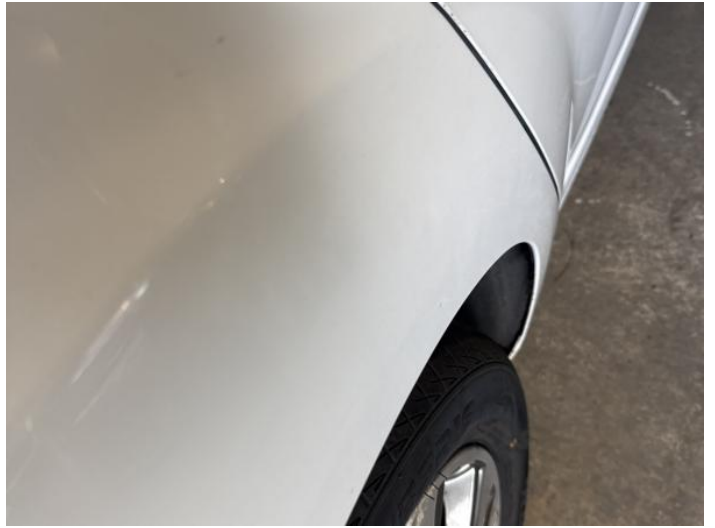
16: Qtr Panel osr
Dented
Over 30mm

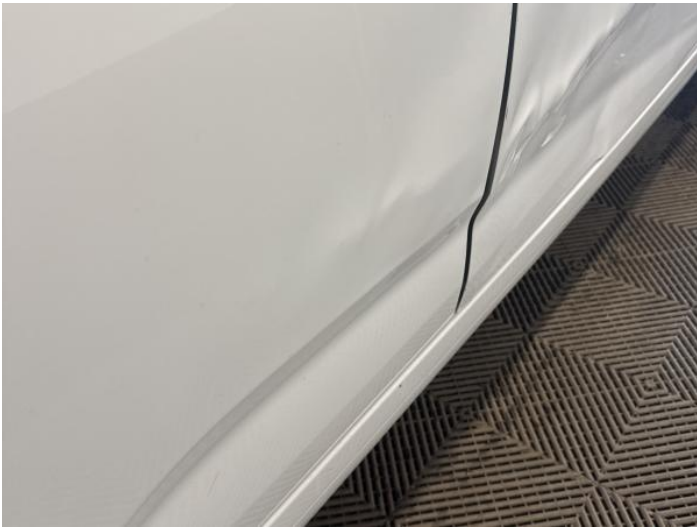
17: Door osr
Dented
Over 30mm

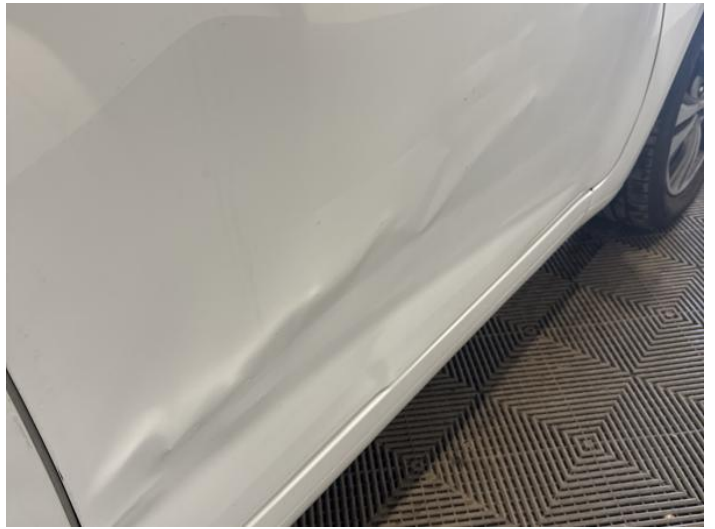
18: Door osf
Dented
Over 30% Of Panel

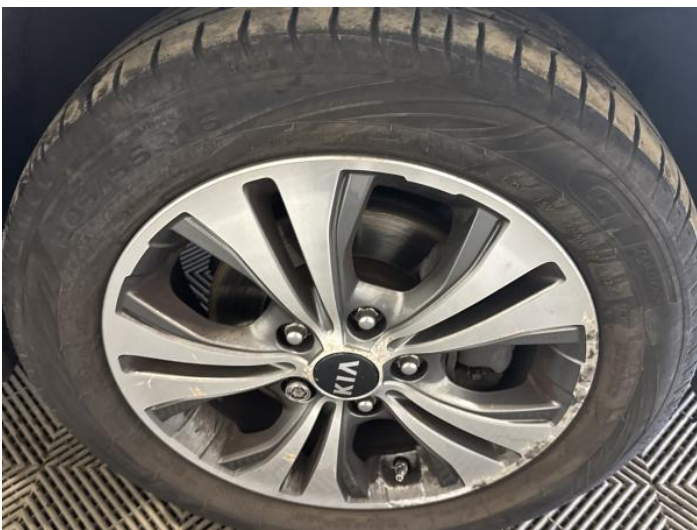
19: Wheel osf
Scratched
Over 50mm

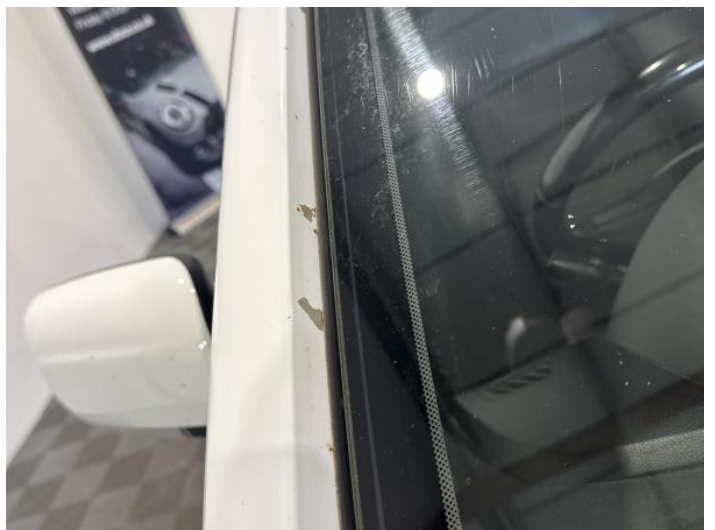
20: A Post os
Scratched
Over 25mm Thru Paint

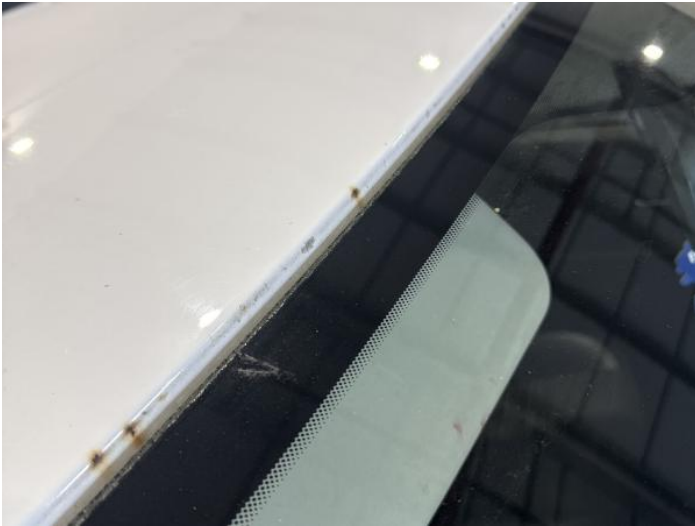
21: Roof
Rusted
Over 5mm

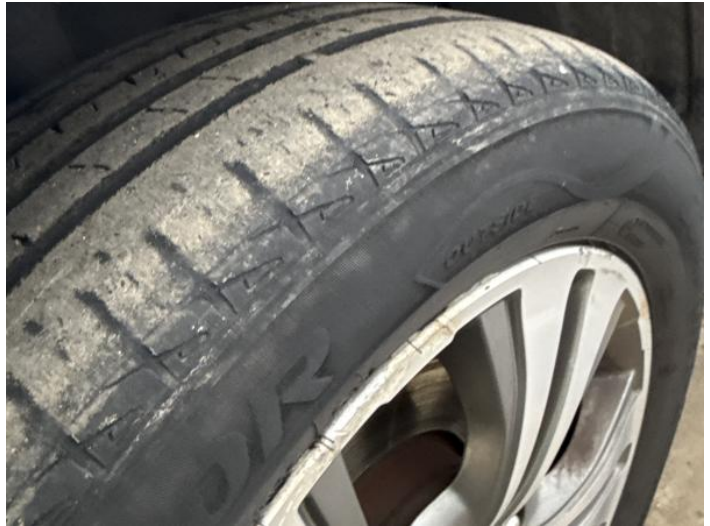
22: Tyre nsf
Damaged
Replace
