VEHICLE INSPECTION REPORT

DN19EYF

Vauxhall Mokka X 1.4T ecoTEC Active 5dr

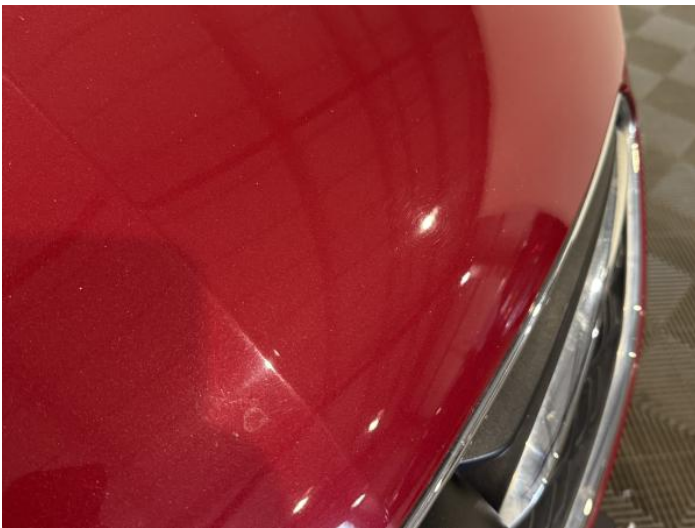
1: Bonnet
Chipped
Multiple Chips

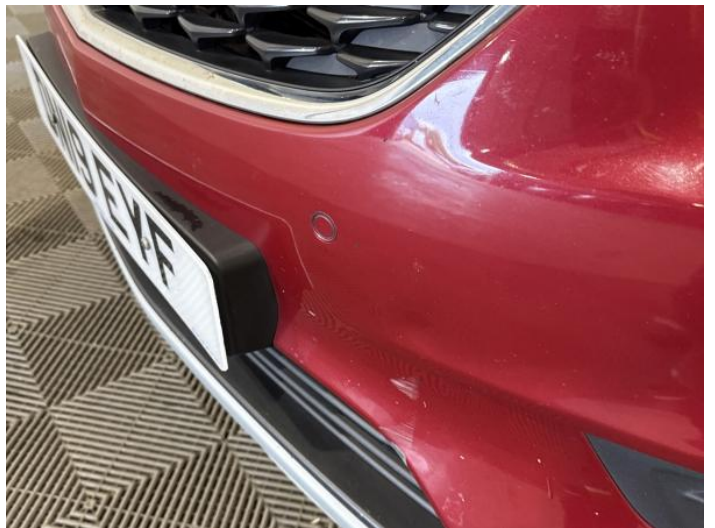
2: Bumper Front
Poor Previous Repair
Poor Paint

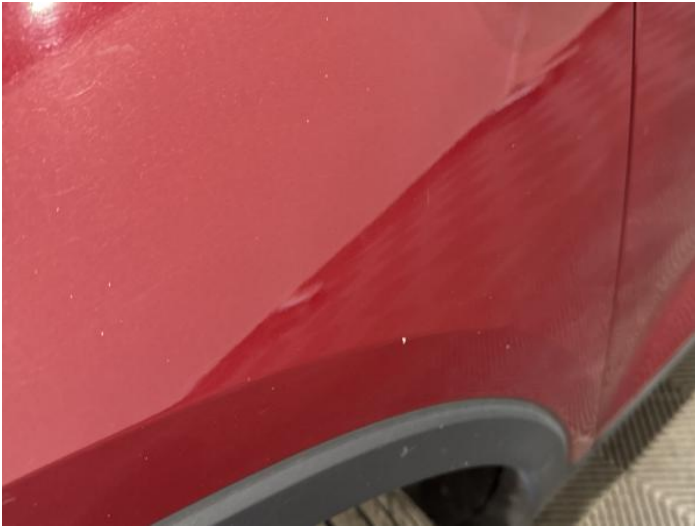
3: Wing nsf
Chipped
1 To 5

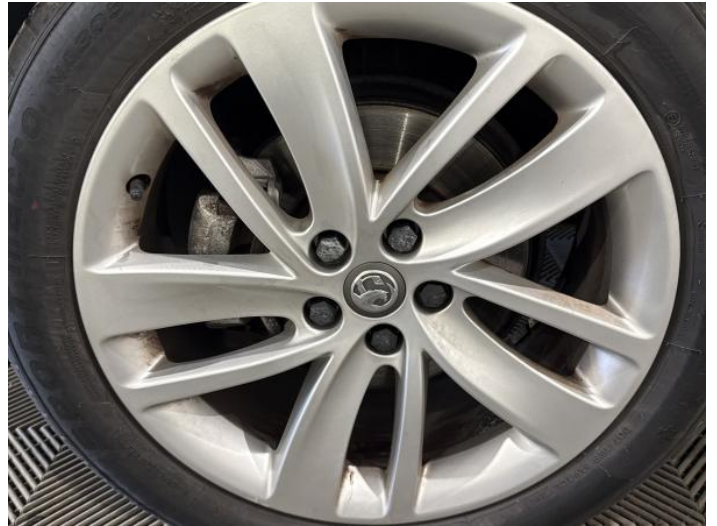
4: Wheel nsf
Scratched
Up To 50mm

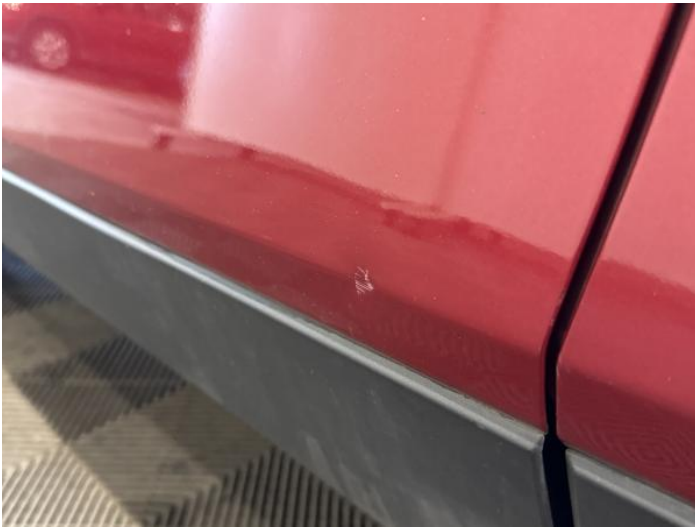
5: Door nsf
Dented
Between 10mm + 30mm

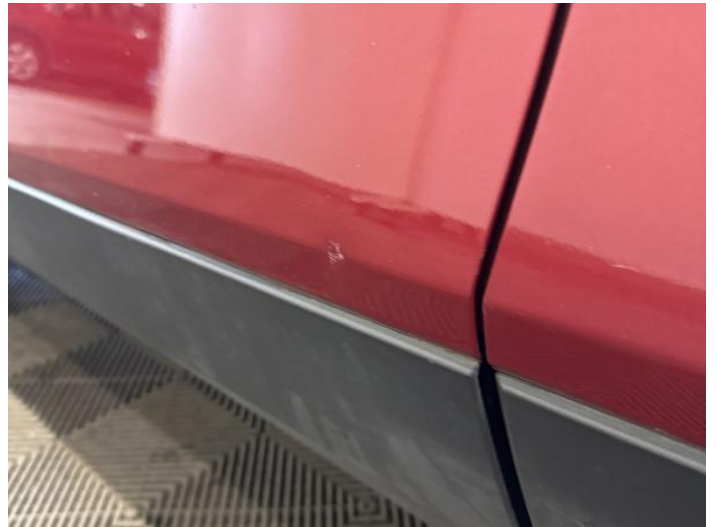
6: Door nsf
Scratched
Over 25mm Thru Paint

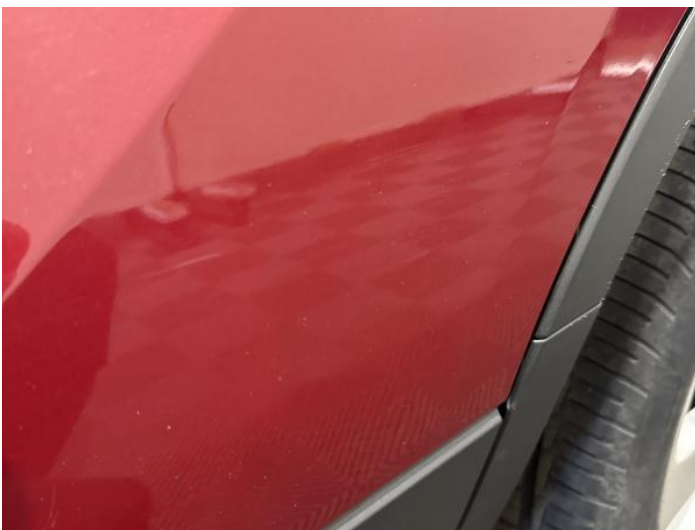
7: Door nsr
Scratched
Over 25mm Thru Paint

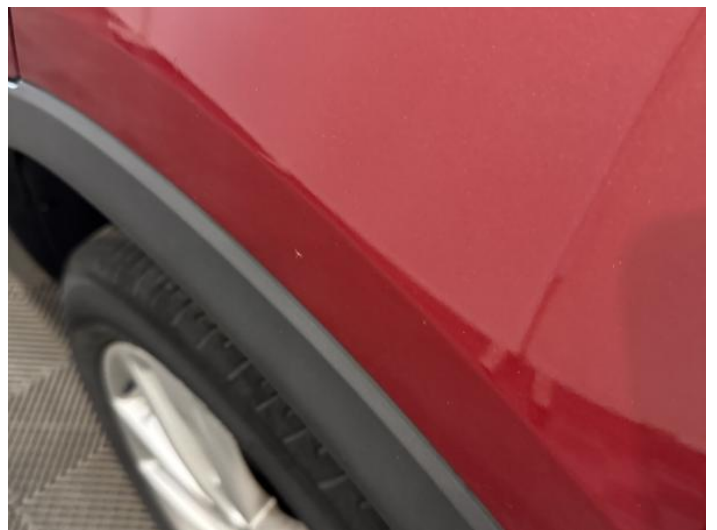
8: Qtr Panel nsr
Chipped
1 To 5

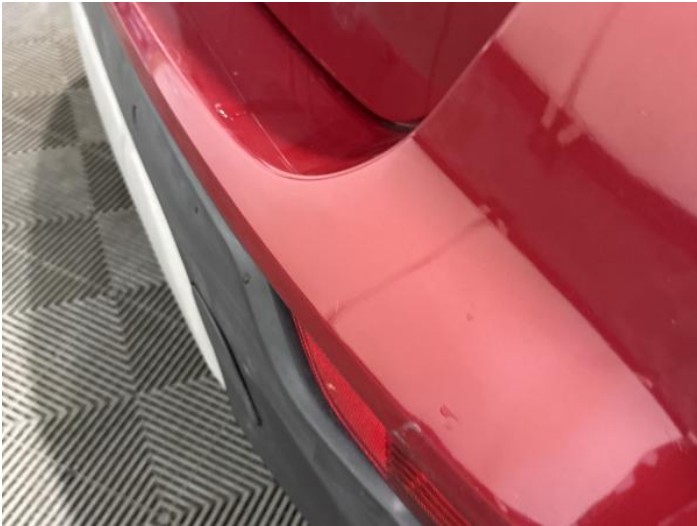
9: Bumper Rear
Scratched
25 to 100mm Thru Paint

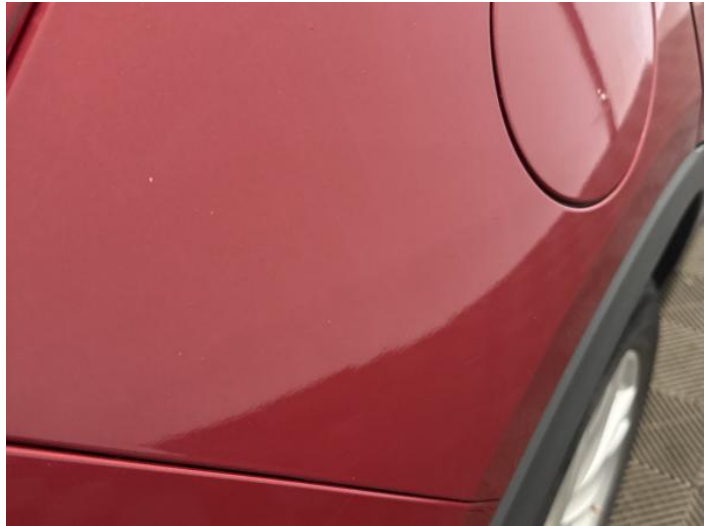
10: Qtr Panel osr
Dented
With Paint Damage

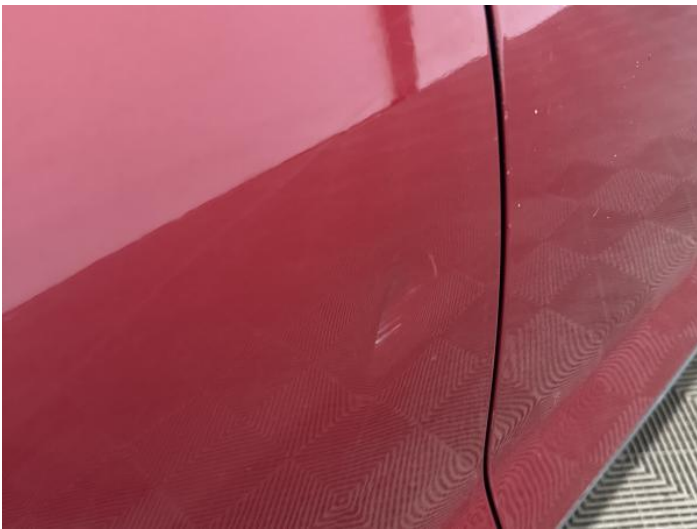
11: Door osr
Dented
With Paint Damage

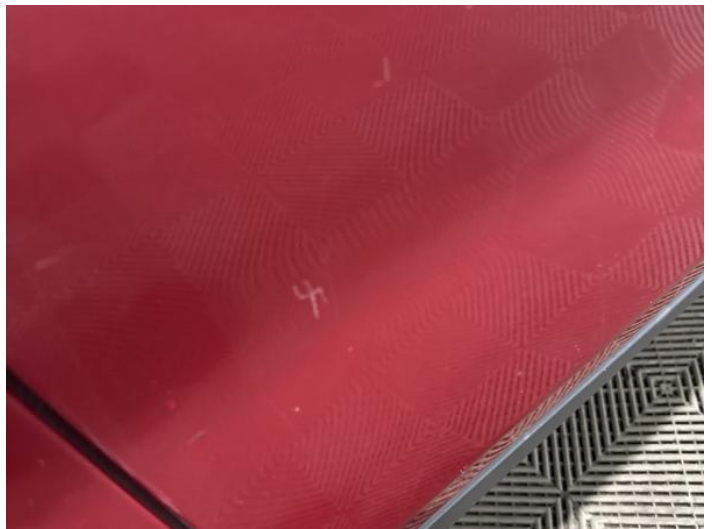
12: Door osf
Scratched
UpTo 25mm Thru Paint

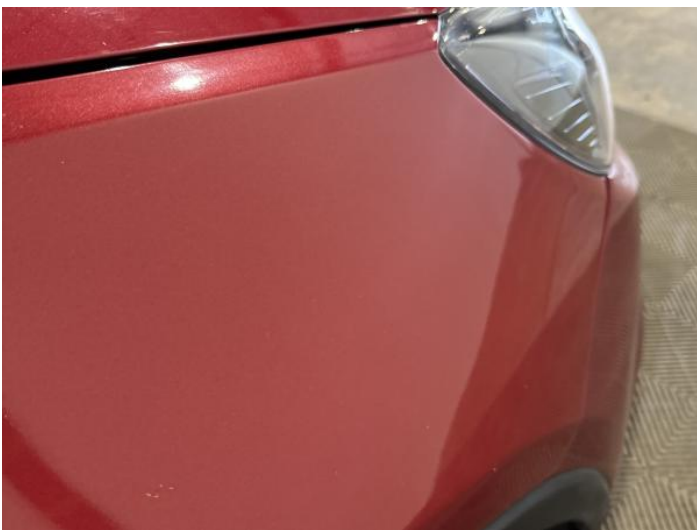
13: Wing osf
Poor Previous Repair
Rippled UpTo 30%

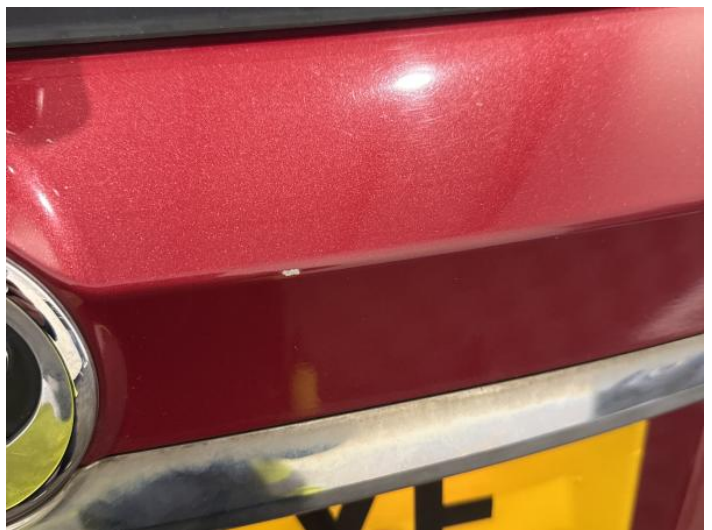
14: Tailgate
Poor Previous Repair
Poor Paint

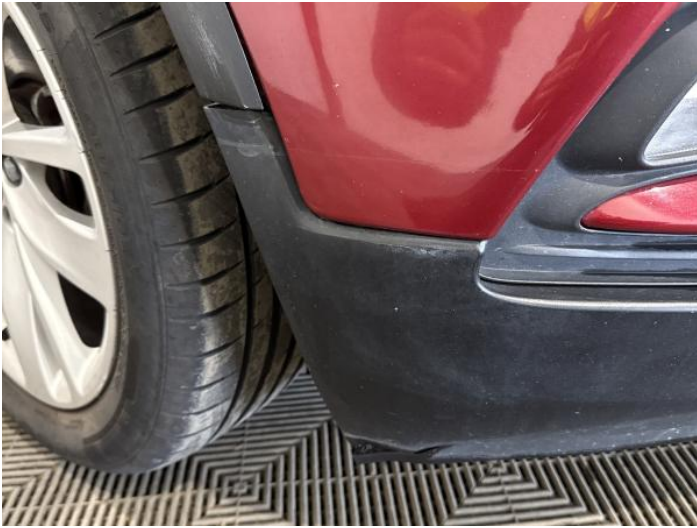
15: Bumper Front Moulding
Broken
Replace
