VEHICLE INSPECTION REPORT

GF12BZE

Ford S-Max 2.0 TDCi 140 Titanium 5dr

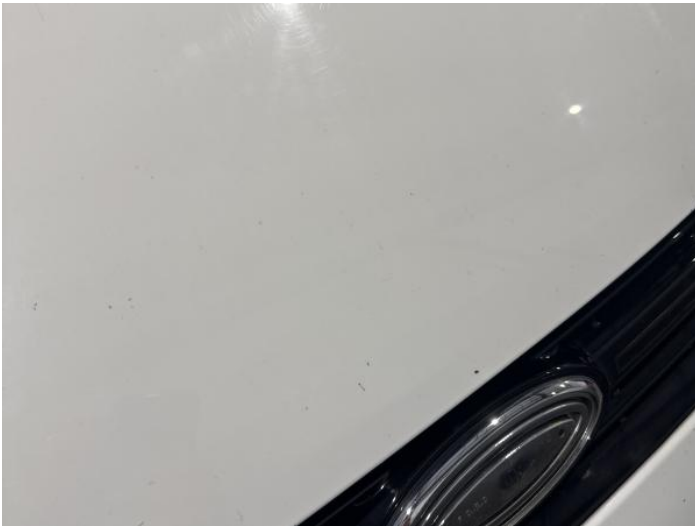
1: Bonnet
Chipped
1 To 5

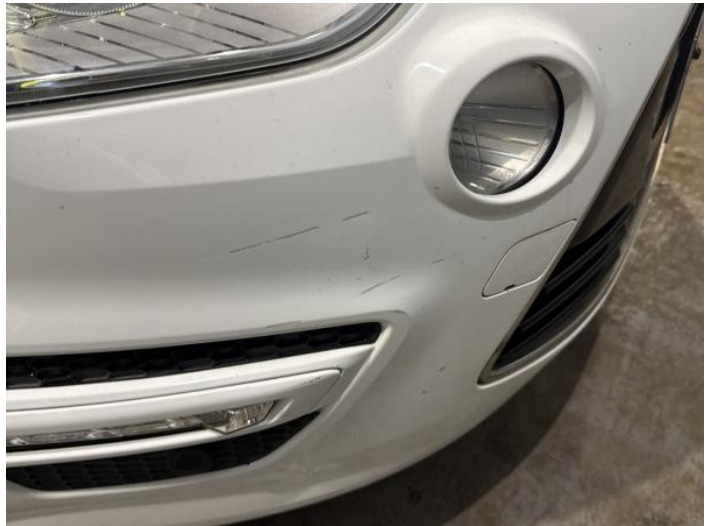
2: Bumper Front
Scratched
25 to 100mm Thru Paint

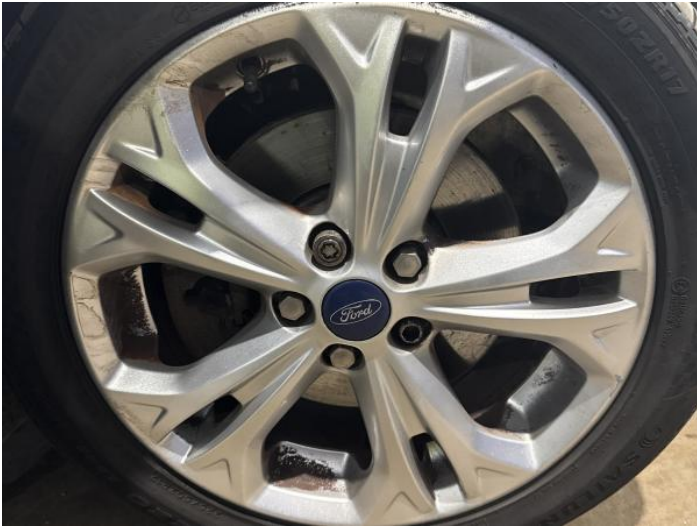
3: Wheel nsf
Scratched
Up To 50mm

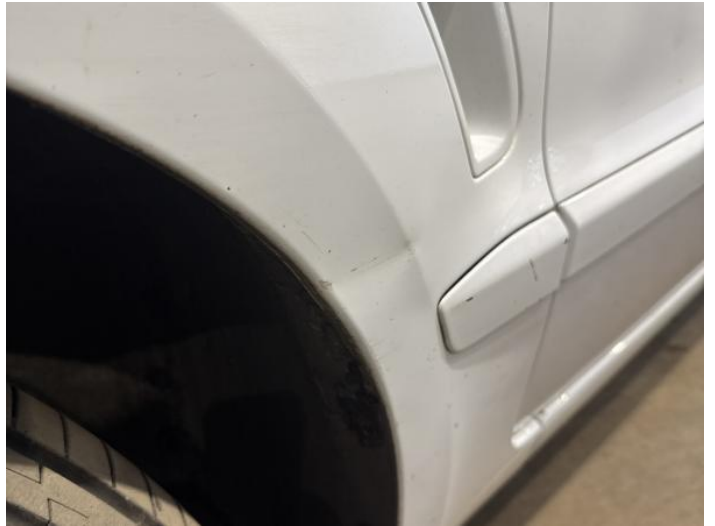
4: Wing nsf
Dented
With Paint Damage

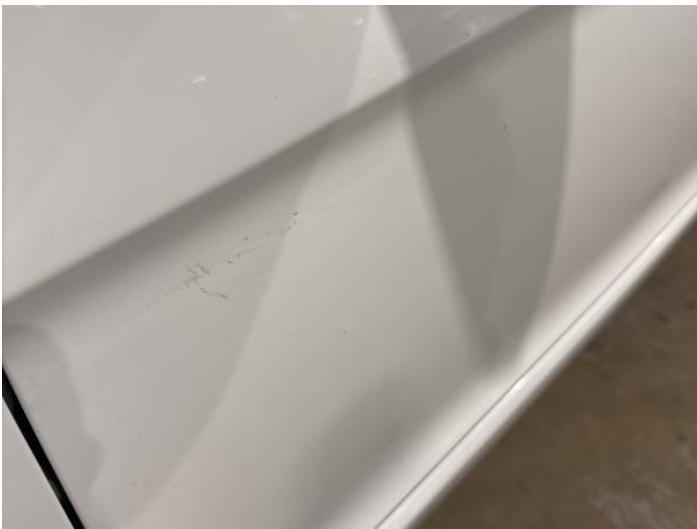
5: Door nsf
Scratched
Over 25mm Thru Paint

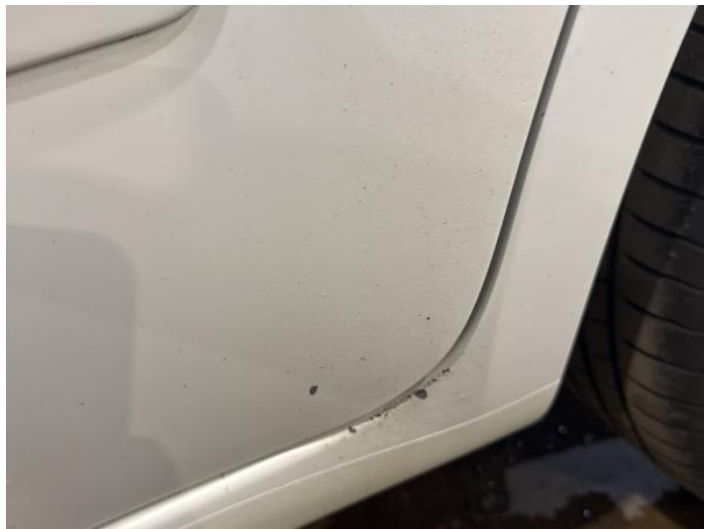
6: Door nsr
Chipped
Multiple Chips

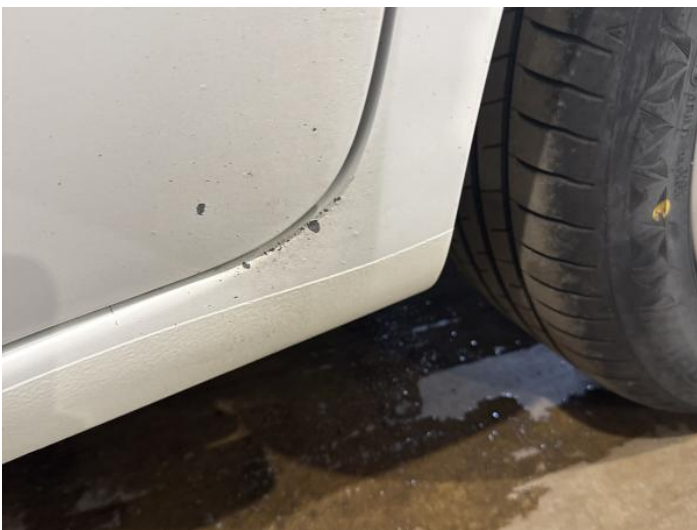
7: Qtr Panel nsr
Chipped
Over 5mm

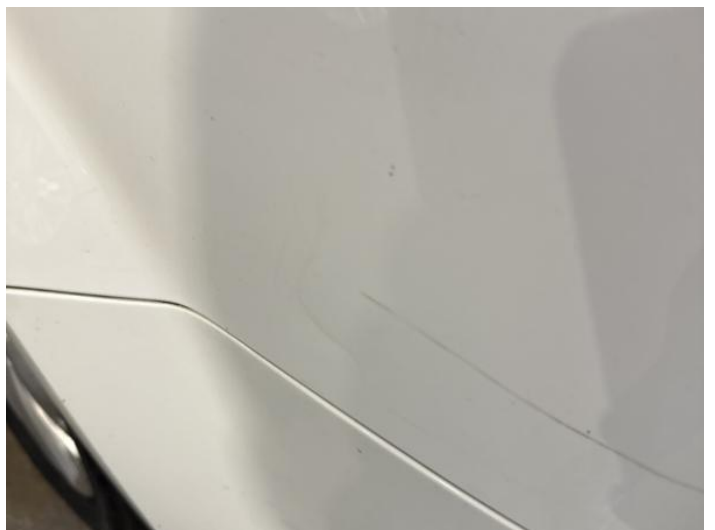
8: Qtr Panel nsr
Dented
With Paint Damage

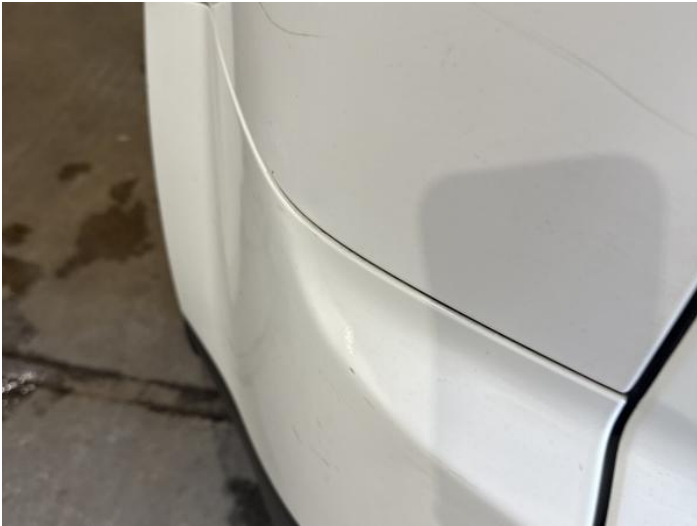
9: Bumper Rear
Scratched
25 to 100mm Thru Paint

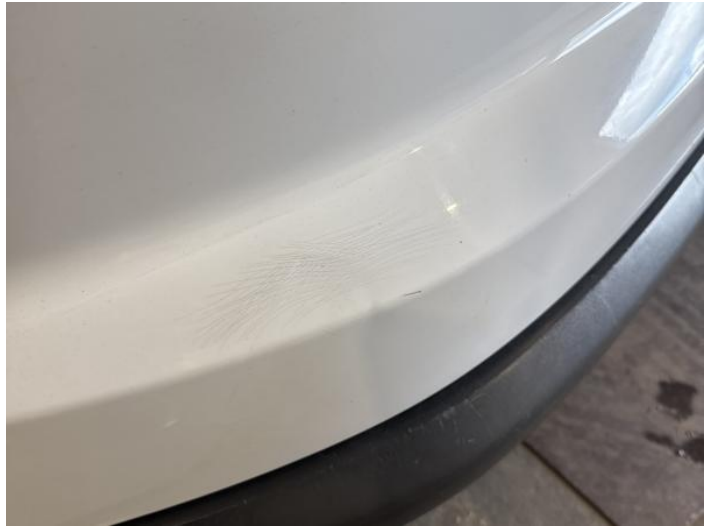
10: Tailgate
Dented
With Paint Damage

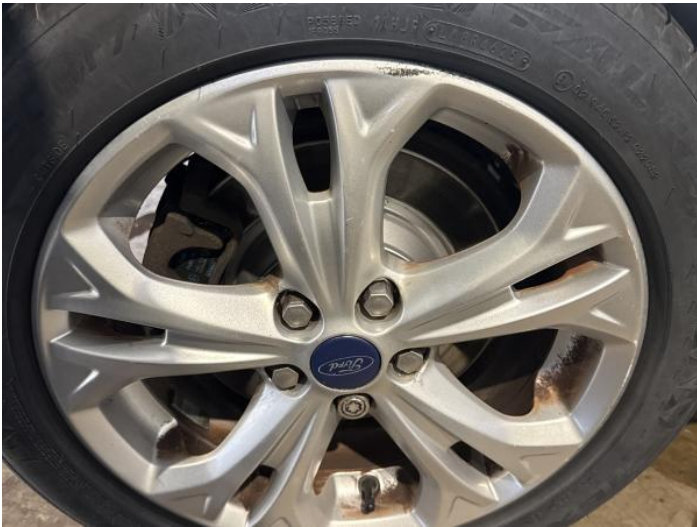
11: Wheel osr
Scratched
Over 50mm

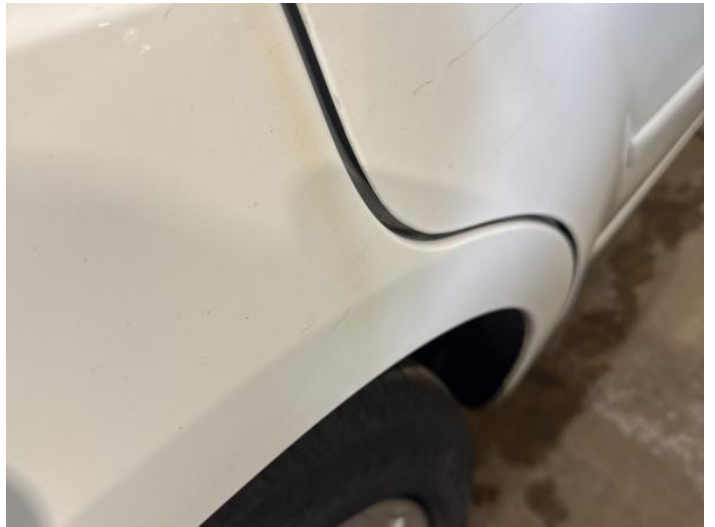
12: Qtr Panel osr
Scratched
UpTo 25mm Thru Paint

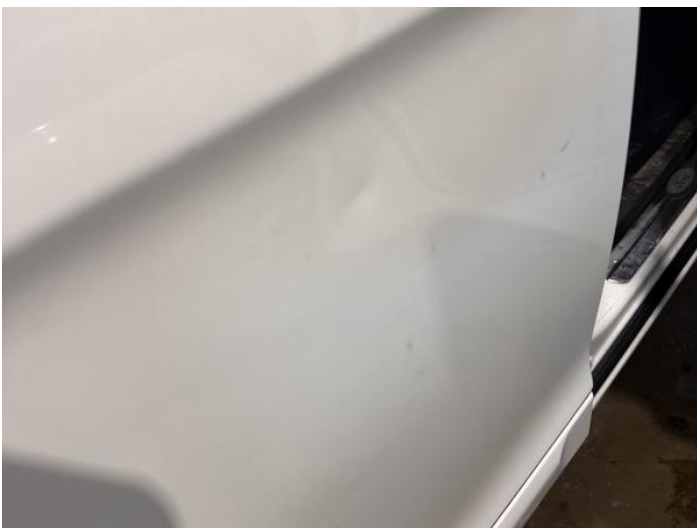
13: Door osr
Dented
With Paint Damage

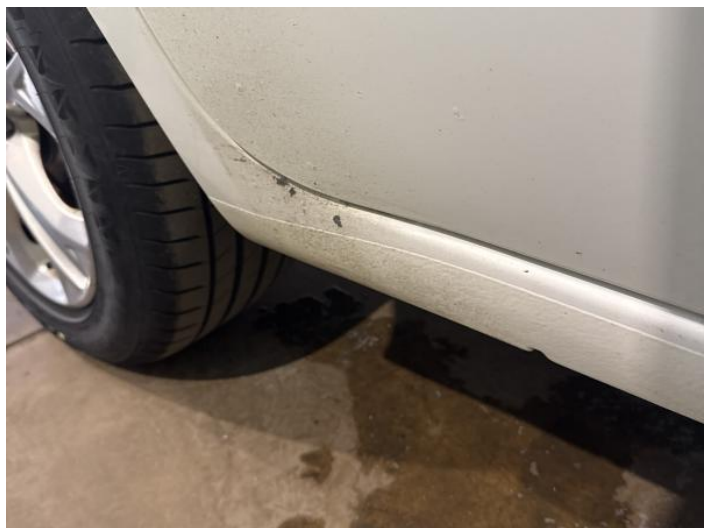
14: Sill os
Chipped
Over 5mm

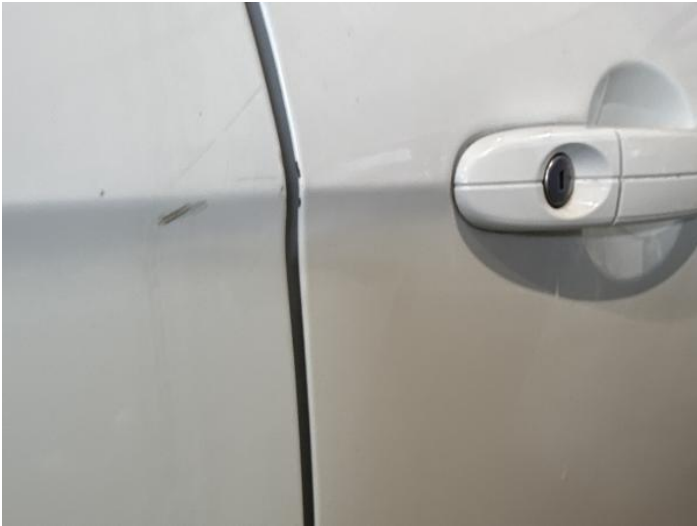
15: Door osf
Chipped
Edge Chip

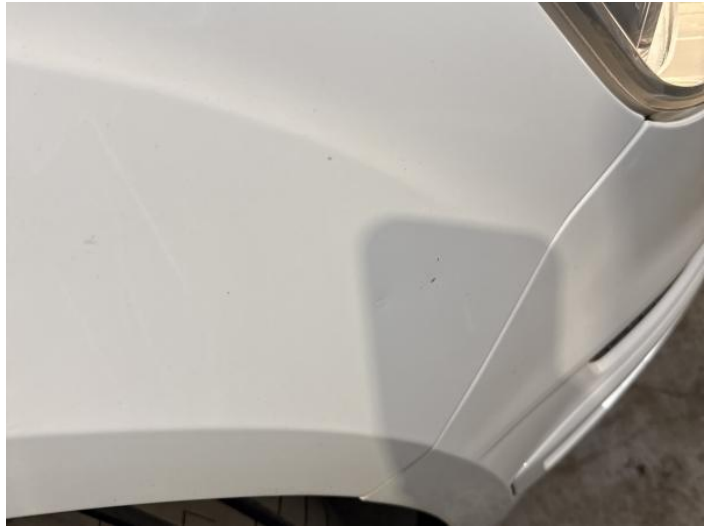
16: Wing osf
Dented
Between 10mm + 30mm

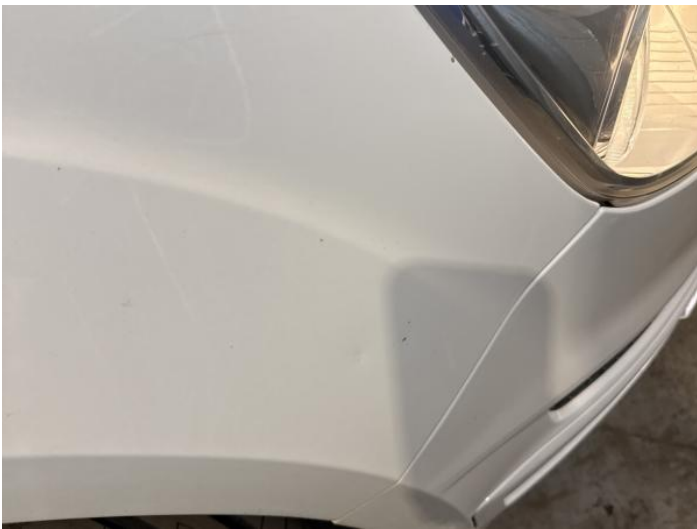
17: Wing osf
Chipped
1 To 5

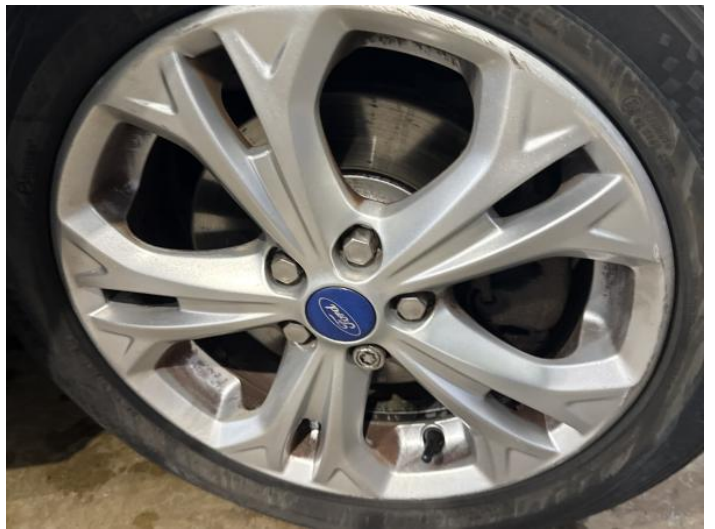
18: Wheel osf
Scratched
Over 50mm

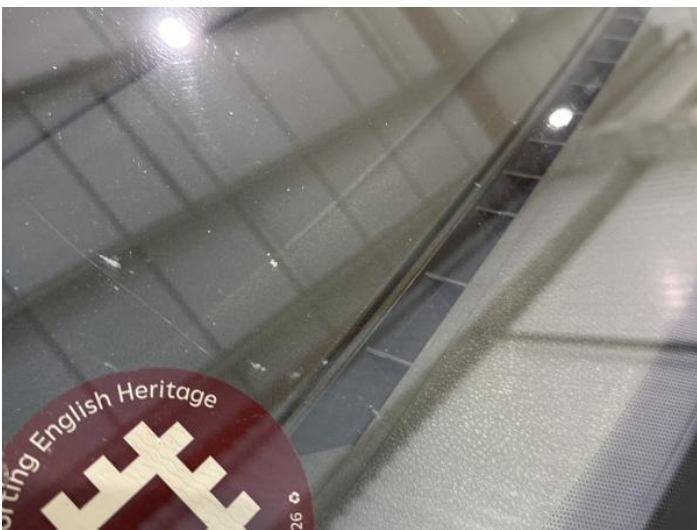
19: Screen Front
Chipped
Up To 10mm
