### Vehicle Inspection Report

**Reg:** LS64OLO

<b>Make</b>	RENAULT	<b>Body Type</b>	MPV	<b>Doors</b>	5
<b>Model</b>	SCENIC D-QUE TT ENERGY TC - 1198cc	<b>Fuel Type</b>	Petrol	<b>Colour</b>	Black
<b>Mileage</b>	88,798 miles	<b>Transmission</b>	Manual	<b>Year of MFR</b>	2014
		<b>Gears</b>	6	<b>Date First Reg</b>	30/09/2014

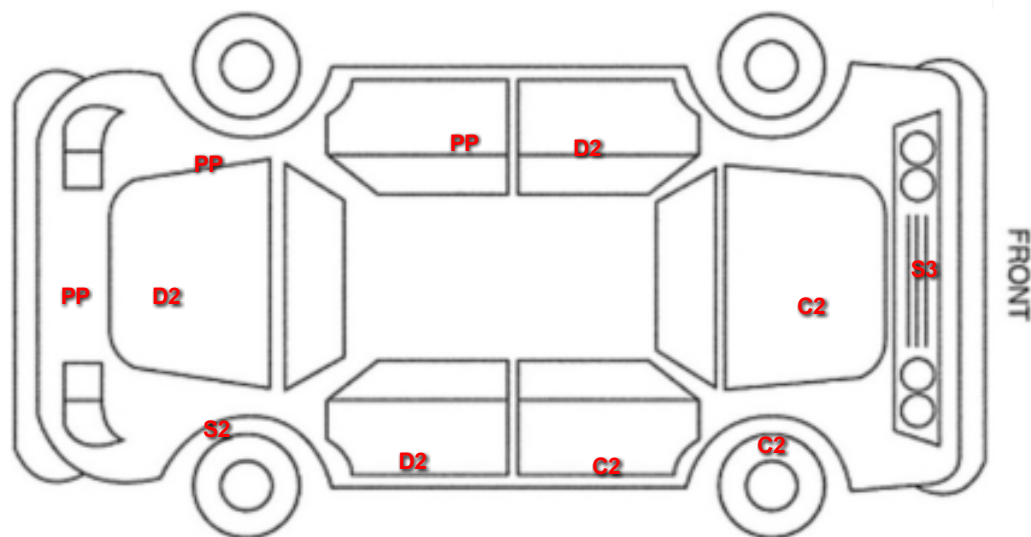
## Vehicle Splat

Component	Condition	Severity	Repair
Seat Base Cover osf	Torn	Over 3mm	Replace
Bumper Rear	Poor Previous Repair	Poor Paint	Refinish
Boot Lid	Dented	Over 30mm	Repair and Refinish
Qtr Panel osr	Scratched	Over 25mm Thru Paint	Refinish
Door osr	Dented	With Paint Damage	Repair and Refinish
Door osf	Chipped	Multiple Chips	Refinish
Wing osf	Scratched	Over 25mm Not Thru Paint	Machine Polish
Wing osf	Chipped	1 To 5	Smart Repair
Bumper Front	Scratched	Over 100mm Thru Paint	Refinish
Bonnet	Chipped	1 To 5	Smart Repair
Wing nsf	Scratched	Over 25mm Not Thru Paint	Machine Polish
Door nsf	Dented	Over 30mm	Repair and Refinish
Door nsr	Poor Previous Repair	Poor Paint	Refinish
Qtr Panel nsr	Dented	Over 30mm	Repair and Refinish
Qtr Panel nsr	Poor Previous Repair	Poor Paint	Refinish

- S2**  
Scratch/Paint defect 30-100mm
- S3**  
Scratch/Paint defect 100m +
- D2**  
Dent/damage 30-100mm
- C2**  
Multiple Chips
- PP**  
Poor Previous
