VEHICLE INSPECTION REPORT

GU14KJE

Volkswagen Tiguan 2.0 TDi BlueMotion Tech Match 5dr

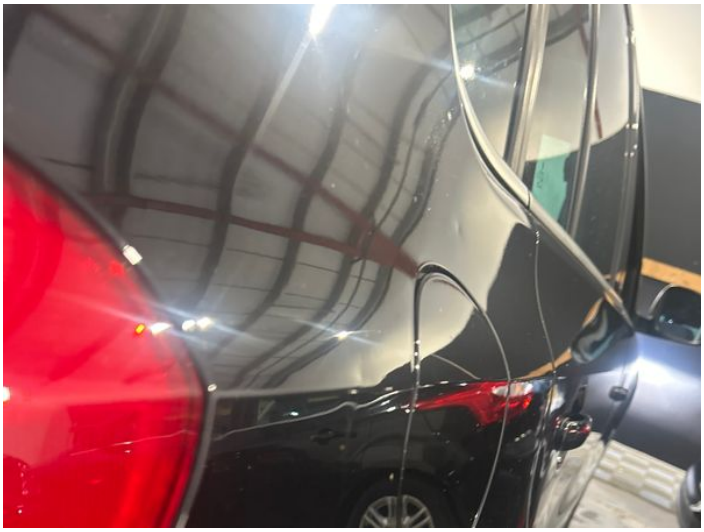
1: Door osf
Dented
2 Or Less UpTo 10mm

2: Wing osf
Chipped
1 To 5

3: Door osf
Chipped
Multiple Chips

4: Qtr Panel osr
Dented
Between 10mm + 30mm

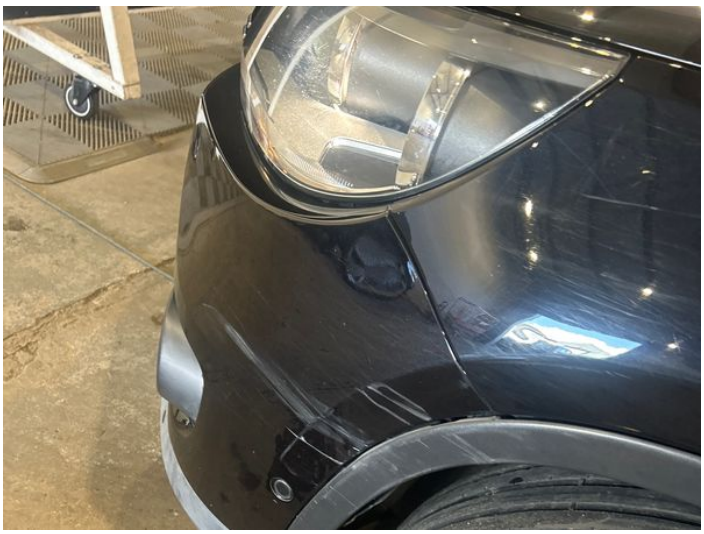
5: Door nsr
Scratched
UpTo 25mm Thru Paint

6: Wing nsf
Dented
With Paint Damage

7: Door nsf
Chipped
Edge Chip

8: Bumper Front
Scratched
25 to 100mm Thru Paint

9: Bumper Front
Chipped
Multiple Chips

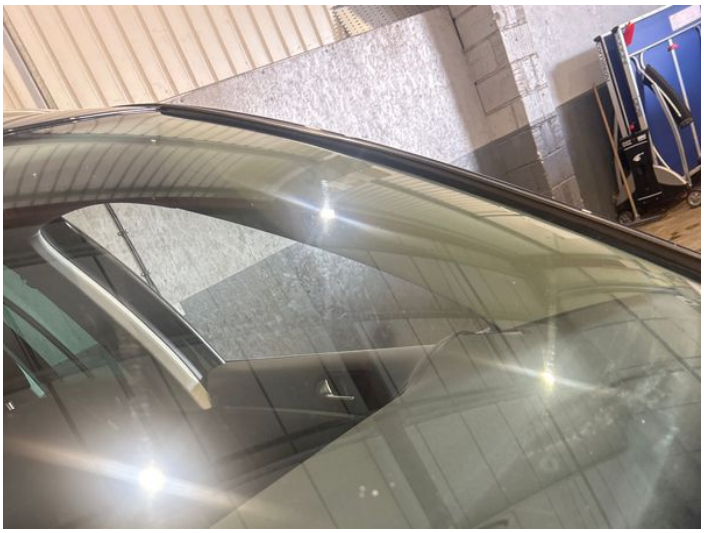
10: Bonnet
Chipped
1 To 5

11: Screen Front
Chipped
UpTo 10mm

12: Tyre osf
Punctured
Replace
