VEHICLE INSPECTION REPORT

YB09YJF

BMW X5 xDrive30d SE 5dr Auto [7 Seat]

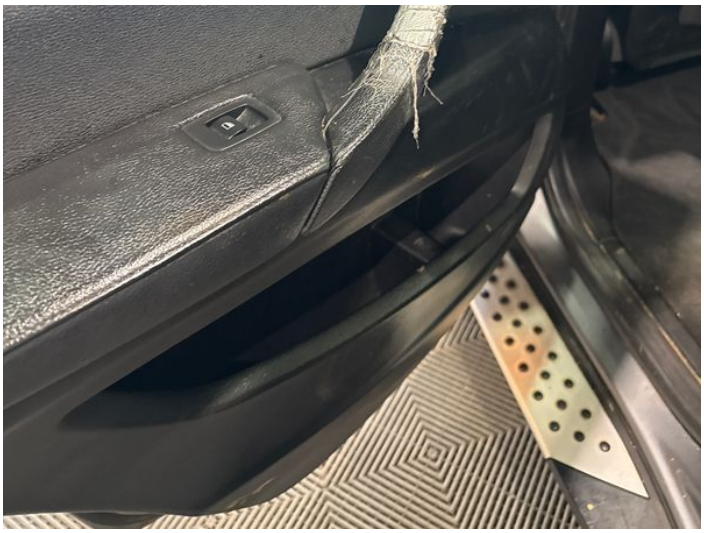
1: Door Pad osr
Scuffed
Over 25mm

2: Door Pad nsr
Scuffed
Over 25mm

3: Door Pad nsf
Scuffed
Over 25mm

4: Fascia Trim
Damaged
Replace

5: Bonnet
Chipped
Multiple Chips

6: Badgedecal Front
Missing
Replace

7: Bumper Front
Poor Previous Repair
Poor Paint

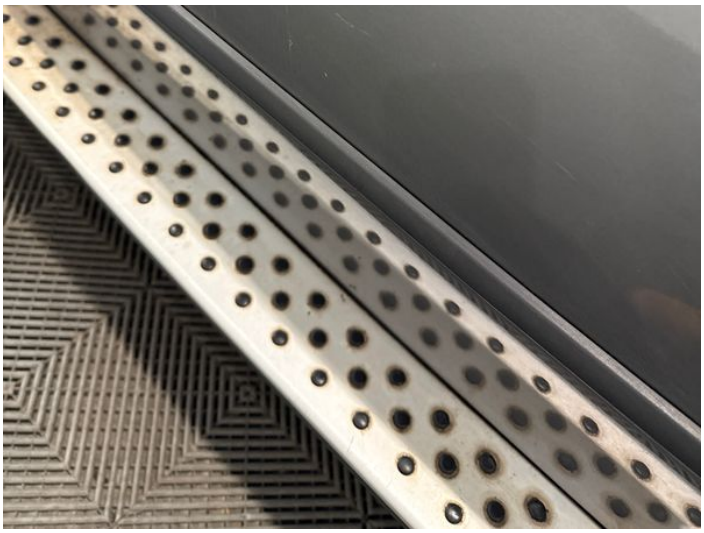
9: Wing nsf
Poor Previous Repair
Poor Paint

10: Wheel nsf
Scratched
Over 50mm

11: Door nsf
Scratched
Rusted

12: Door nsr
Scratched
Over 25mm Thru Paint

13: Wheel nsr
Scratched
Over 50mm

14: Door nsr
Dented
Over 30mm

15: Lamp nsr
Broken
Replace

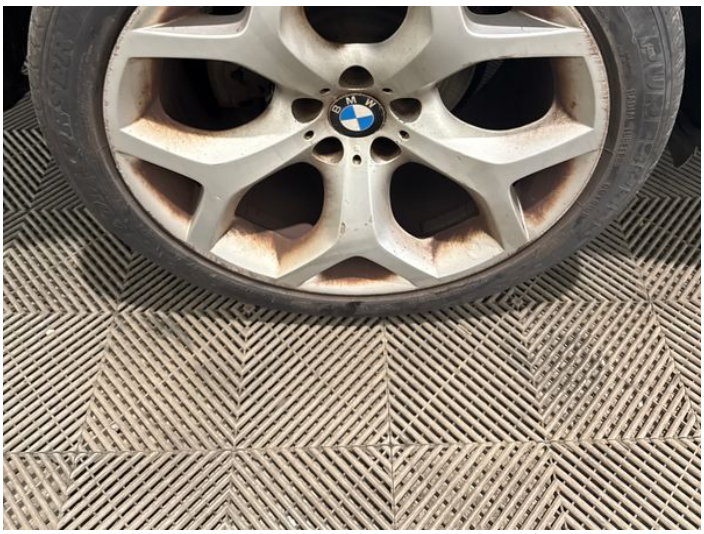
16: Tailgate
Poor Previous Repair
Poor Paint

17: Bumper Rear
Scratched
Over 100mm Thru Paint

18: Qtr Panel osr
Dented
Over 30mm

19: Wheel osr
Scratched
Over 50mm

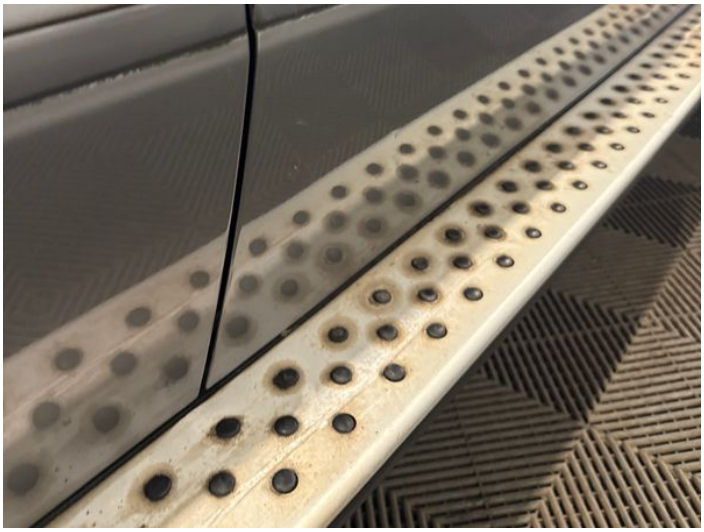
20: Door osr
Dented
With Paint Damage

21: Door osf
Chipped
1 To 5

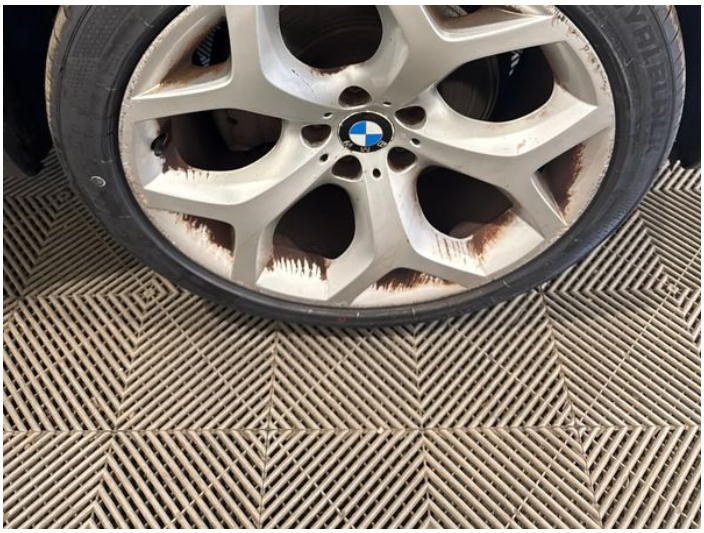
22: Wing osf
Poor Previous Repair
Poor Paint

23: Wheel osf
Scratched
Over 50mm

24: Screen Front
Chipped
Over 10mm

26: Fascia Trim
Missing
Replace
