VEHICLE INSPECTION REPORT

KX68YSH

Volvo V60 2.0 D3 Momentum Pro 5dr Auto

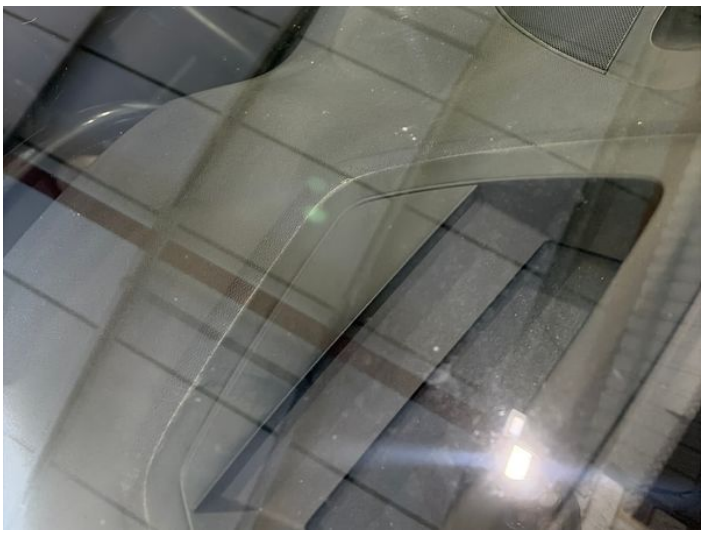
1: Wheel osf
Scratched
Over 50mm

2: Wing osf
Scratched
Over 25mm Thru Paint

3: Door osf
Dented
Over 30% Of Panel

4: Qtr Panel osr
Chipped
1 To 5

5: Wheel osr
Corroded
Light

6: Bumper Rear
Scratched
Over 100mm Thru Paint

7: Wheel nsr
Scratched
Over 50mm

8: Door nsr
Chipped
1 To 5

9: Door nsf
Chipped
1 To 5

10: Door Mirror Assy nsf
Scratched (Painted)
UpTo 25mm Thru Paint

11: Wheel nsf
Scratched
Over 50mm

12: Bumper Front
Scratched
Over 100mm Thru Paint

13: Bonnet
Chipped
1 To 5

14: Screen Front
Chipped
UpTo 10mm

15: Tyre nsf
Damaged
Replace

16: Tyre osr
Damaged
Replace

17: Tyre nsr
Damaged
Replace
