VEHICLE INSPECTION REPORT

EU65SRY

Audi A4 2.0 TDI Ultra 136 SE Technik 5dr

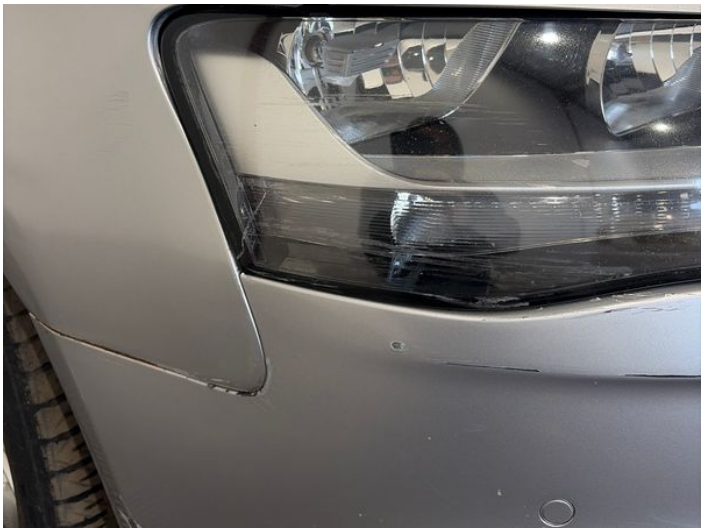
1: Bonnet
Poor Previous Repair
Paint Flake

2: Bumper Front
Dented
With Paint Damage

3: Headlamp os
Broken
Replace

4: Wing nsf
Poor Previous Repair
Poor Paint

5: Wheel nsf
Scratched
Up To 50mm

6: Door nsf
Chipped
1 To 5

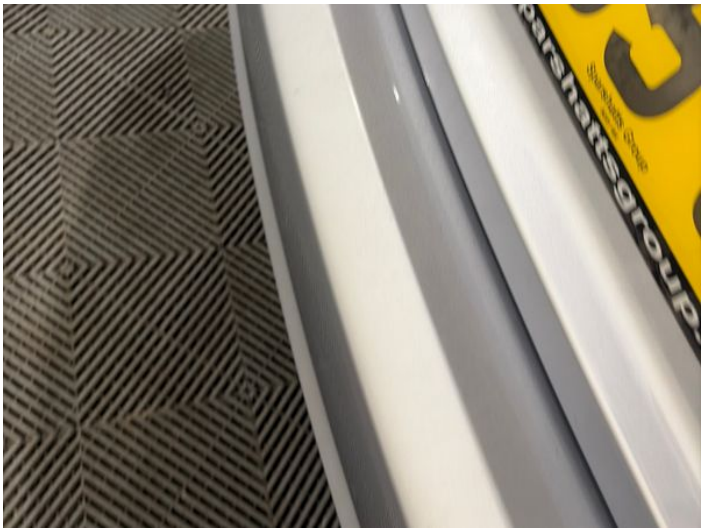
7: Door nsr
Scratched
Over 25mm Thru Paint

8: Wheel nsr
Scratched
Up To 50mm

9: Qtr Panel nsr
Chipped
1 To 5

10: Bumper Rear
Scratched
25 to 100mm Thru Paint

11: Qtr Panel osr
Scratched
Over 25mm Thru Paint

12: Wheel osr
Scratched
Up To 50mm

13: Door osr
Dented
Between 10mm + 30mm

14: Door osr
Scratched
UpTo 25mm Thru Paint

15: Door osf
Chipped
1 To 5

16: Wing osf
Poor Previous Repair
Rippled UpTo 30%

17: Wheel osf
Scratched
Over 50mm

18: Screen Front
Chipped
UpTo 10mm

19: Roof
Chipped
Edge Chip
