# VEHICLE INSPECTION REPORT

**AR19OCN**

## Citroen C3 1.2 PureTech 83 Flair 5dr

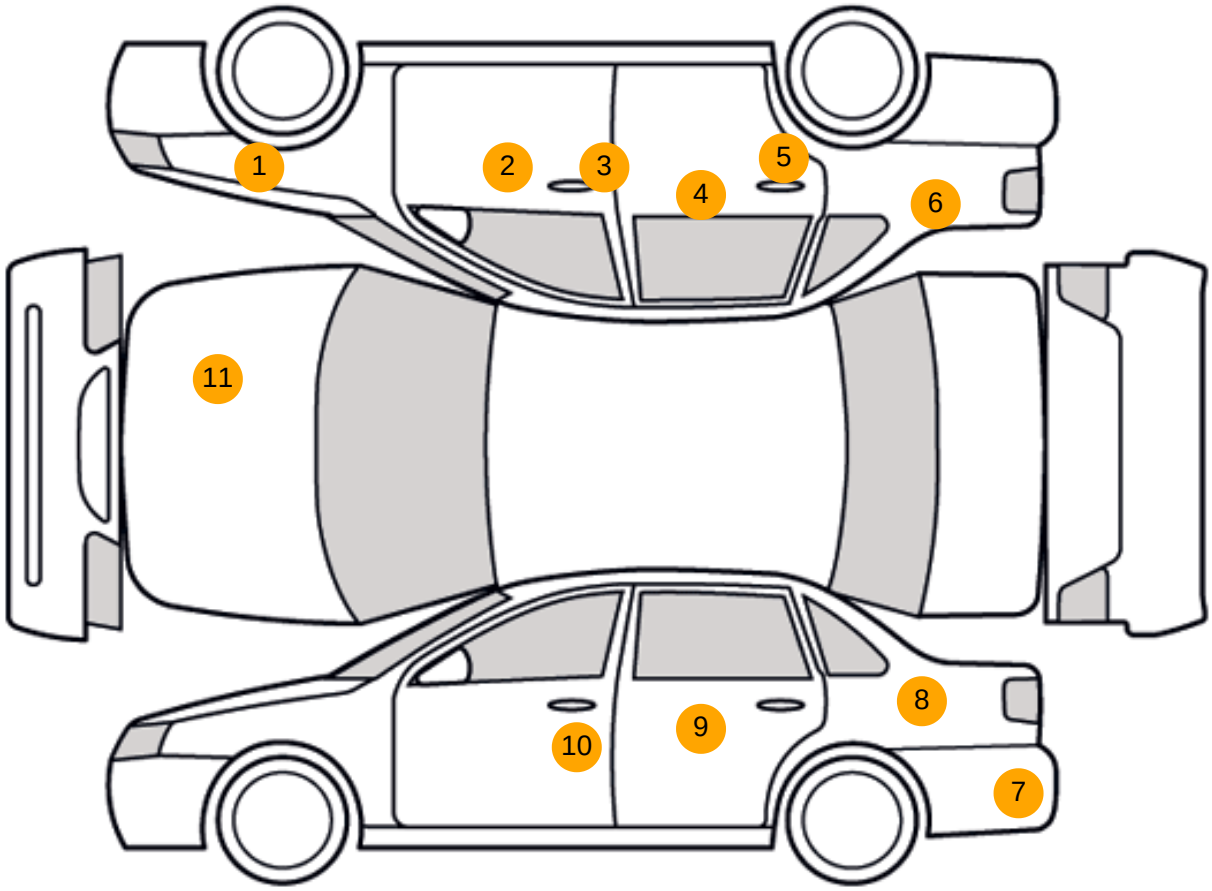
1: Wing osf
Chipped
1 To 5

2: Door osf
Chipped
1 To 5

3: Door osf
Chipped
Edge Chip

4: Door osr
Dented
2 Or Less UpTo 10mm

5: Door osr
Chipped
Edge Chip

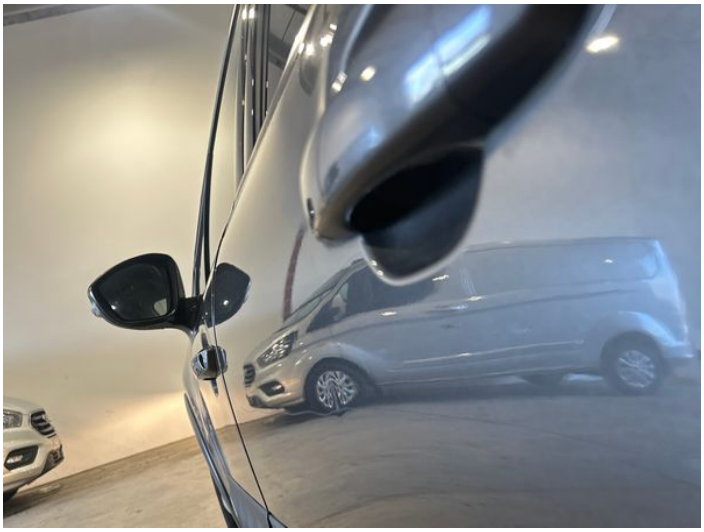
6: Qtr Panel osr
Dented
Between 10mm + 30mm

7: Bumper Rear
Chipped
1 To 5

8: Qtr Panel nsr
Poor Previous Repair
Poor Paint

9: Door nsr
Dented
Between 10mm + 30mm

10: Door nsf
Chipped
1 To 5

11: Bonnet
Chipped
1 To 5

12: Tyre nsf
Damaged
Replace
