VEHICLE INSPECTION REPORT

CY17PXU

Volvo XC60 D5 [220] SE Lux Nav 5dr AWD Geartronic

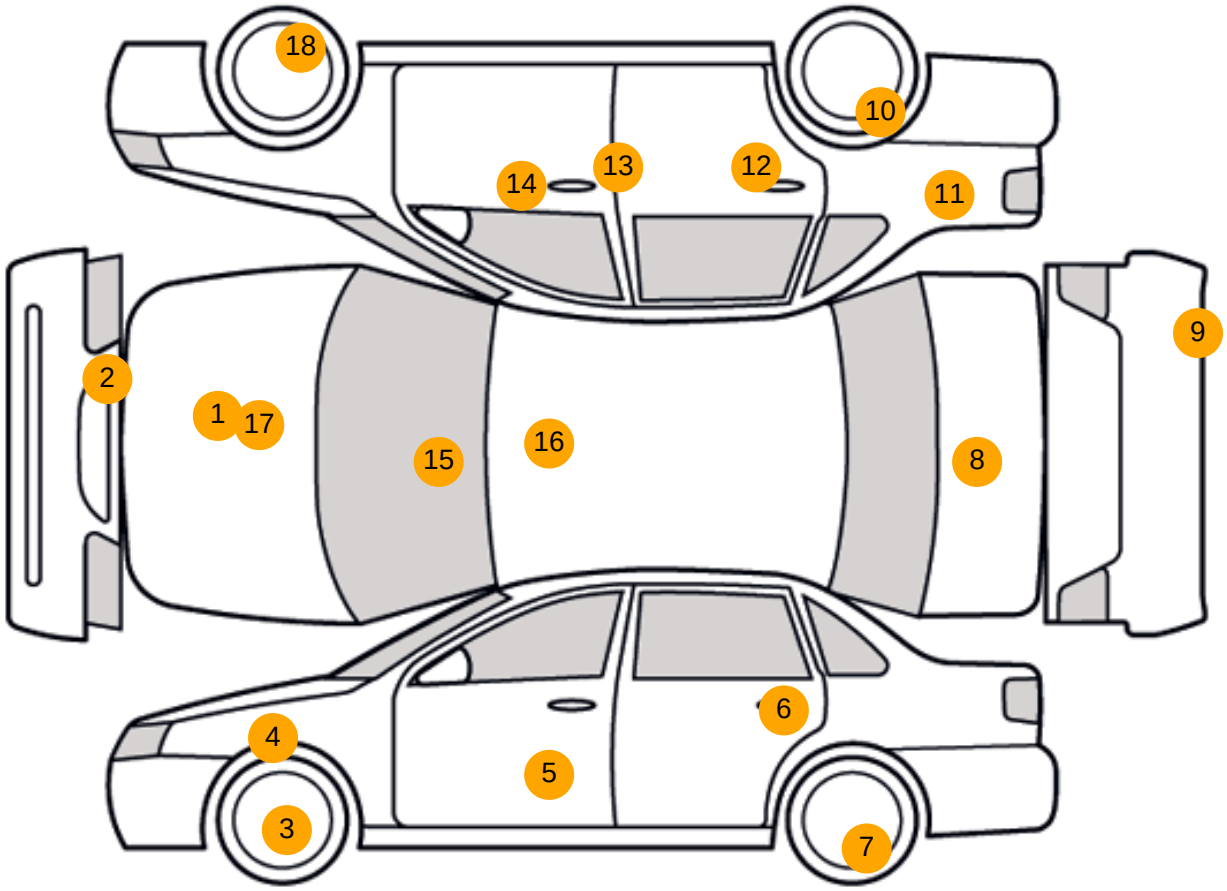
Condition Check

1: Bonnet
Chipped
1 To 5

2: Bumper Front
Scratched
25 to 100mm Thru Paint

3: Wheel nsf
Scratched
Over 50mm

4: Wing nsf
Chipped
1 To 5

9: Bumper Rear
Poor Previous Repair
Poor Paint

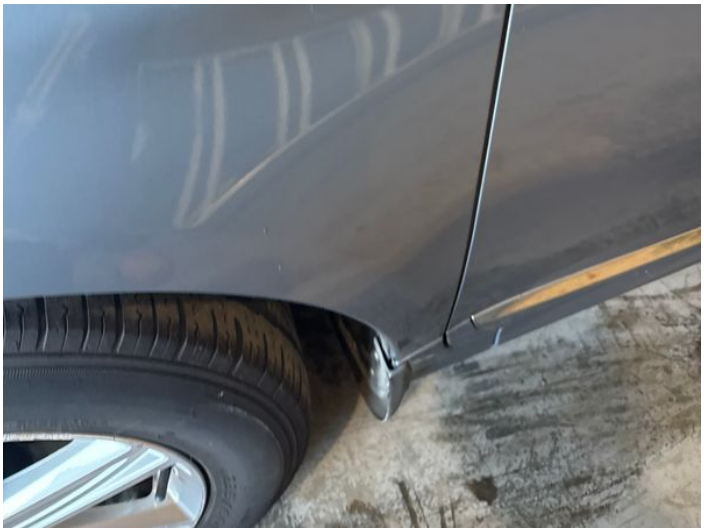
5: Door nsf
Scratched
UpTo 25mm Thru Paint

6: Door nsr
Scratched
Over 25mm Thru Paint

7: Wheel nsr
Scratched
Up To 50mm

8: Tailgate
Chipped
1 To 5

10: Wheel osr
Scratched
Over 50mm

11: Qtr Panel osr
Scratched
UpTo 25mm Thru Paint

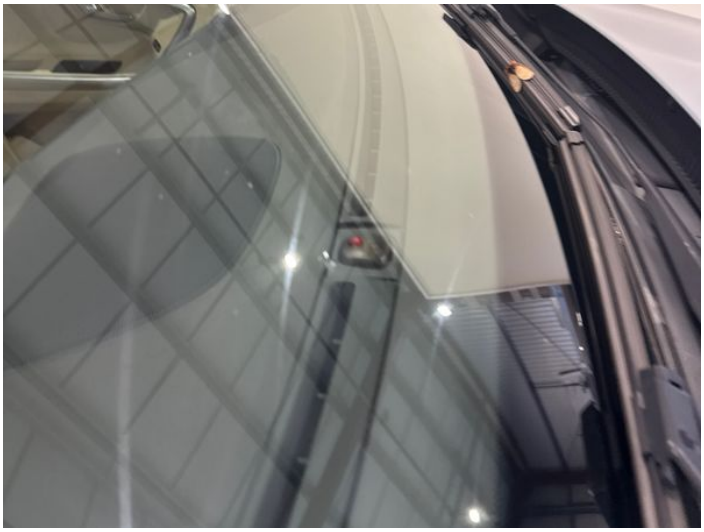
12: Door osr
Chipped
1 To 5

13: Door osf
Dented
Between 10mm + 30mm

14: Door osf
Chipped
1 To 5

15: Screen Front
Chipped
UpTo 10mm

16: Roof
Chipped
Edge Chip

17: Bonnet
Dented
Over 30mm

18: Wheel osf
Scratched
Up To 50mm
