VEHICLE INSPECTION REPORT

BK13ETA

Honda CR-V 2.0 i-VTEC S 5dr 2WD

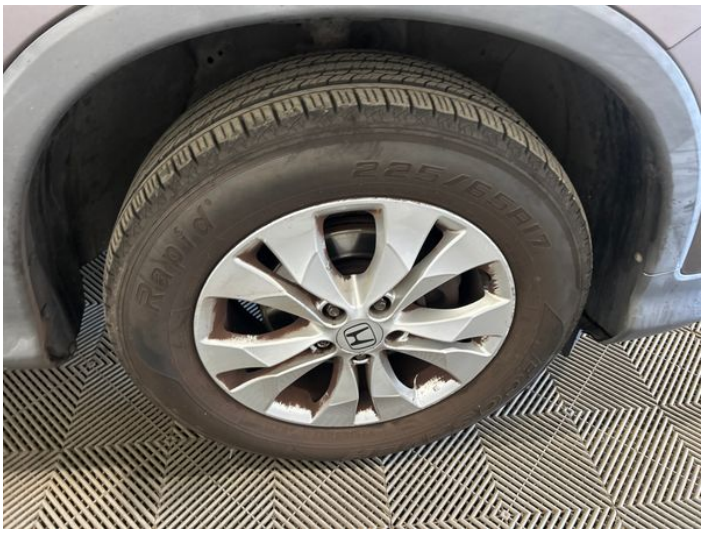
1: Wing osf
Chipped
1 To 5

2: Wheel osf
Scratched
Over 50mm

3: Door osf
Chipped
1 To 5

4: Door osr
Scratched
Over 25mm Thru Paint

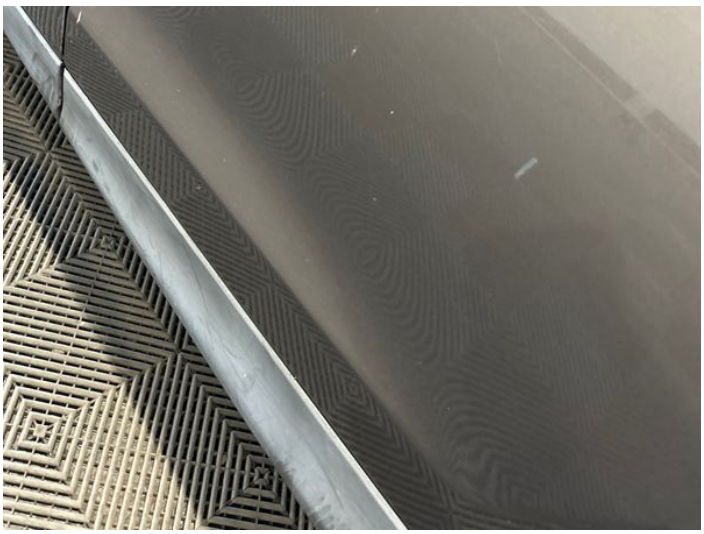
5: Wheel osr
Corroded
Light

6: Qtr Panel nsr
Chipped
1 To 5

7: Wheel nsr
Corroded
Light

8: Door nsr
Chipped
Multiple Chips

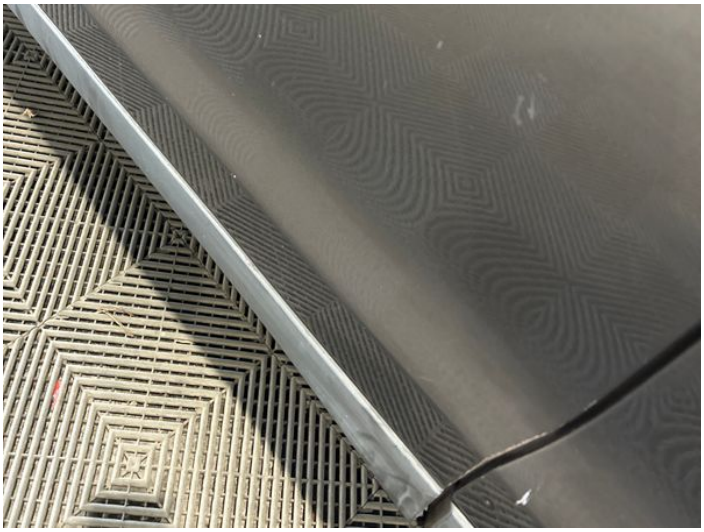
9: Door nsf
Chipped
Edge Chip

10: Door nsf
Chipped
1 To 5

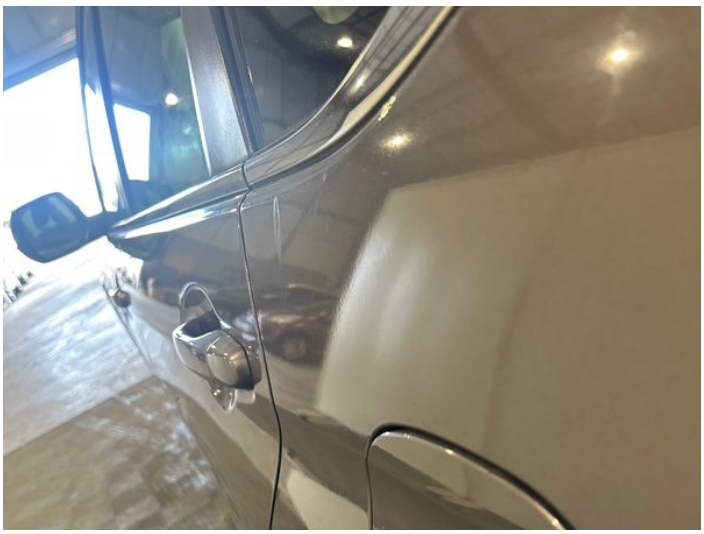
11: Wheel nsf
Scratched
Over 50mm

12: Bumper Front
Poor Previous Repair
Paint Flake

13: Bonnet
Chipped
1 To 5

14: Qtr Panel nsr
Dented
2 Or Less UpTo 10mm
