VEHICLE INSPECTION REPORT

DP73TFX

Vauxhall Corsa 1.2 Turbo GS 5dr

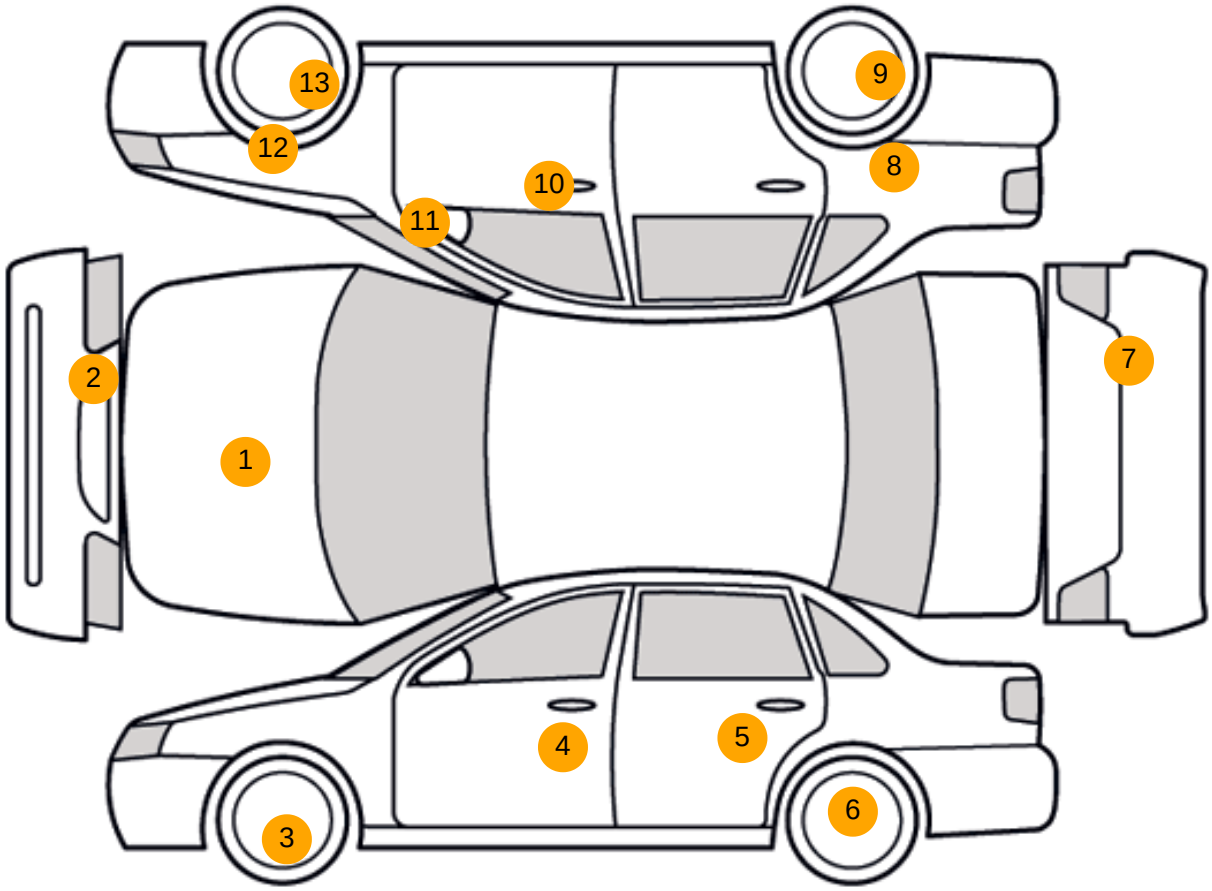
Condition Check

Engine Runs	OK	Gearbox 1st and Reverse Test	OK
Brakes	OK	Clutch Slip Test from Static	OK
Turbo Boosting	OK	Gearbox Static Gear Selection (engine running)	OK
Parking Brake	OK	No Excessive Smoking	OK
EML light illuminated	OK	Oil warning light illuminated	OK
Airbag light illuminated	OK	Service indicator light illuminated	OK
ABS light illuminated	OK		
Windows	OK	Radio	OK
		Steering	OK

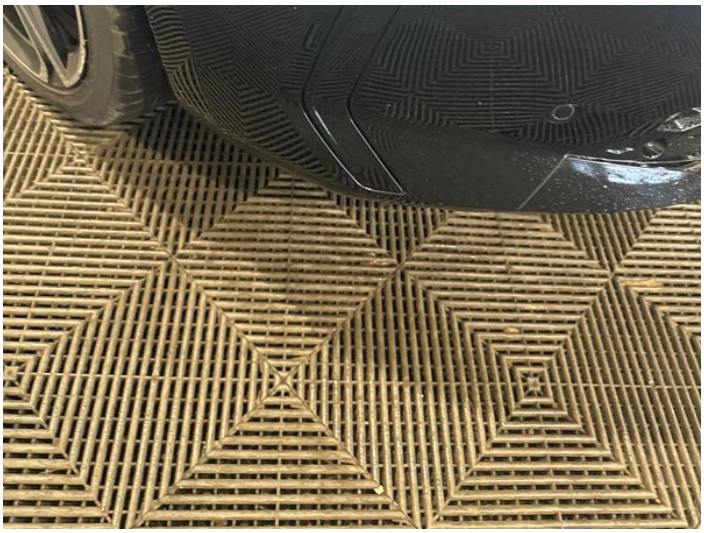
Damage Photos

1: Bonnet
Scratched
Over 25mm Thru Paint

2: Bumper Front
Chipped
1 To 5

3: Wheel nsf
Scratched
Over 50mm

4: Door nsf
Scratched
Over 25mm Thru Paint

5: Door nsr
Poor Previous Repair
Rippled UpTo 30%

6: Wheel nsr
Scratched
Over 50mm

7: Bumper Rear
Scratched
Up To 25mm Thru Paint

8: Qtr Panel osr
Chipped
1 To 5

9: Wheel osr
Scratched
Up To 50mm

10: Door osf
Chipped
Edge Chip

11: Door Mirror Assy osf
Scratched (Painted)
UpTo 25mm Thru Paint

12: Wing osf
Chipped
1 To 5

13: Wheel osf
Scratched
Over 50mm
