VEHICLE INSPECTION REPORT

LO70DXC

Nissan Qashqai 1.3 DiG-T 160 [157] N-Connecta 5dr DCT Glass Roof

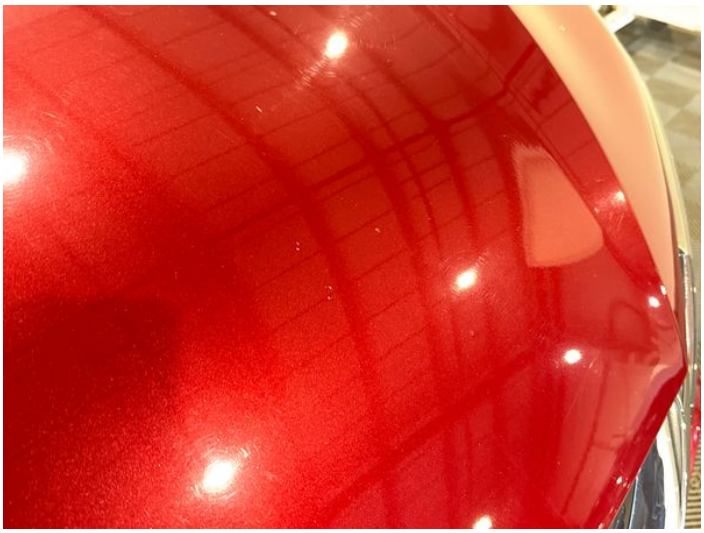
1: Bonnet
Chipped
Multiple Chips

2: Bumper Front
Scratched
25 to 100mm Thru Paint

3: Bumper Front
Scratched
25 to 100mm Thru Paint

4: Wing nsf
Chipped
1 To 5

5: Wheel nsf
Scratched
Up To 50mm

6: Door nsf
Chipped
Edge Chip

7: Door nsr
Chipped
1 To 5

8: Wheel nsr
Scratched
Over 50mm

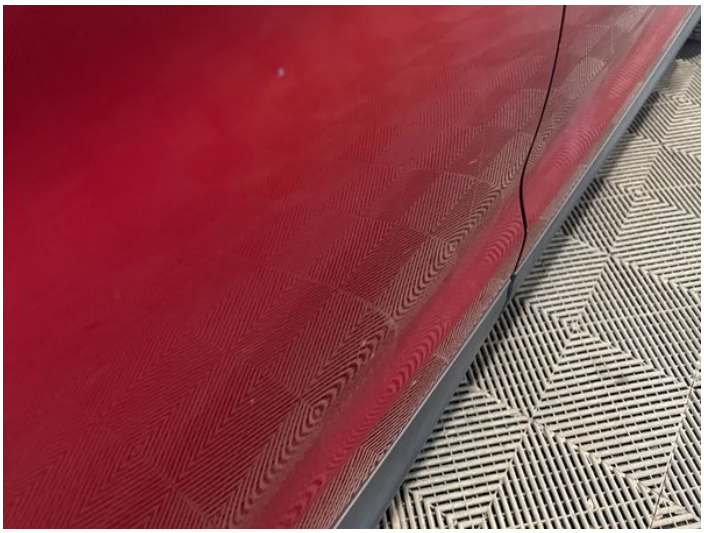
9: Qtr Panel nsr
Poor Previous Repair
Paint Flake

10: Bumper Rear
Scratched
25 to 100mm Thru Paint

11: Wheel osr
Scratched
Up To 50mm

12: Door osr
Dented
2 Or Less UpTo 10mm

13: Door osr
Chipped
1 To 5

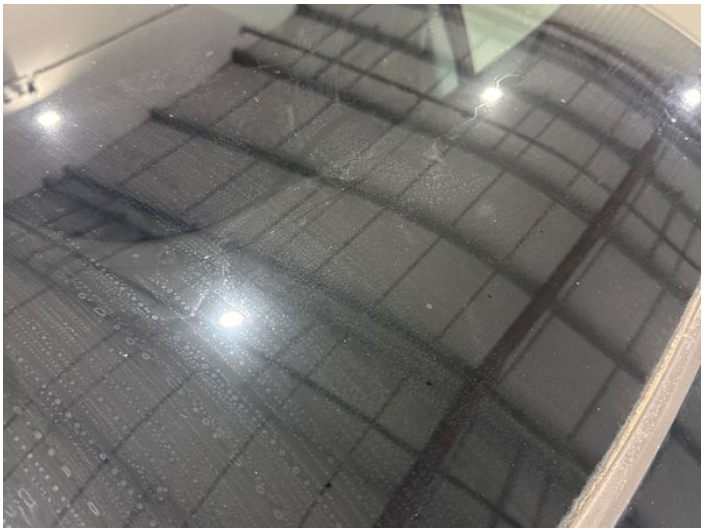
14: Door osf
Chipped
Edge Chip

15: Glass Roof
Cracked
Replace

16: Lamp osr
Broken
Replace
