VEHICLE INSPECTION REPORT

BG18GJF

Nissan Qashqai 1.2 DiG-T N-Connecta 5dr

Eastbourne Car Auctions

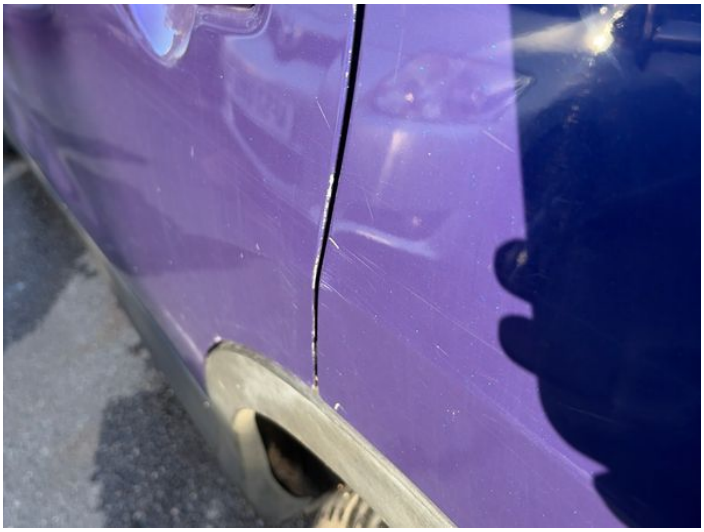
Damage Photos

1: Wing nsf
Chipped
1 To 5

2: Door nsf
Chipped
Multiple Chips

3: Door nsr
Chipped
1 To 5

4: Door nsr
Chipped
Edge Chip

5: Qtr Panel nsr
Scratched
UpTo 25mm Thru Paint

6: Tailgate
Chipped
1 To 5

7: Qtr Panel osr
Scratched
Over 25mm Thru Paint

8: Door osr
Dented
With Paint Damage

9: Door osf
Chipped
1 To 5

10: Door osf
Chipped
Edge Chip

11: Wing osf
Scratched
UpTo 25mm Thru Paint

12: Wing osf
Chipped
1 To 5

13: Bumper Front
Chipped
Multiple Chips

14: Bonnet
Chipped
1 To 5

15: Wheel nsf
Scratched
Over 50mm
