VEHICLE INSPECTION REPORT

DE14HTN

Vauxhall Insignia 2.0 CDTi [163] ecoFLEX Elite Nav 5dr [Start Stop]

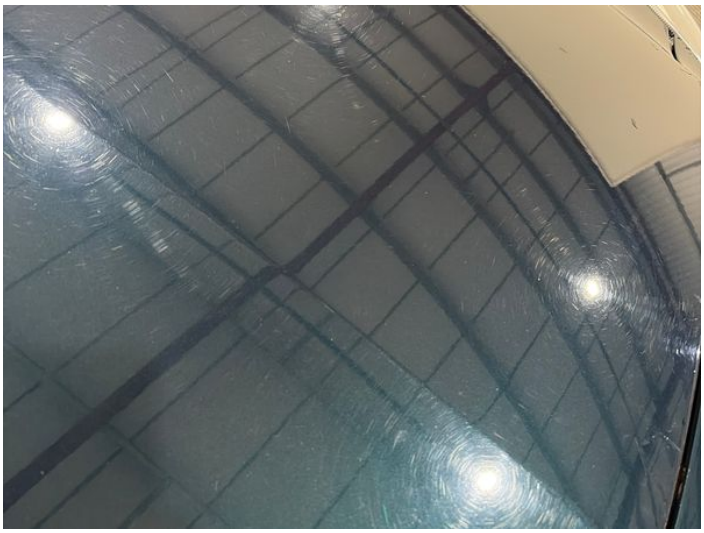
1: Wheel osf
Scratched
Over 50mm

2: Wheel osr
Scratched
Over 50mm

3: Tailgate
Scratched
Over 25mm Thru Paint

4: Wheel nsr
Scratched
Over 50mm

5: Door nsr
Dented
With Paint Damage

6: Door nsf
Dented
With Paint Damage

7: Wheel nsf
Scratched
Over 50mm

8: Bumper Front
Chipped
Multiple Chips

9: Bumper Front
Scratched
25 to 100mm Thru Paint

11: Door osr
Scratched
UpTo 25mm Thru Paint

12: Qtr Panel osr
Chipped
1 To 5

13: Qtr Panel osr
Dented
2 Or Less UpTo 10mm

14: Bumper Rear
Chipped
Multiple Chips

15: Bumper Rear
Scratched
25 to 100mm Thru Paint

16: Sill ns
Dented
With Paint Damage

17: Bonnet
Chipped
1 To 5

18: Door osf
Scratched
UpTo 25mm Thru Paint
