VEHICLE INSPECTION REPORT

EU65YPG

Ford Ecosport 1.0 EcoBoost Zetec 5dr

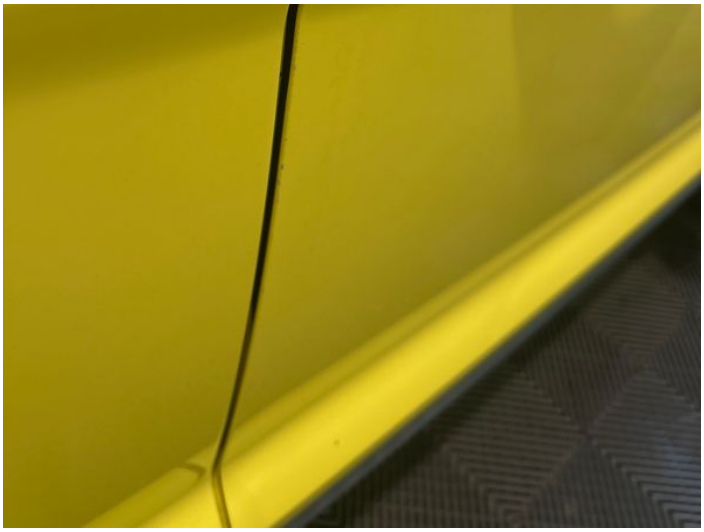
Condition Check

1: Wheel osf
Scratched
Up To 50mm

2: A Post os
Chipped
1 To 5

3: Door osf
Chipped
Edge Chip

4: Door osf
Chipped
1 To 5

5: Door osr
Chipped
Edge Chip

6: Qtr Panel osr
Dented
With Paint Damage

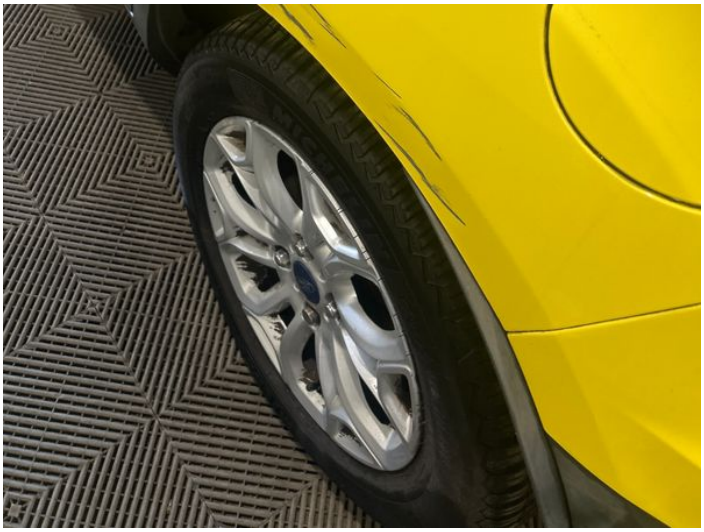
7: Tailgate
Dented
With Paint Damage

8: Bumper Rear
Scratched
Over 100mm Thru Paint

9: Bumper Rear Moulding
Broken
Replace

10: Qtr Panel nsr
Dented
With Paint Damage

11: Wheel nsr
Scratched
Up To 50mm

12: Door nsr
Scratched
Over 25mm Thru Paint

13: Door Mirror Assy nsf
Scratched (Painted)
Over 25mm Thru Paint

14: Wheel nsf
Scratched
Up To 50mm

15: Wing nsf
Dented
With Paint Damage

16: Bumper Front
Scratched
Over 100mm Thru Paint

17: Bonnet
Chipped
Multiple Chips

18: Roof
Chipped
1 To 5

19: Door nsf
Dented
Over 30mm
