VEHICLE INSPECTION REPORT

SM14VMW

BMW X1 xDrive 18d xLine 5dr

Eastbourne Car Auctions

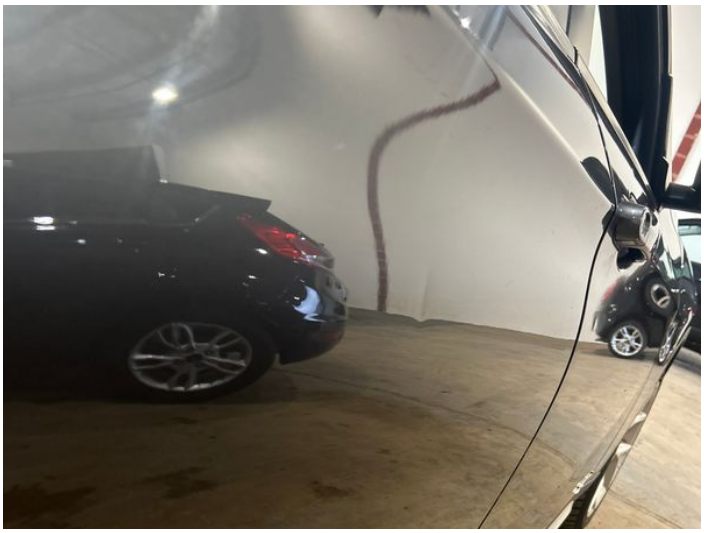
1: Wing osf
Dented
With Paint Damage

2: Wheel osf
Scratched
Over 50mm

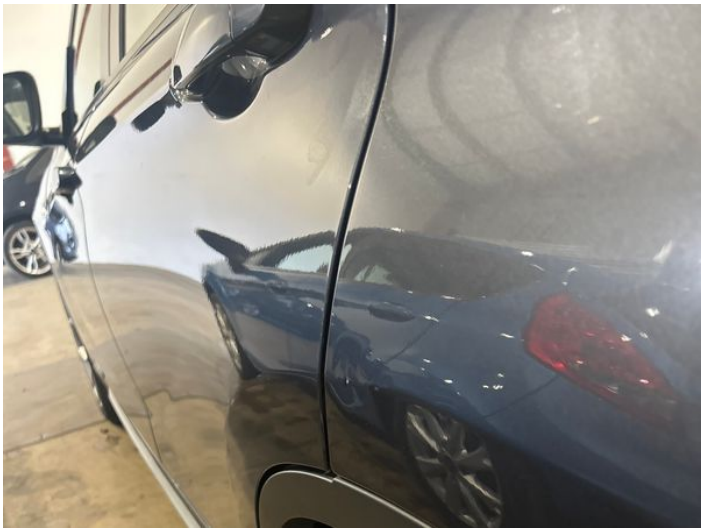
3: Door osf
Chipped
1 To 5

4: Door osf
Chipped
Edge Chip

5: Door osr
Chipped
1 To 5

6: Door osr
Dented
Between 10mm + 30mm
