VEHICLE INSPECTION REPORT

GJ65XVA

Peugeot 3008 1.6 BlueHDi 120 Allure 5dr EAT6

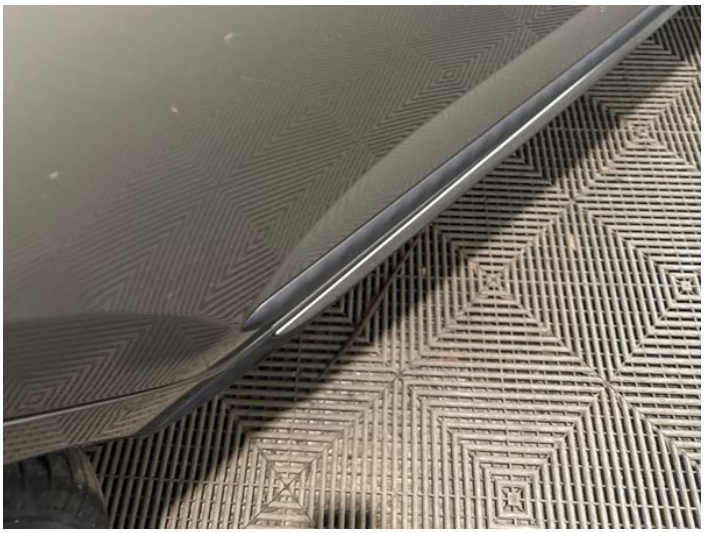
1: Bonnet
Chipped
1 To 5

2: Bumper Front
Chipped
1 To 5

3: Wheel nsf
Scratched
Over 50mm

4: Wing nsf
Chipped
1 To 5

5: Door nsf
Scratched
Over 25mm Thru Paint

6: Door nsr
Scratched
Over 25mm Thru Paint

7: Wheel nsr
Scratched
Over 50mm

8: Qtr Panel nsr
Dented
Between 10mm + 30mm
