VEHICLE INSPECTION REPORT

LE19WYZ

Ford Transit Custom 2.0 EcoBlue 105ps Low Roof D/Cab Trend Van

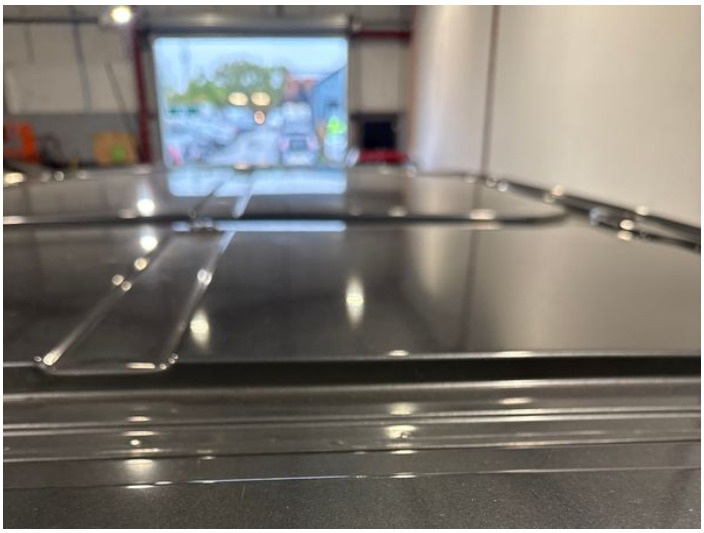
1: Bonnet
Dented
Between 10mm + 30mm

2: Bonnet
Chipped
Multiple Chips

3: Bumper Front
Scratched
Over 100mm Thru Paint

4: Wing nsf
Chipped
1 To 5

5: Door nsf
Dented
With Paint Damage

6: Tyre nsr
Damaged
Replace

7: Door nsr
Dented
Between 10mm + 30mm

8: Door nsr
Scratched
Over 25mm Thru Paint

9: Qtr Panel nsr
Dented
2 Or Less UpTo 10mm

10: Qtr Panel nsr
Chipped
1 To 5

11: Tailgate
Dented
With Paint Damage

12: Roof
Dented
Between 10mm + 30mm

13: Qtr Panel osr
Scratched
Over 25mm Thru Paint

14: Panel Front
Dented
Over 30mm

15: Door osf
Scratched
Over 25mm Thru Paint

16: Wing osf
Chipped
1 To 5

17: Door Mirror Assy osf
Scratched (Painted)
UpTo 25mm Thru Paint
