VEHICLE INSPECTION REPORT

GK70ASZ

Audi A3 30 TFSI S Line 5dr

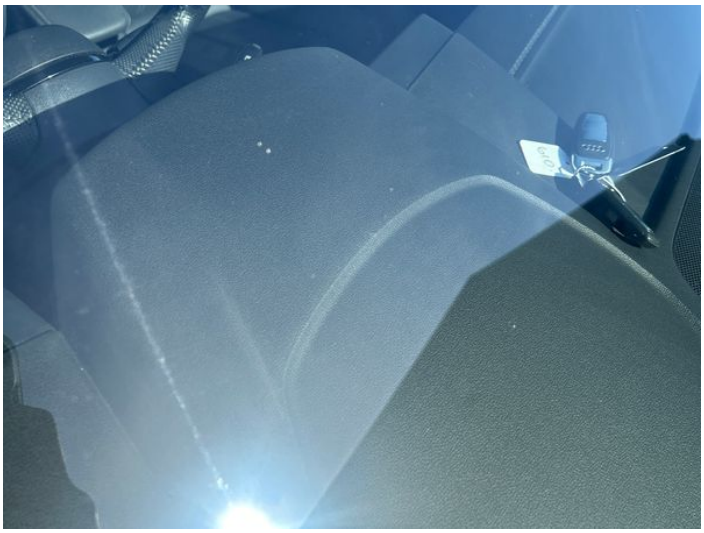
1: Wheel osf
Scratched
Over 50mm

2: Door osf
Chipped
1 To 5

3: Door osr
Scratched
Over 25mm Thru Paint

4: Wheel osr
Scratched
Over 50mm

5: Qtr Panel osr
Dented
With Paint Damage

6: Bumper Rear
Scratched
Over 100mm Thru Paint

7: Qtr Panel nsr
Scratched
Over 25mm Thru Paint

8: Wheel nsr
Scratched
Over 50mm

9: Door nsf
Scratched
Over 25mm Thru Paint

10: Sill Panel Trim ns
Scratched (Painted)
Over 25mm Thru Paint

11: Door nsr
Scratched
UpTo 25mm Thru Paint

12: Wheel nsf
Scratched
Over 50mm

13: Wing nsf
Chipped
1 To 5

14: Bumper Front
Cracked
Over 25mm

15: Bumper Front Grill
Broken
Replace

16: Bonnet
Chipped
1 To 5

17: Screen Front
Chipped
UpTo 10mm

18: Roof
Scratched
Over 25mm Thru Paint

19: Tyre osf
Damaged
Replace
