VEHICLE INSPECTION REPORT

WF67JPX

Kia Sportage 1.7 CRDi ISG 3 5dr

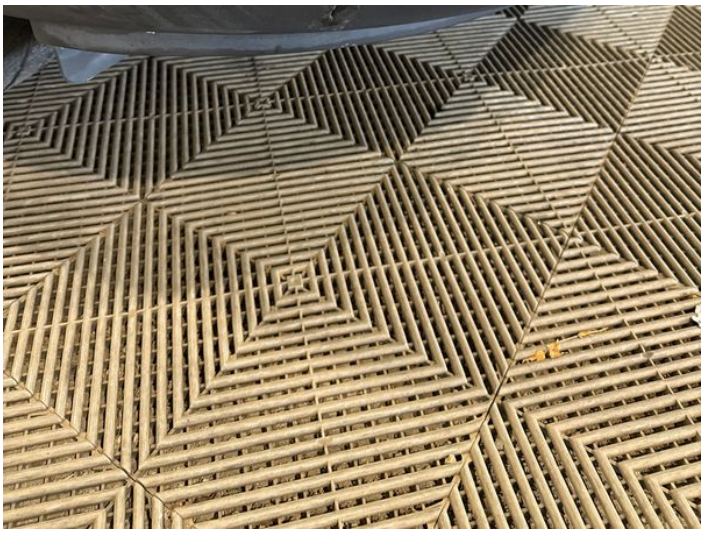
1: Bumper Front
Cracked
UpTo 25mm

2: Bumper Front Moulding
Broken
Replace

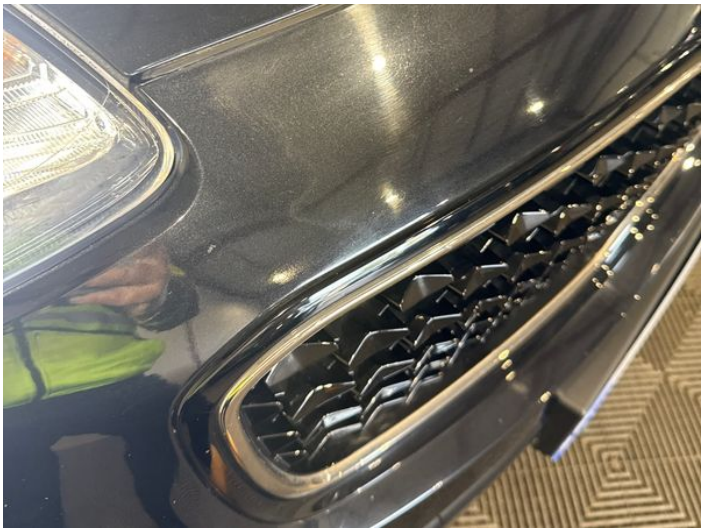
3: Bumper Front
Poor Previous Repair
Poor Paint

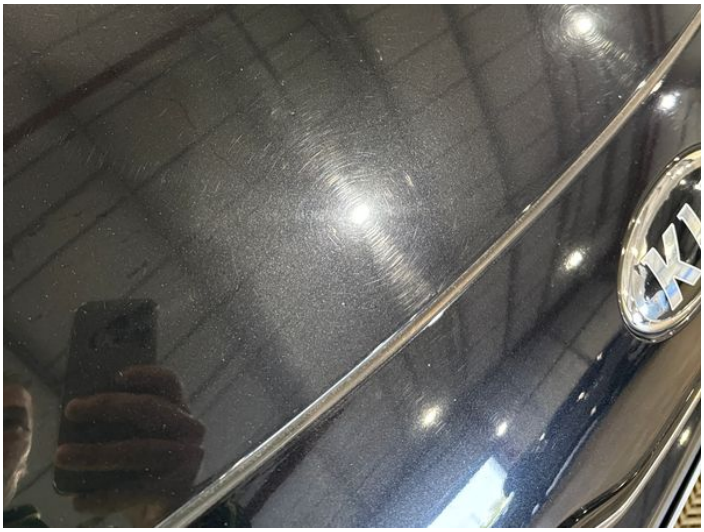
4: Bonnet
Chipped
1 To 5

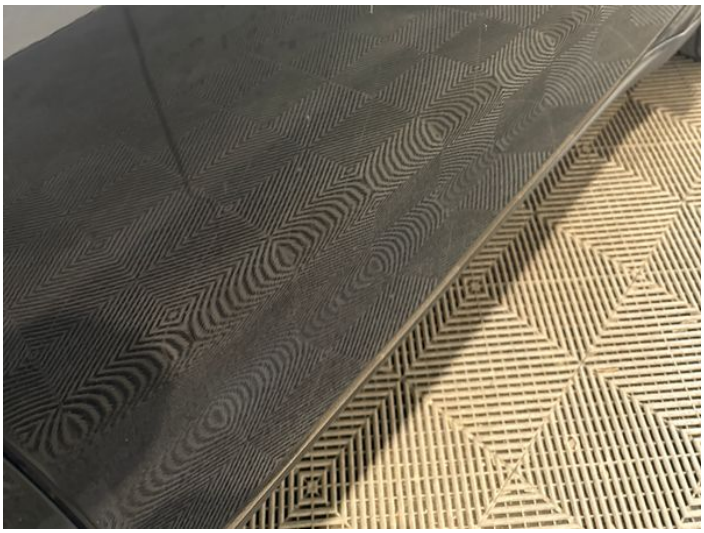
17: Door osr
Scratched
UpTo 25mm Thru Paint
