VEHICLE INSPECTION REPORT

GH19NTD

Skoda Octavia 1.0 TSI SE Technology 5dr DSG

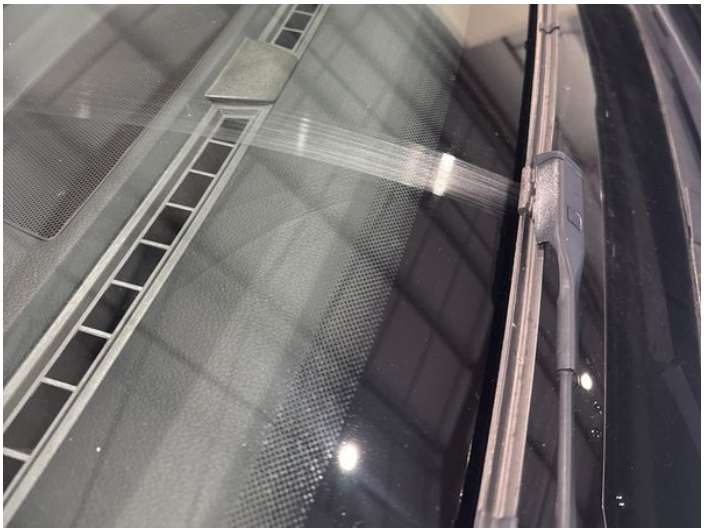
1: Bonnet
Chipped
Multiple Chips

2: Bumper Front
Poor Previous Repair
Poor Paint

3: Wing nsf
Poor Previous Repair
Poor Paint

4: Door nsf
Chipped
Edge Chip

5: Bumper Rear
Scratched
25 to 100mm Thru Paint

6: Door osr
Chipped
Edge Chip

7: Door osf
Chipped
Edge Chip

8: Wing osf
Chipped
1 To 5

9: Screen Front
Scratched
Over 30mm
