VEHICLE INSPECTION REPORT

AV65XOS

Ford Focus 1.0 EcoBoost 125 Titanium 5dr

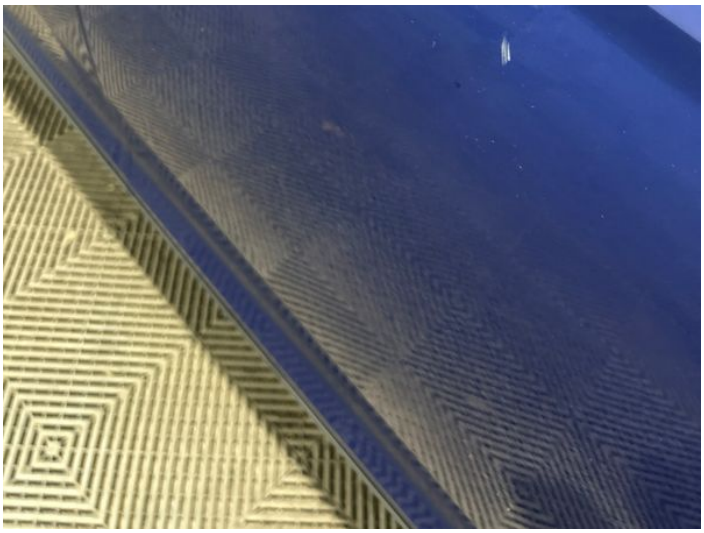
1: Wing osf
Chipped
1 To 5

2: Door osf
Chipped
1 To 5

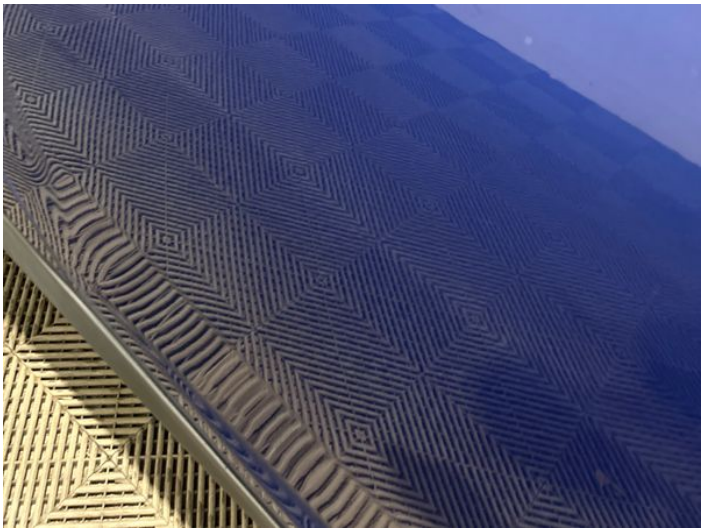
3: Door osr
Chipped
1 To 5

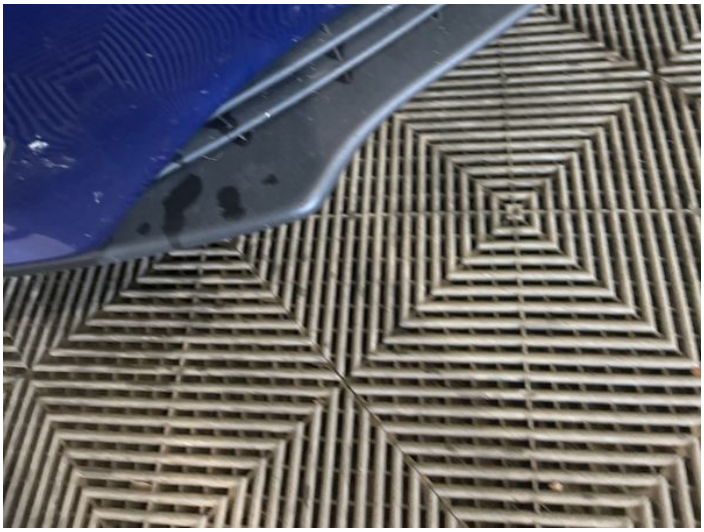
4: Bumper Front
Scratched
UpTo 25mm Thru Paint

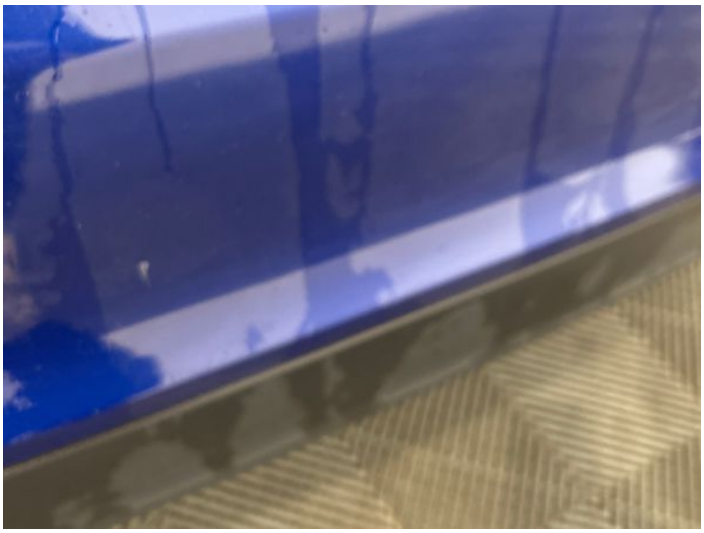
5: Bonnet
Chipped
Multiple Chips

6: Bumper Rear
Chipped
1 To 5

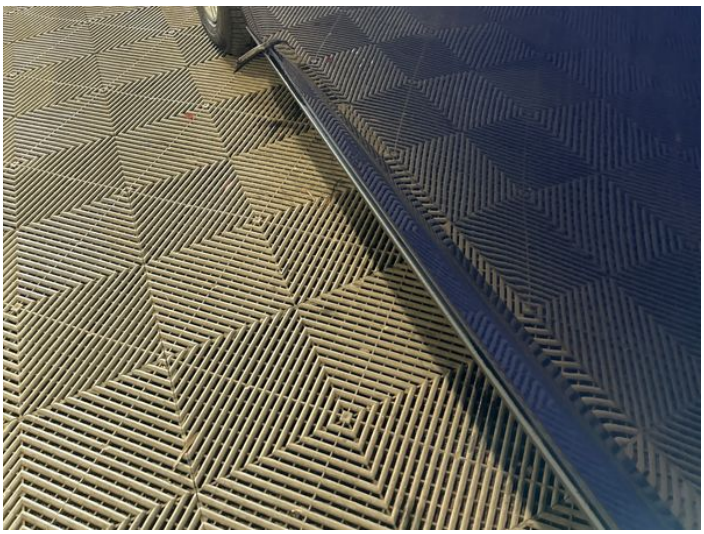
7: Door nsf
Dented
Over 30mm
