VEHICLE INSPECTION REPORT

VU63KKX

Volkswagen Golf 2.0 TDI SE 5dr

nama GRADE 4

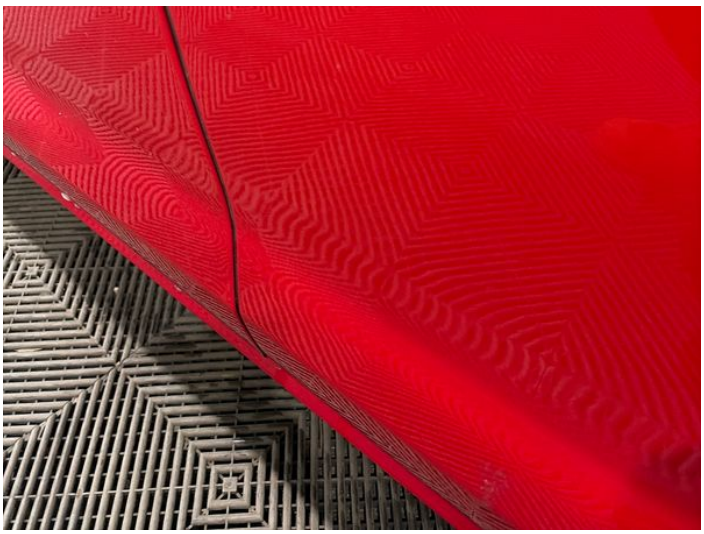
1: Bonnet
Chipped
Multiple Chips

2: Bumper Front
Poor Previous Repair
Paint Flake

3: Wing nsf
Chipped
1 To 5

4: Wheel nsf
Scratched
Over 50mm

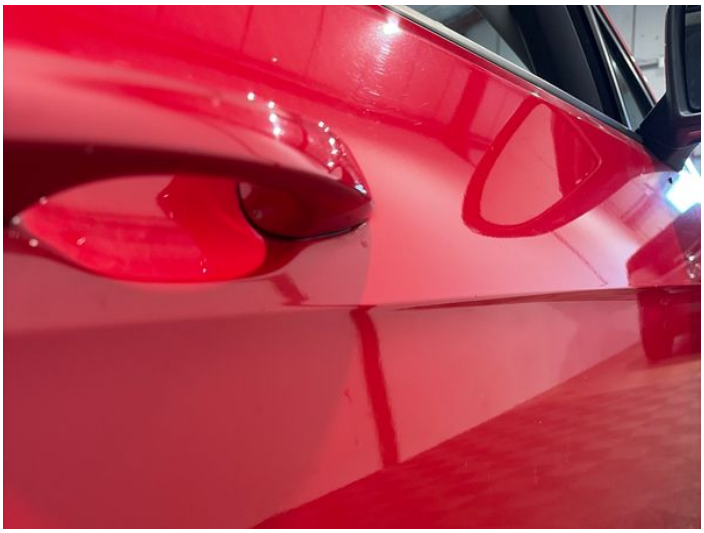
5: A Post ns
Chipped
1 To 5

6: Roof
Chipped
Edge Chip

7: Door nsf
Dented
With Paint Damage

8: Door nsr
Chipped
1 To 5

9: Qtr Panel nsr
Rusted
Over 5mm

10: Wheel nsr
Scratched
Over 50mm

11: Bumper Rear
Scratched
25 to 100mm Thru Paint

12: Boot Lid
Scratched
UpTo 25mm Thru Paint

13: Qtr Panel osr
Dented
Between 10mm + 30mm
