VEHICLE INSPECTION REPORT

VN12KWJ

Nissan Note 1.4 N-Tec+ 5dr

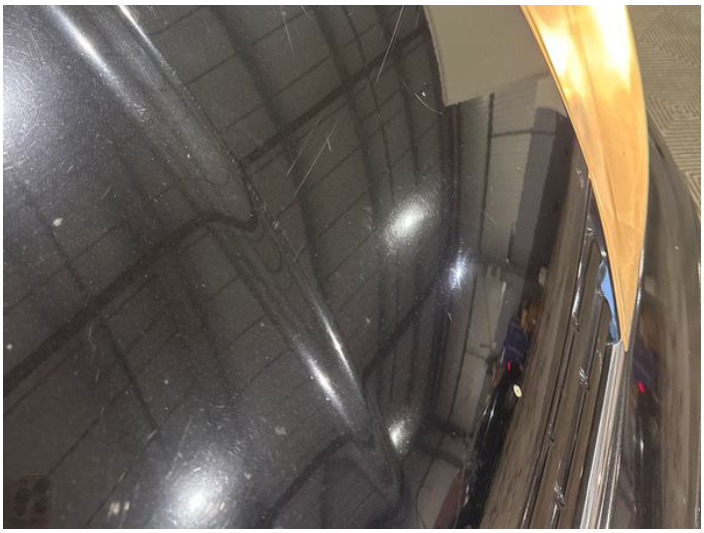
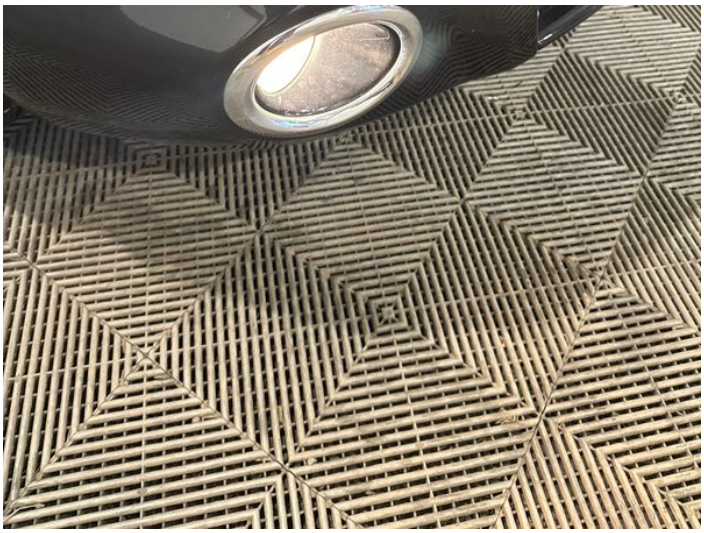
1: Bonnet
Scratched
Over 25mm Thru Paint

2: Bumper Front
Scratched
25 to 100mm Thru Paint

3: Bumper Front
Chipped
1 To 5

4: Wheel nsf
Scratched
Over 50mm

5: Wing nsf
Scratched
Over 25mm Thru Paint

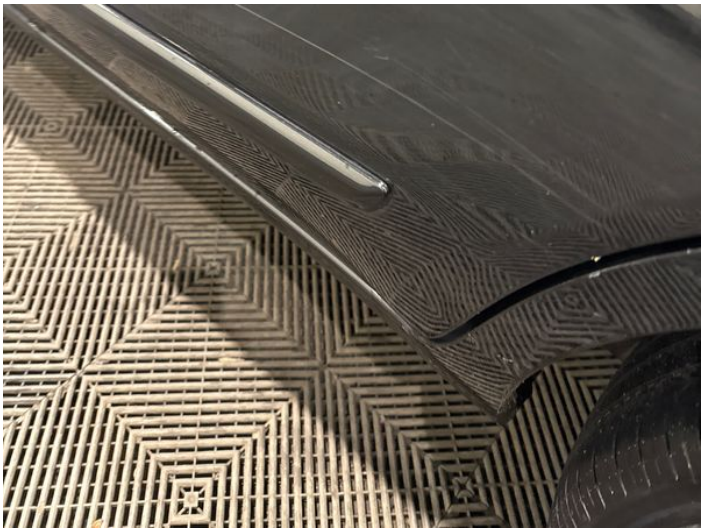
6: Door Mirror Assy nsf
Scratched (Painted)
UpTo 25mm Thru Paint

7: A Post ns
Scratched
UpTo 25mm Thru Paint

8: Door nsf
Scratched
Over 25mm Thru Paint

9: Door nsr
Scratched
Over 25mm Thru Paint

10: Qtr Panel nsr
Dented
With Paint Damage

11: Wheel nsr
Scratched
Over 50mm

12: Bumper Rear
Scratched
25 to 100mm Thru Paint

13: Boot Lid
Dented
With Paint Damage

14: Qtr Panel osr
Scratched
Over 25mm Thru Paint

15: Wheel osr
Scratched
Over 50mm

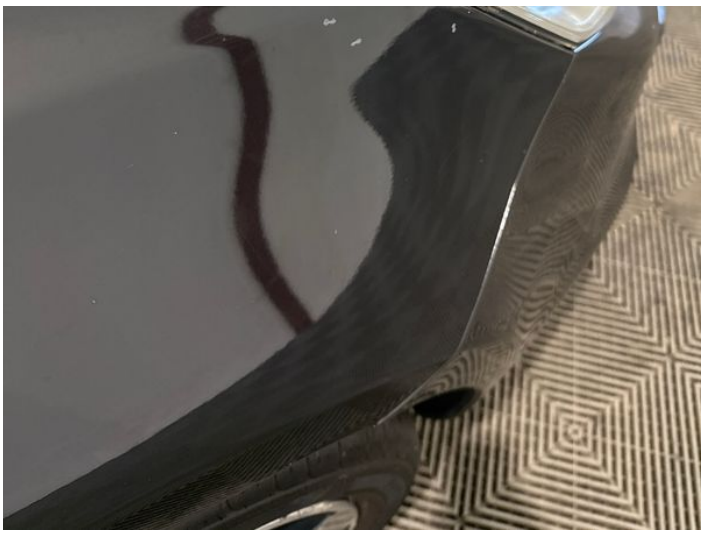
16: Sill os
Dented
Between 10mm + 30mm

17: Door osr
Scratched
Over 25mm Thru Paint

18: Door osf
Scratched
Over 25mm Thru Paint

19: Wing osf
Chipped
1 To 5

20: Wheel osf
Scratched
Over 50mm

21: Roof
Chipped
Edge Chip

22: Tyre osr
Damaged
Replace
