VEHICLE INSPECTION REPORT

LY19KWN

Ford Ecosport 1.0 EcoBoost 125 Titanium 5dr Auto

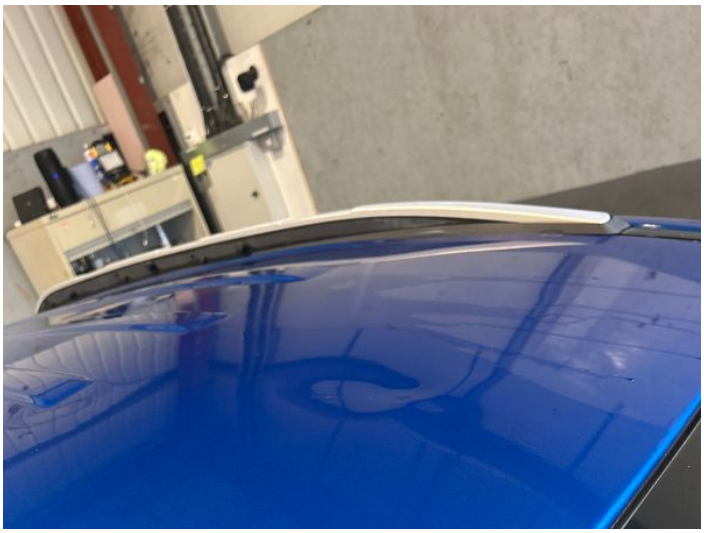
Damage Photos

1: Wheel osf
Scratched
Over 50mm

2: Door osf
Scratched
Over 25mm Thru Paint

3: Door osr
Chipped
1 To 5

4: Wheel osr
Scratched
Up To 50mm

5: Wheel nsr
Scratched
Up To 50mm

6: Door nsf
Scratched
Over 25mm Thru Paint

7: Wing nsf
Poor Previous Repair
Poor Paint

8: Bumper Front
Scratched
UpTo 25mm Thru Paint

9: Bonnet
Poor Previous Repair
Poor Paint

10: Door nsr
Poor Previous Repair
Poor Paint

11: Roof
Dented
Over 30mm
