VEHICLE INSPECTION REPORT

SB63DAB

Volkswagen Tiguan 2.0 TDi BlueMotion Tech R-Line 5dr

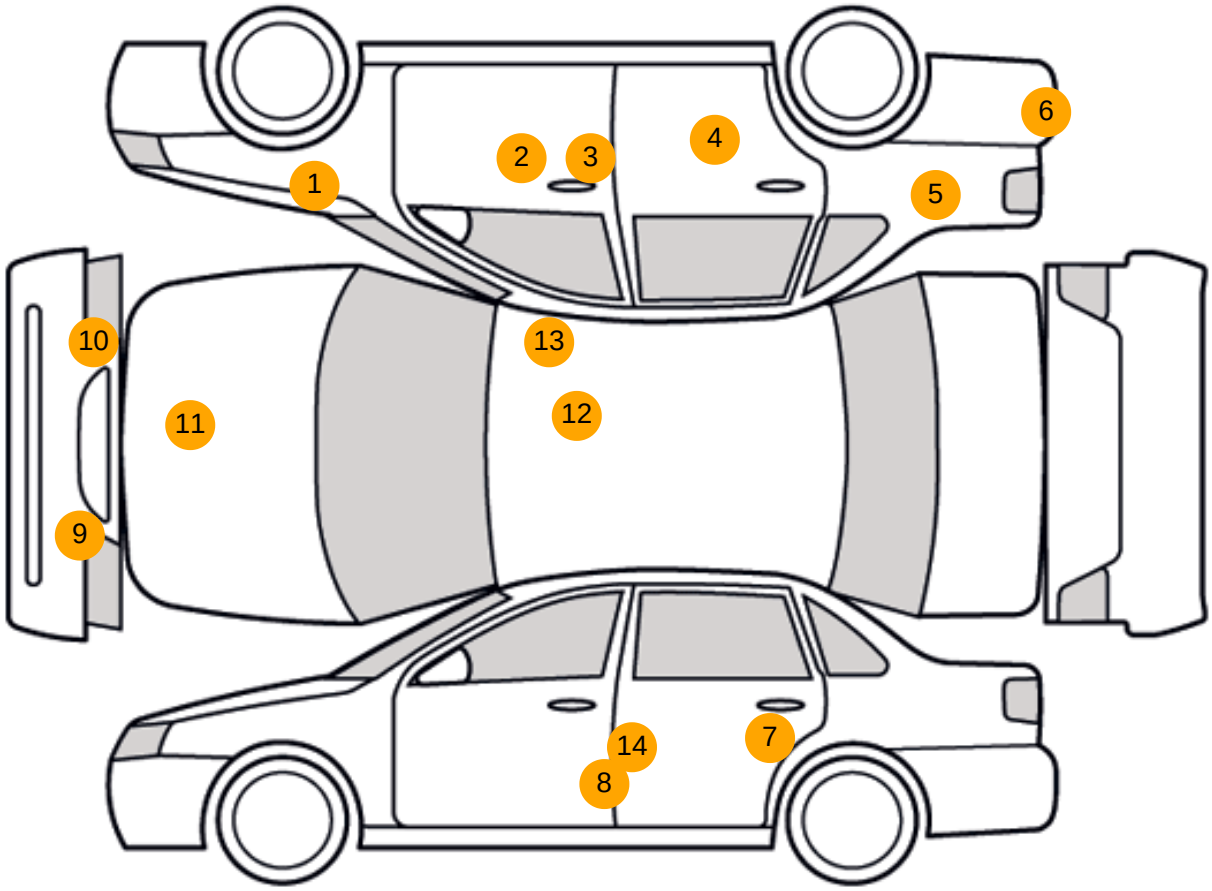
1: Wing osf
Poor Previous Repair
Poor Paint

2: Door osf
Dented
Between 10mm + 30mm

3: Door osf
Chipped
Edge Chip

4: Door osr
Dented
Between 10mm + 30mm

5: Qtr Panel osr
Chipped
1 To 5

6: Bumper Rear
Cracked
Over 25mm

7: Door nsr
Dented
Over 30mm

10: Bumper Front
Chipped
Multiple Chips

11: Bonnet
Chipped
1 To 5

12: Roof
Chipped
1 To 5

13: Roof
Rusted
UpTo 5mm

14: Door nsf
Dented
Over 30mm
