VEHICLE INSPECTION REPORT

AK13FPA

Volkswagen Passat 2.0 TDI Bluemotion Tech Sport 4dr

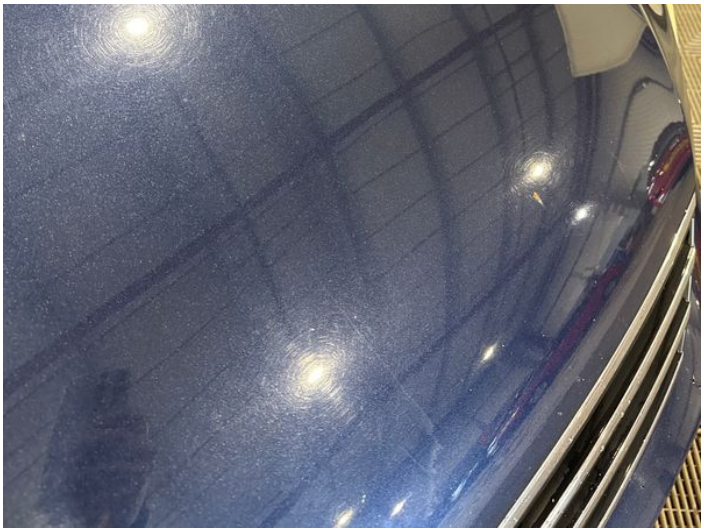
1: Door Pad osf
Scuffed
Over 25mm

2: Tyre nsf
Damaged
Replace

3: Bonnet
Chipped
Multiple Chips

4: Bumper Front
Scratched
Over 100mm Thru Paint

5: Door Mirror Assy nsf
Broken
Replace

6: Flasher Side Repeater ns
Broken
Replace

7: Wheel nsf
Scratched
Over 50mm

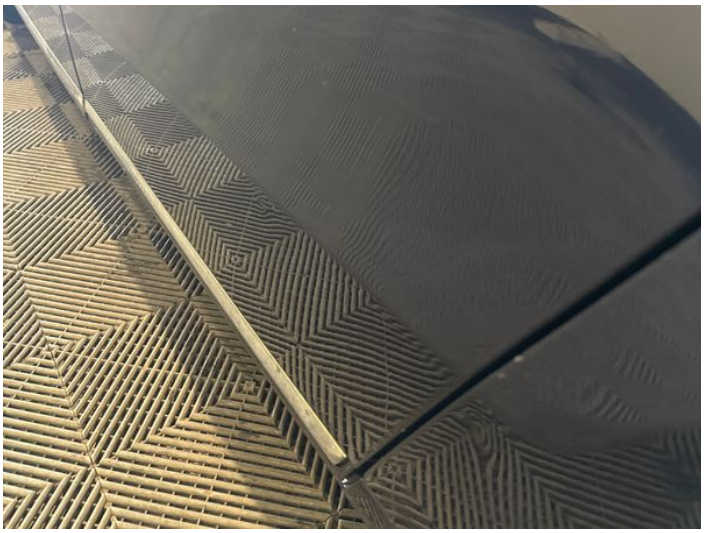
8: Wing nsf
Chipped
1 To 5

9: Door nsf
Dented
With Paint Damage

10: Door nsr
Dented
Between 10mm + 30mm

11: Door nsr
Scratched
UpTo 25mm Thru Paint

12: Wheel nsr
Scratched
Over 50mm

13: Qtr Panel nsr
Scratched
Over 25mm Thru Paint

14: Bumper Rear
Scratched
Over 100mm Thru Paint

15: Boot Lid
Chipped
1 To 5

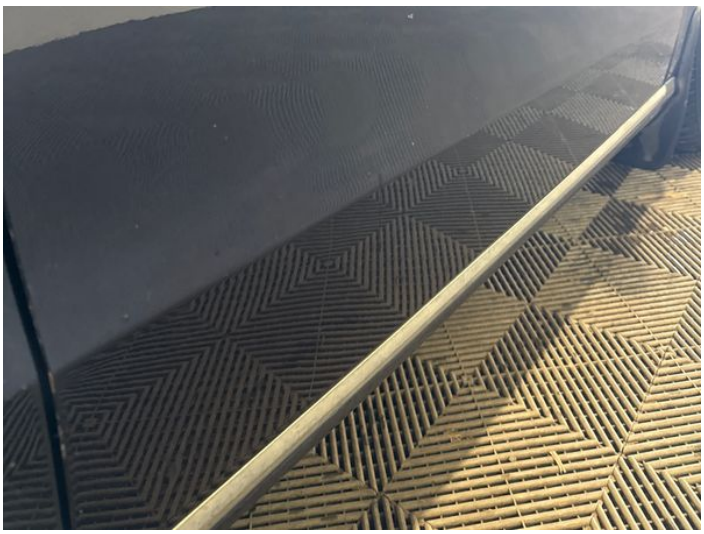
16: Qtr Panel osr
Scratched
Over 25mm Thru Paint

17: Wheel osr
Scratched
Over 50mm

18: Door osr
Dented
With Paint Damage

19: Door osf
Scratched
Over 25mm Thru Paint

20: Wing osf
Scratched
Over 25mm Thru Paint

21: Wheel osf
Scratched
Over 50mm

22: Roof
Chipped
Edge Chip
