VEHICLE INSPECTION REPORT

LD10YPU

Volkswagen Golf 1.4 TSI SE 5dr

Cat: D | Incident History

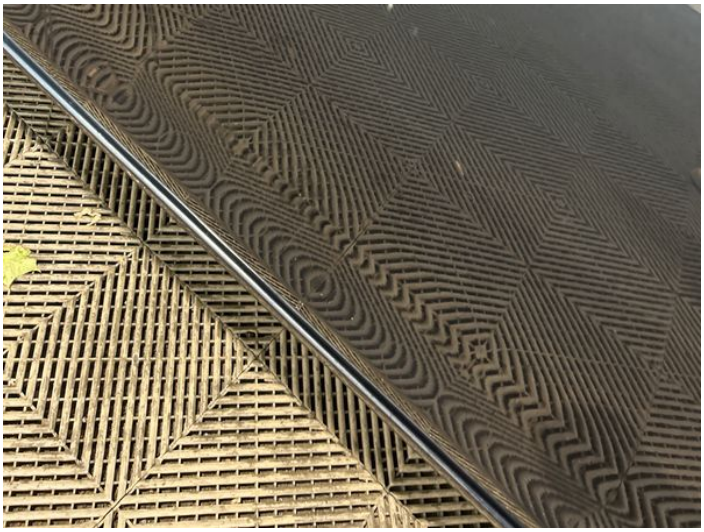
2: Wing osf
Scratched
Over 25mm Thru Paint

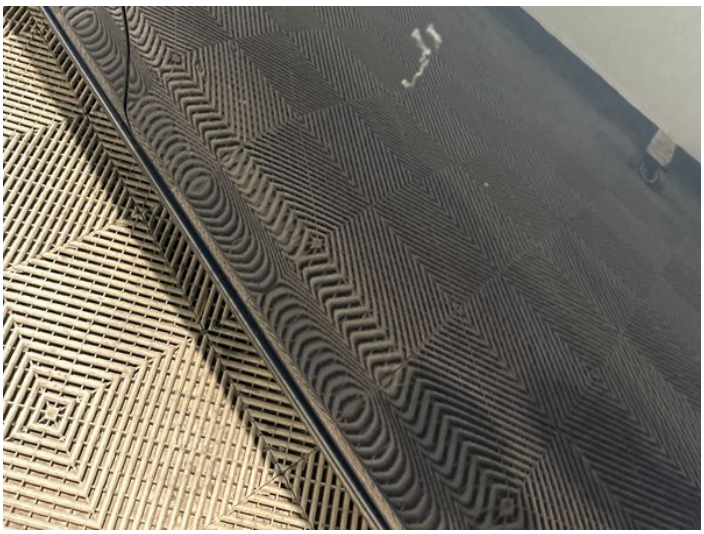
9: Bumper Rear
Scratched
Over 100mm Thru Paint
