VEHICLE INSPECTION REPORT

MT68FHR

Hyundai Tucson 1.6 GDi SE Nav 5dr 2WD

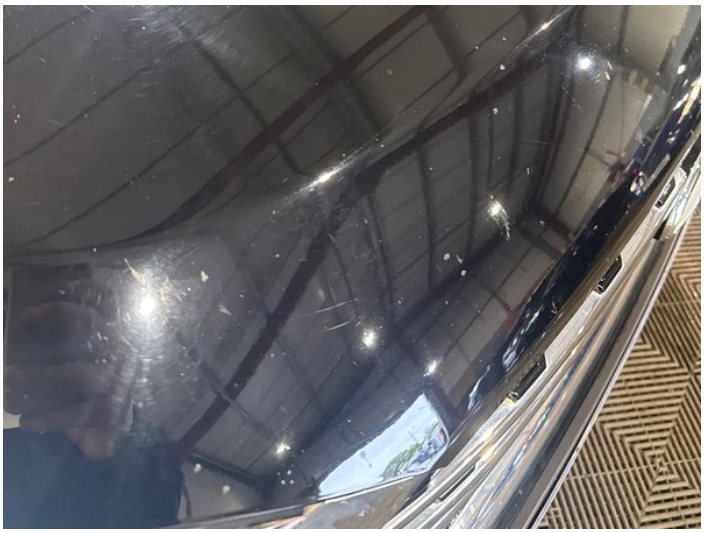
1: Bonnet
Chipped
Multiple Chips

2: Bumper Front
Scratched
25 to 100mm Thru Paint

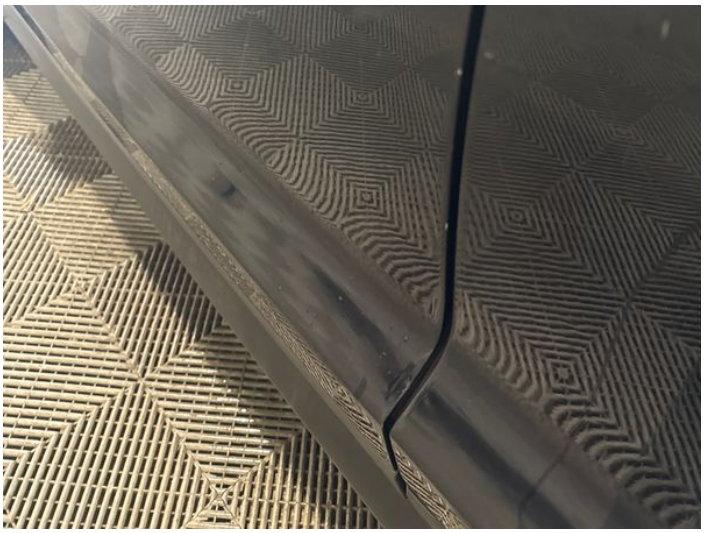
3: Wing nsf
Scratched
Over 25mm Thru Paint

4: Wheel nsf
Scratched
Over 50mm

5: Door Mirror Assy nsf
Scratched (Painted)
Over 25mm Thru Paint

6: Door nsf
Chipped
Edge Chip

7: Door nsr
Dented
Between 10mm + 30mm

8: Door nsr
Scratched
UpTo 25mm Thru Paint

9: Wheel nsr
Scratched
Up To 50mm

10: Qtr Panel osr
Dented
Between 10mm + 30mm

11: Door osr
Scratched
Over 25mm Thru Paint

12: Door osf
Scratched
Over 25mm Thru Paint

13: Door Mirror Assy osf
Scratched (Painted)
UpTo 25mm Thru Paint

14: Wing osf
Chipped
1 To 5

15: Screen Front
Chipped
UpTo 10mm

16: A Post os
Scratched
Over 25mm Thru Paint

17: Qtr Panel osr
Dented
Between 10mm + 30mm
