# VEHICLE INSPECTION REPORT

**GX69VTA**

## Volkswagen Tiguan 2.0 TDi 190 4Motion Match 5dr DSG

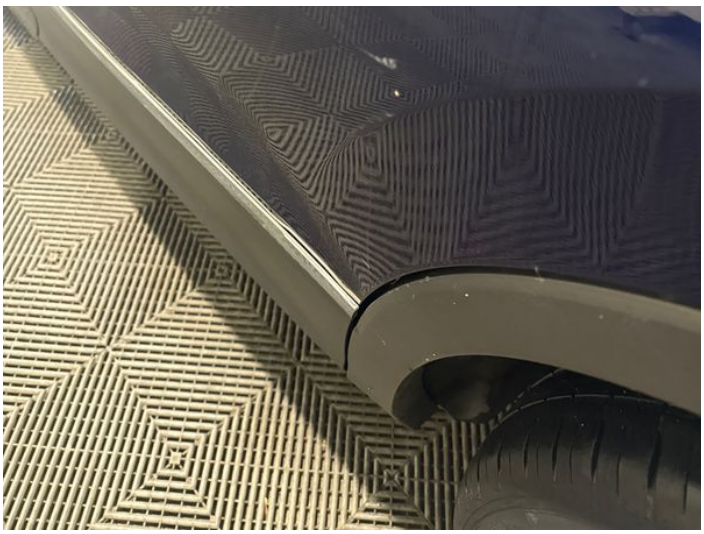
1: Bonnet
Scratched
Over 25mm Thru Paint

2: Bumper Front Moulding
Scuffed (Unpainted)
Over 100mm

3: Bumper Front
Scratched
25 to 100mm Thru Paint

4: Wheel nsf
Scratched
Over 50mm

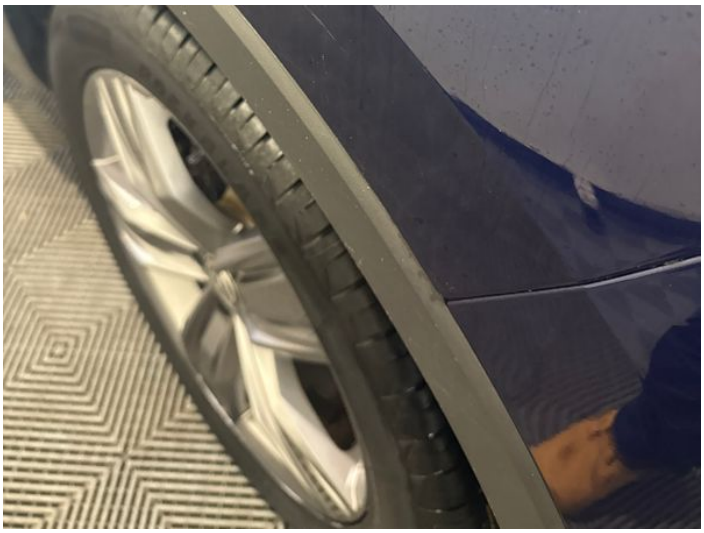
5: Wing nsf
Chipped
1 To 5

6: Door nsf
Dented
Between 10mm + 30mm

7: Door nsf
Chipped
Edge Chip

8: Door nsr
Scratched
Over 25mm Thru Paint

9: Door nsr
Dented
2 Or Less UpTo 10mm

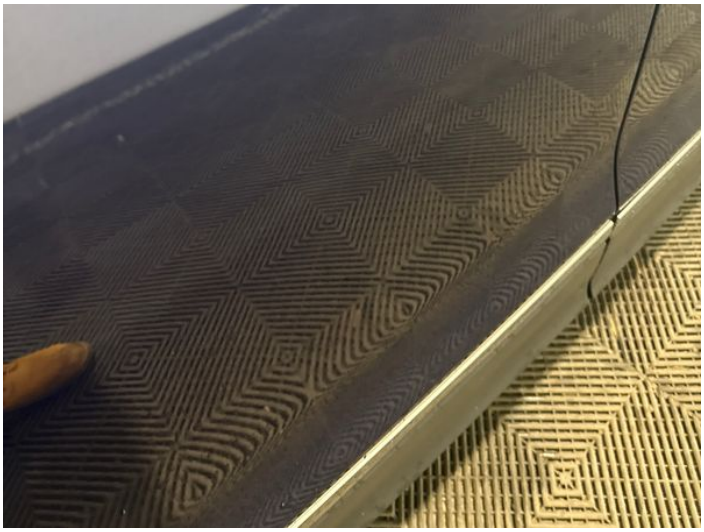
11: Qtr Panel nsr
Scratched
UpTo 25mm Thru Paint

12: Bumper Rear
Scratched
Over 100mm Thru Paint
