VEHICLE INSPECTION REPORT

TJ70MOD

Mercedes-Benz GLB GLB 220d 4Matic AMG Line Prem 5dr 8G-Tron [5 seat]

nama GRADE 3

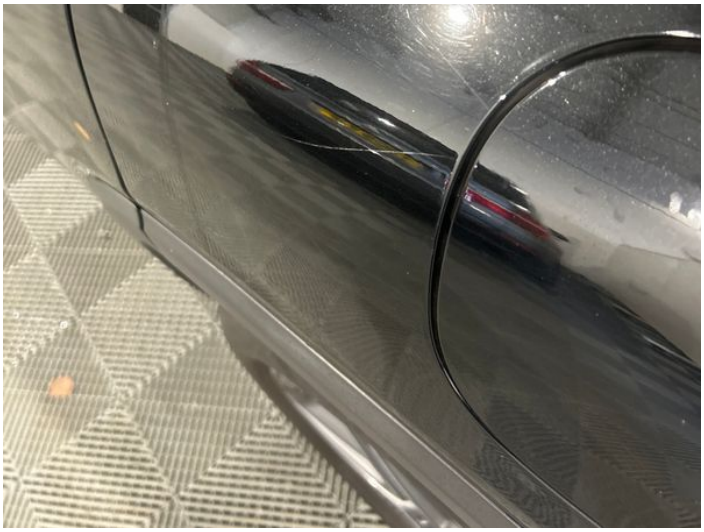
Damage Photos

1: Wing osf
Chipped
1 To 5

2: Door osr
Chipped
1 To 5

3: Qtr Panel osr
Dented
2 Or Less UpTo 10mm

4: Qtr Panel nsr
Scratched
Over 25mm Thru Paint

5: Wheel nsr
Corroded
Light

6: Door nsf
Chipped
Edge Chip

7: Wing nsf
Chipped
1 To 5

8: Bonnet
Chipped
1 To 5

9: Bumper Front
Scratched
UpTo 25mm Thru Paint

10: Boot Lid
Dented
Over 30mm
